BRUNSWICK STEAM ELECTRIC PLANT, UNIT 2
NRC DOCKET NO. 50-324
OPERATING LICENSE NO. DPR-62
NUREG-0619 FEEDWATER NOZZLE AND SPARGER EXAMINATION RESULTS

FEEDWATER SPARGER
CIRCUMFERENTIAL CRACKING EVALUATION
FOR BRUNSWICK UNITS 1 AND 2
General Electric Report GE-NE-523-112-1191
November 1981

FEEDWATER SPARGER
CIRCUMFERENTIAL CRACKING
EVALUATION FOR
BRUNSWICK UNITS 1 AND 2

BRUNSWICK STEAM ELECTRIC PLANT UNIT 2
NINETH REFUELING OUTAGE - OCTOBER, 1991
INVESSEL VISUAL INSPECTION (IVVI)
INSPECTION REPORT AND VIDEO REVIEW

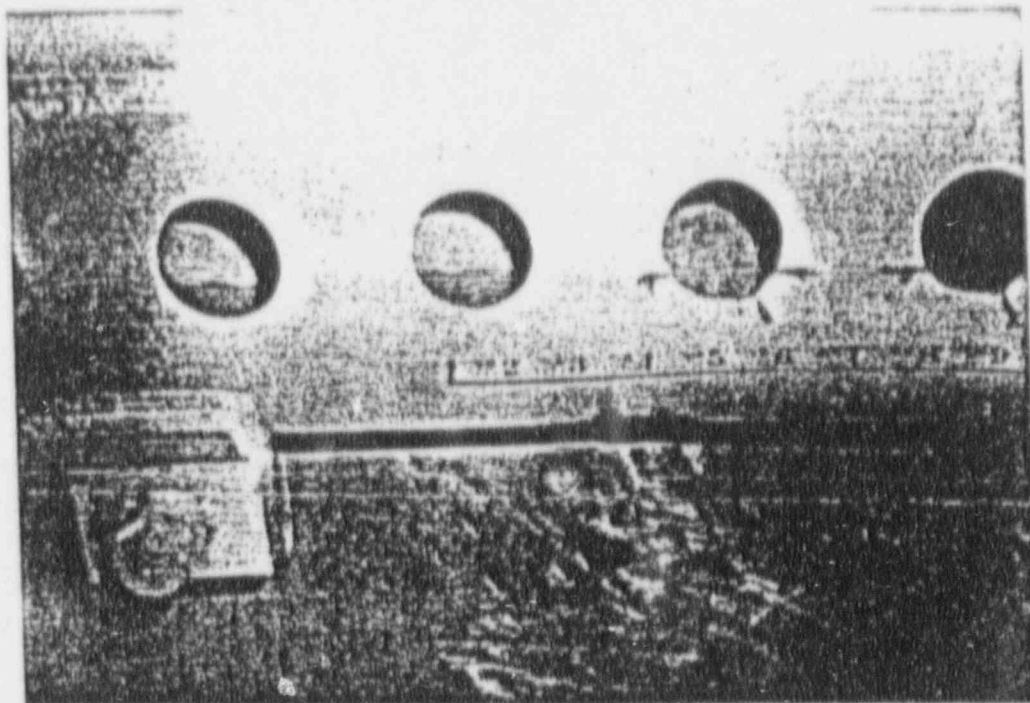
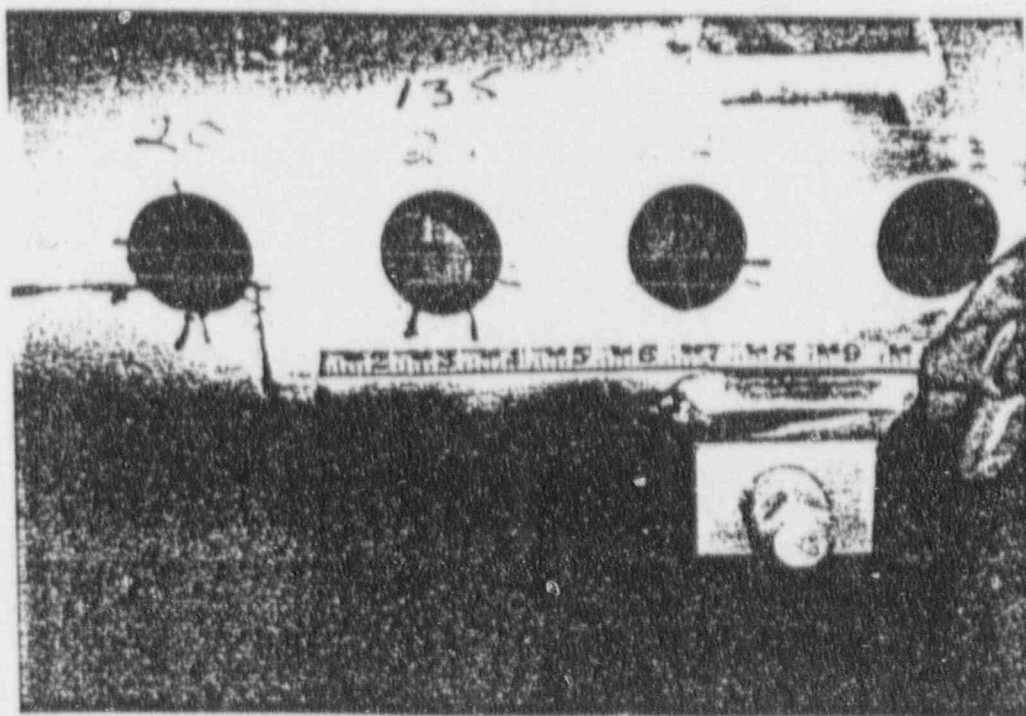
Figure 2-1. Results of 1989 Sparger PT Inspection

- The Unit 2 inspection showed the longest circumferential crack to be about 2 inches long. Comparison of inspection results from this outage and the previous outage for one of the cracks indicates that no significant crack growth occurred during the last cycle.

135° HOLE # 17, & 18

The circumferential welds were LP tested and ultrasonically tested (UT). The LP tests show the longest crack to be 2 inches. The UT results show that the crack lengths inside the spargers are no more than the LP indications on the outside surfaces. Comparison of a crack length measured during the last outage and during this outage shows that no significant crack growth has occurred.

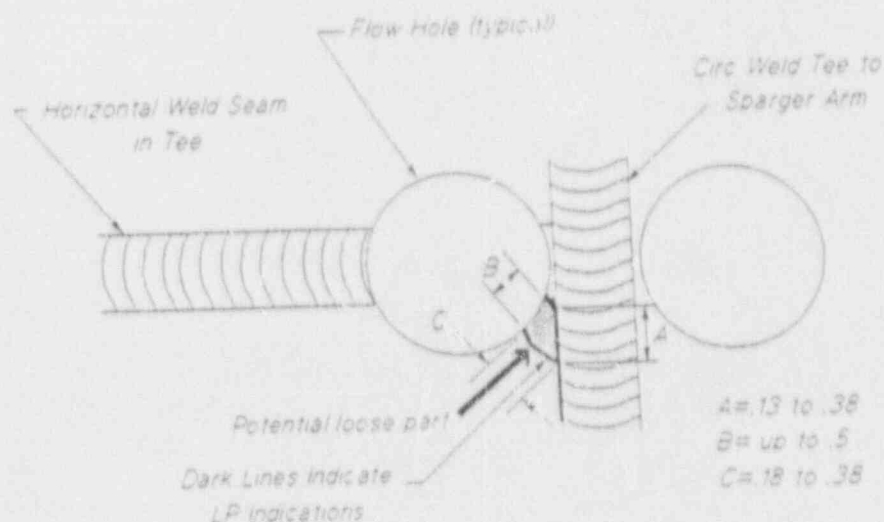
1. No relevant indications were found on the nozzle inner blend radius.
2. Crack growth continues on the flow holes but no pieces have separated. Note: The pieces did not separate during the hydrolase cleaning operation using a 20,000 psi plus hydrolaser unit prior to the examination. In addition to the horizontal piece between the flow holes which has been previously addressed by GE, the size of other potential loose pieces is as shown. The largest of which has also been previously addressed by GE.

POTENTIAL FEEDWATER SPARGER LOOSE PART
