ENGINE REBUILD REPORT

Motor Vessel Columbia

State of Alaska
Division of Marine Transportation
Department of Public Works

March 31, 1981

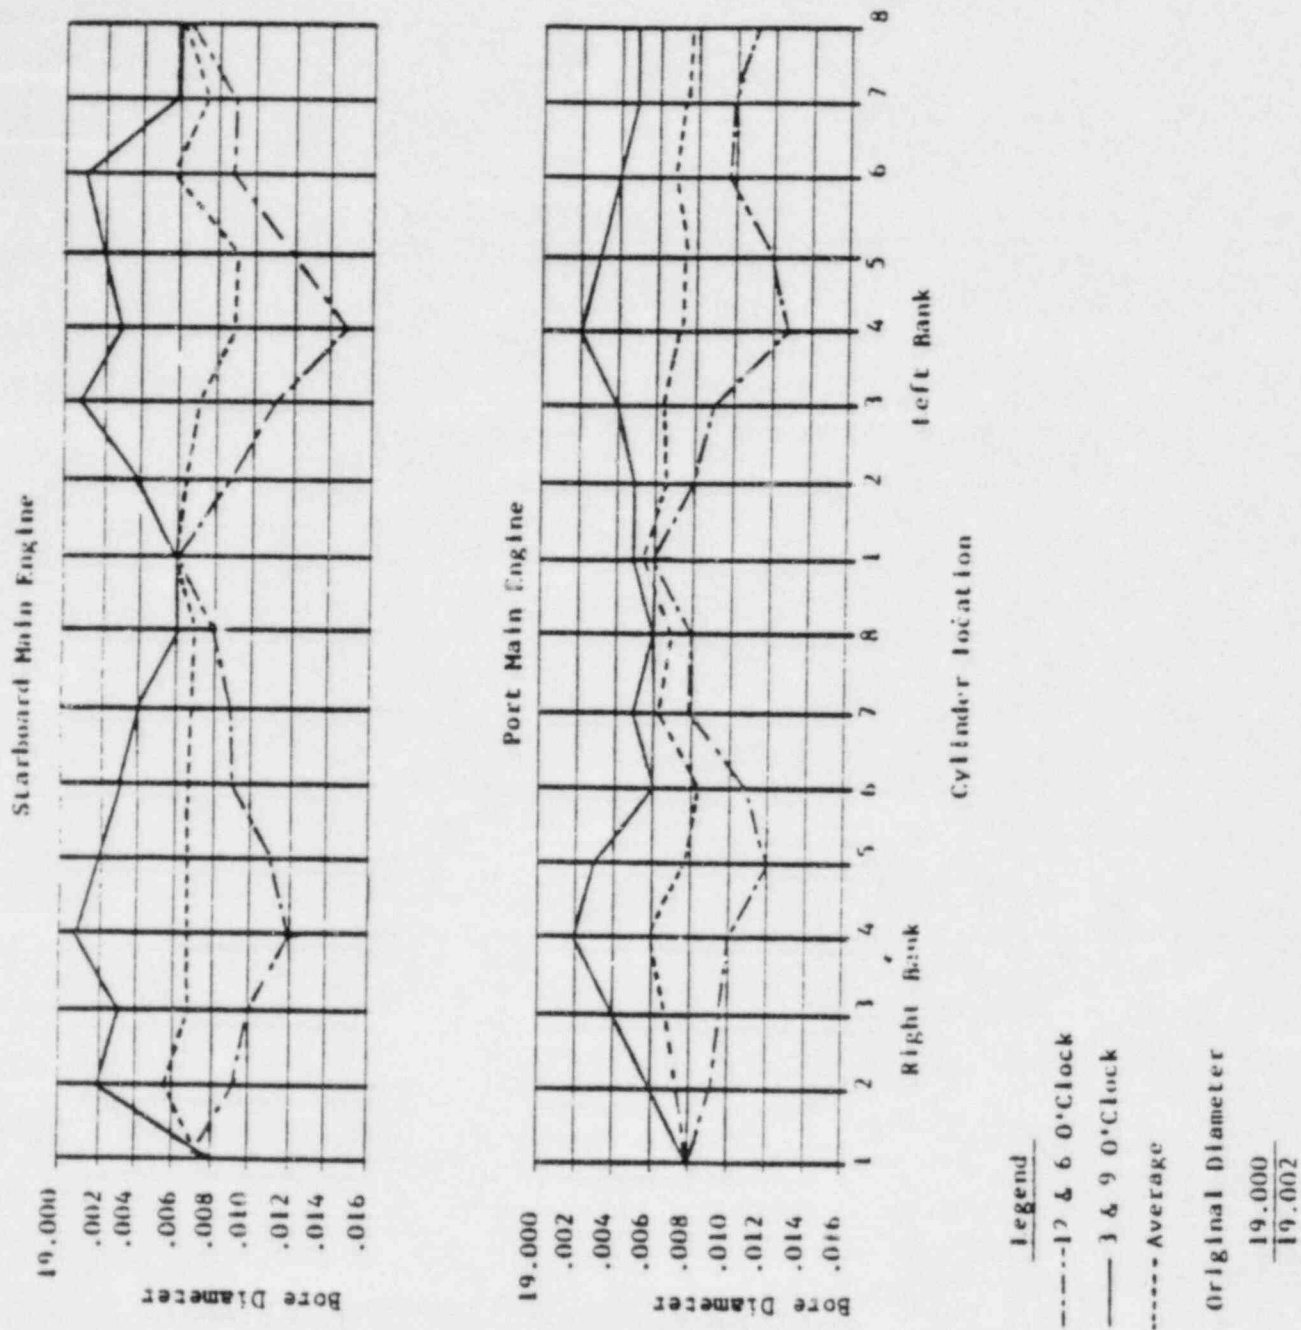
Figure 3. Bore Diameter, Engine Blocks, M/V Columbia, December 19, 1980

Figure 3 data show a gradual increase in all cylinder diameters and a pattern of non-symmetrical change similar for all four blocks. All the bore diameters have grown uniformly between .006 and .007 inch over the lifetime of the engine. This increase indicates an interstitial flow within the metallic structure of the block that has allowed a permanent change in dimensions.

In addition to the uniform increase in all bore diameters, there is a pattern of non-uniform deformation. While the cylinders at the ends of the blocks remain essentially circular the cylinders at the center show a gradual change to a maximum ovalness of .012 to .015 inch. This ovalness is a result of dimensional changes beyond the uniform increase in diameter to which all the cylinders are subject. It indicates that the structural webs between the cylinders are subject to the effects of creep.

Both uniform diameter increase and ovalness have resulted from metallic creep. Because the combined stresses (41,000 psi) are well above design limits for cast iron, metallic failure was expected in the intercylinder web areas and around the cylinder circumferences where the proximity of holes for cooling water and studs produce stress concentrations. Metallic failure was found and is discussed in Section V, Nondestructive Testing. T-4

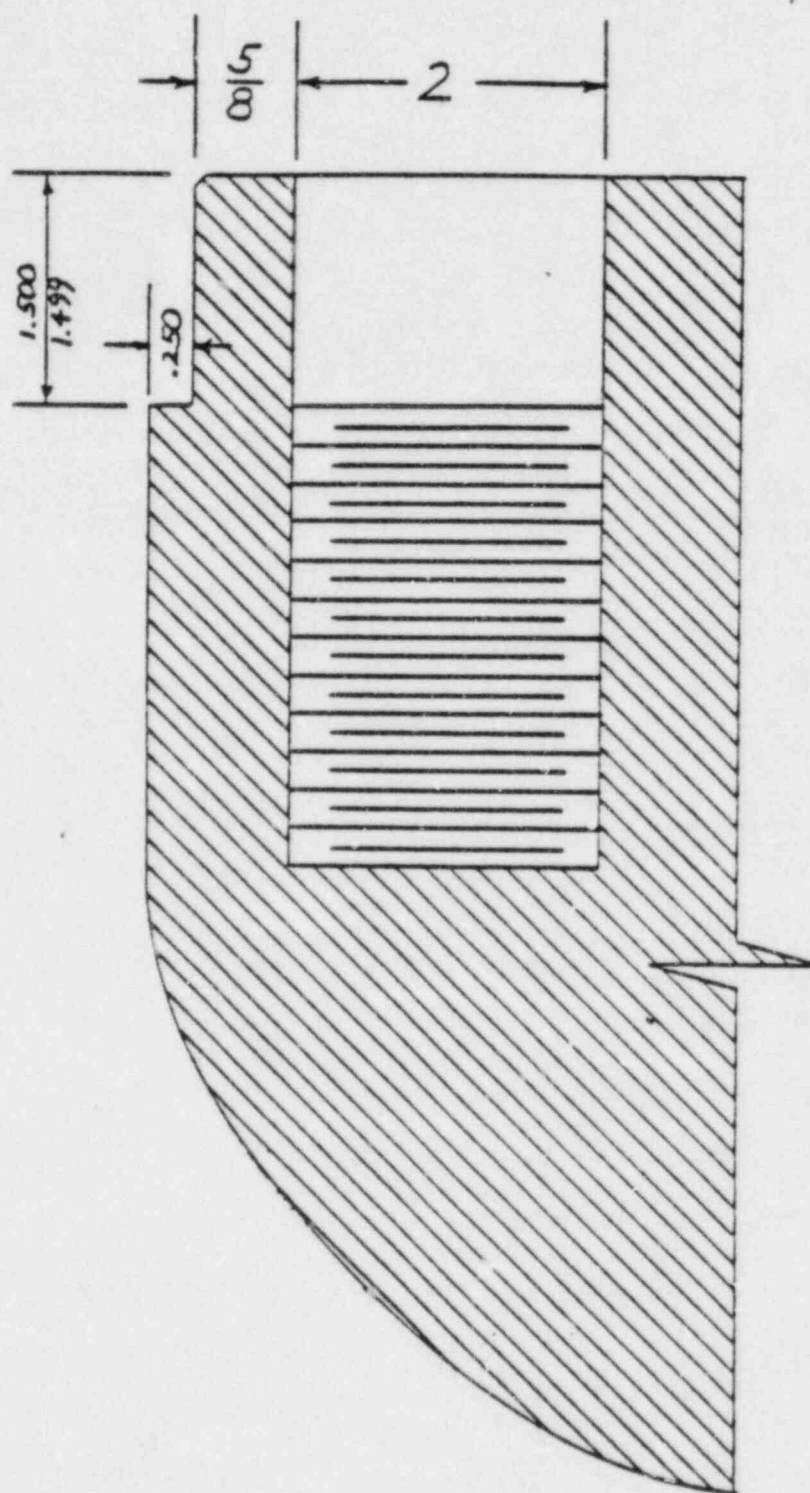
Figure 4. Counterbore and Stud Configuration

Additional stress on the counterbore lip was caused by the near presence of the termination of threads for the cylinder head studs as shown in Figure 4 (p. I-11). Both counterbore depth and the beginning of the threads in the block are 1.500 inches below the block surface leaving only a .625 inch space between the two. Because this space experiences extremely high stress concentration it was examined for the possibility of metal failure. Various types were found. T-6

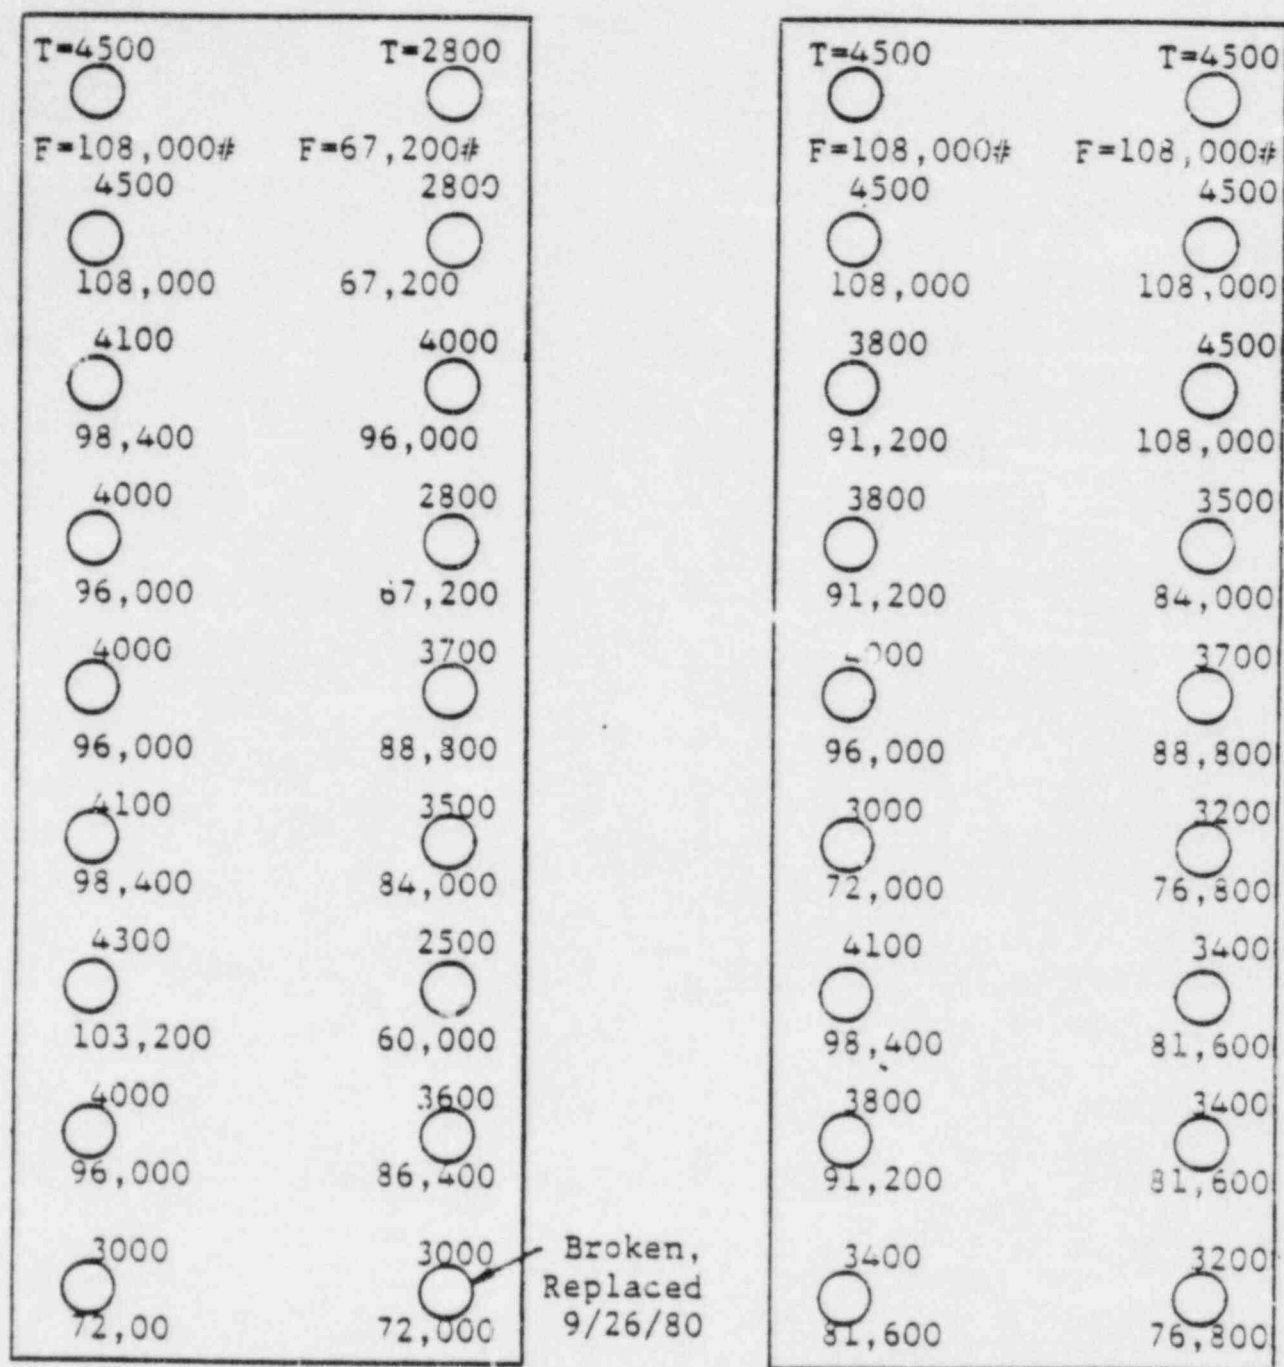
Figure 5. Block to Crankcase Bolts, Starboard Main Engine, December 31, 1980

On September 26, 1980, a bolt broke on the left rear block of the starboard main engine. Temporary repairs were made and the bolt was replaced on return to Seattle. During installation of the new bolt, the torque levels of all block bolts were checked by noting when the nuts moved during a retorquing procedure. The procedure used was to begin at one corner of the block and proceed down one side and back up the other. Figures 5 and 6 (pp. I-13 and I-14) show the recorded break-loose torque levels observed during this procedure and the force levels of preload in the bolts. (3)

In Figure 7 (p. I-15), the force from the calculated preload by the four bolts surrounding each cylinder is compared to the maximum force generated by the firing pressure. The question is whether or not, in the partially torqued condition observed, there was sufficient structural integrity in the preload forces to keep the engine properly together. The data show that for several cylinders on the starboard engine, preload force was inadequate, while on the port engine preload force was sufficient but not optimum.

To reduce the possibility of fretting, maximum torque on the block bolts must be maintained at all times. But, because of piston side thrust, it probably cannot be eliminated, only minimized. The procedure by which the bolts are brought to full torque is critical and is explained under Engine Alignment, page V-12.

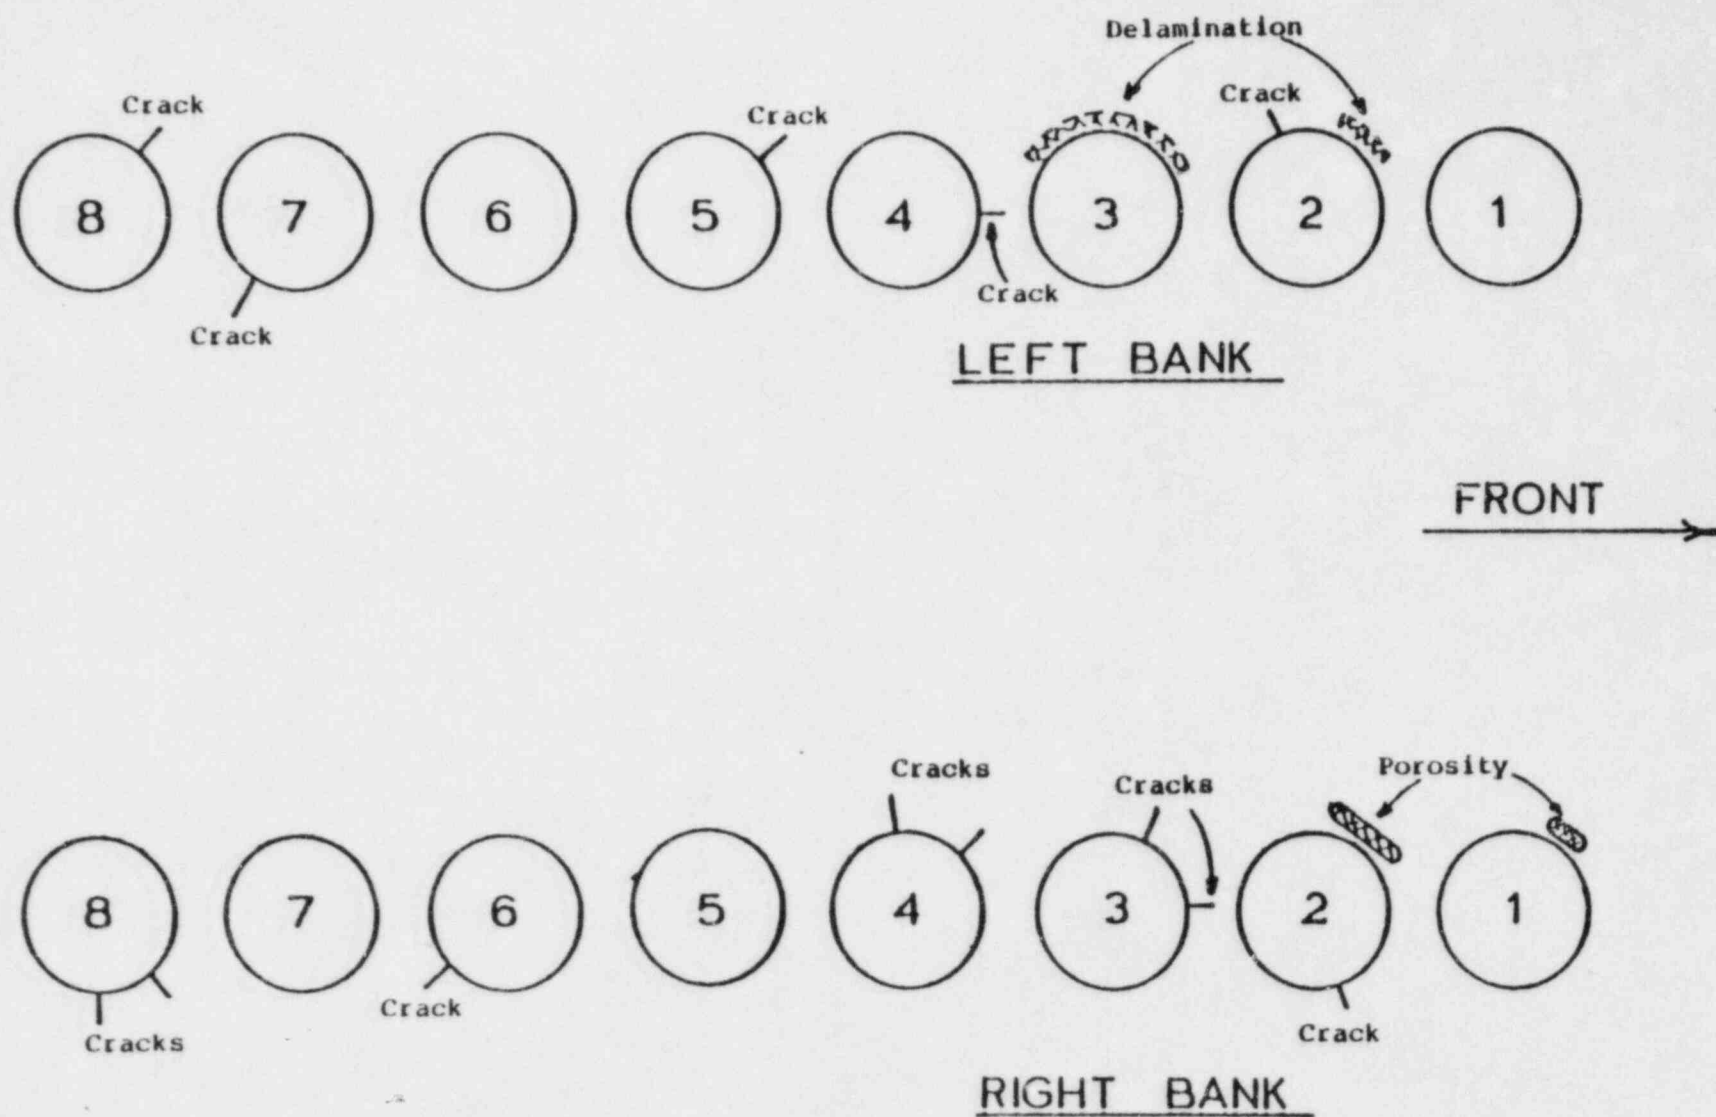
Figure 12. Nondestructive Testing, Starboard Main Engine

Fractures seen most frequently were radial cracks extending out from the cylinder counterbore. The radial cracks were either in areas of stress concentrations caused by holes for cooling water passage or stud drillings, or in the inter-web area between cylinders in the center of the block. The most destructive type of fracture was seen in cylinders 2 and 3 of the left bank of the starboard engine. Figure 14 shows the form of the delamination crack where the cylinder liner lip was separating from the block structure. This fracture prevented the liner from being properly installed and could have led to a catastrophic engine failure.

1. high compressive stresses on the counterbore lip,
2. localized stress condition from the combinations of sharp internal corner for lip (1/32 inch radius),
3. nearby drilling for waterjacket or stud,
4. termination of stud threading at the same level,
5. creep deformation, and
6. fatigue.

Because of the delamination cracks, one block was not serviceable, and so both blocks for the starboard engine were renewed.

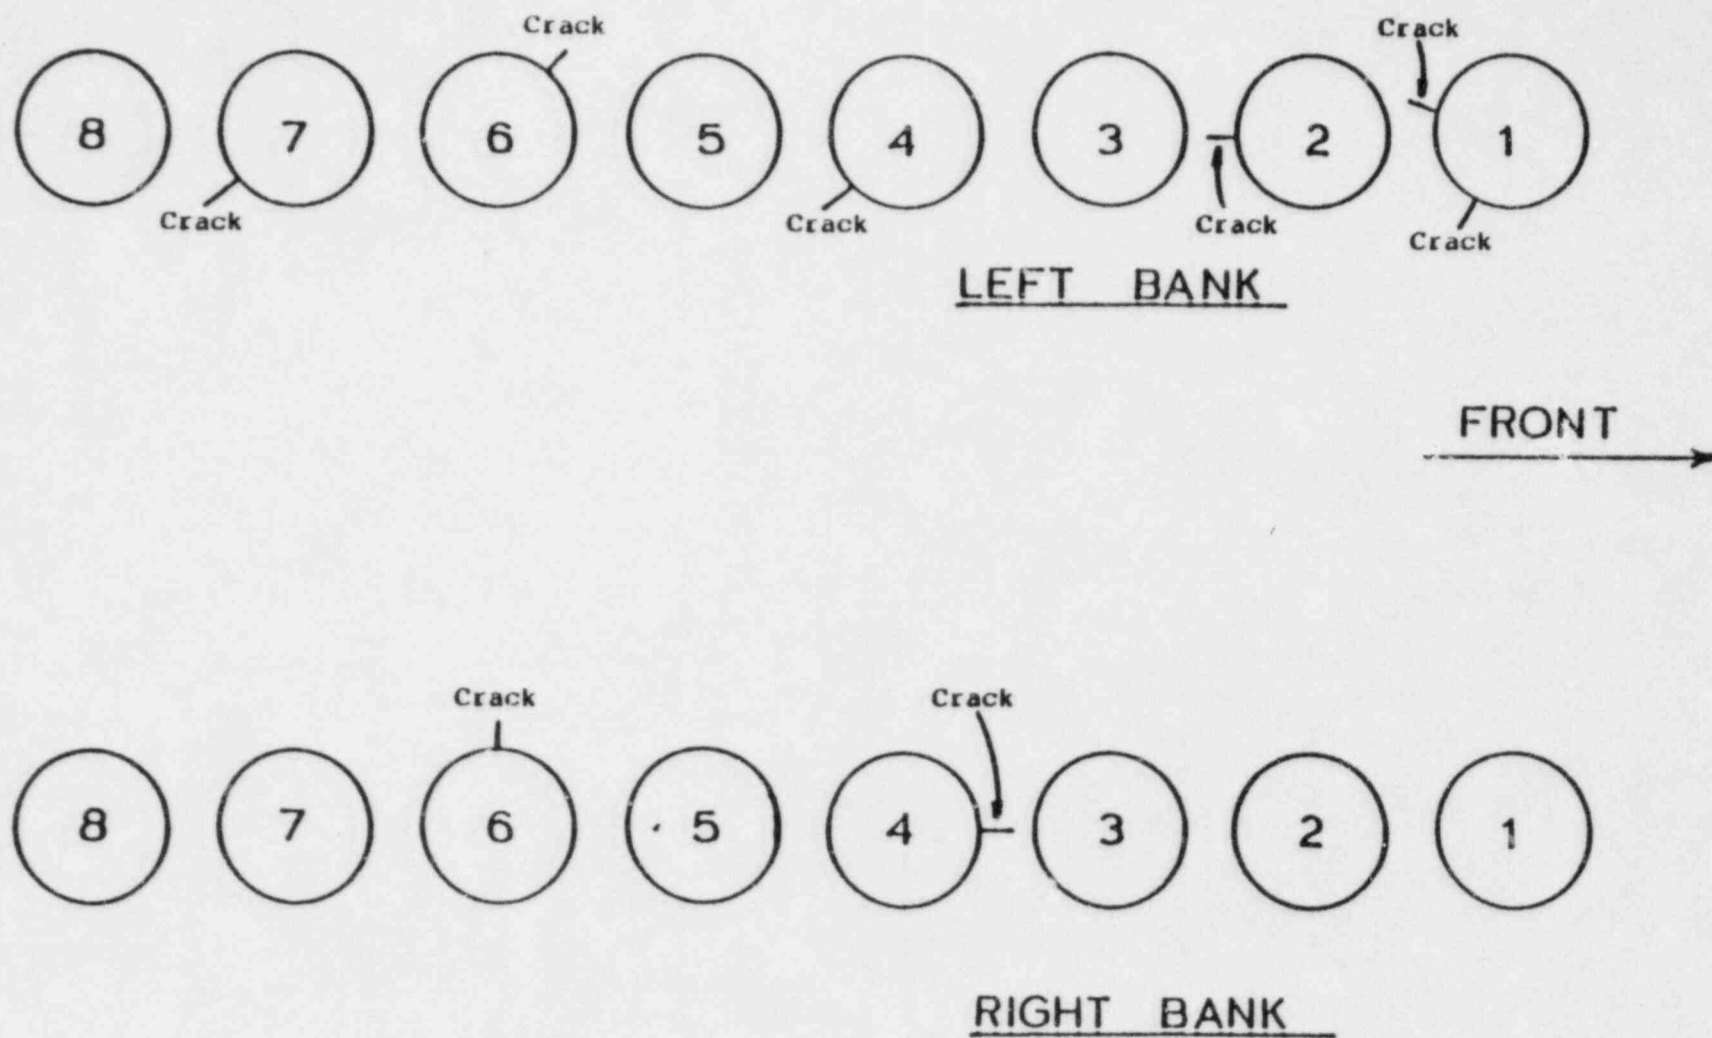
Figure 13. Nondestructive Testing, Port Main Engine

The port engine, although showing radial cracks, did not have the delamination failure seen in the starboard engine. The port engine was renovated by boring the block to a larger diameter and resurfacing the counterbore lip to a consistent depth for all cylinders. When the first cuts were made on the counterbore lip, the exposed surface showed shear fractures extending downward in the counterbore lip. Specific ultrasound probes for curved surfaces confirmed the shear fractures in cylinder 3 of the port engine. Cylinder 14 also had a shear fracture at the counterbore lip.

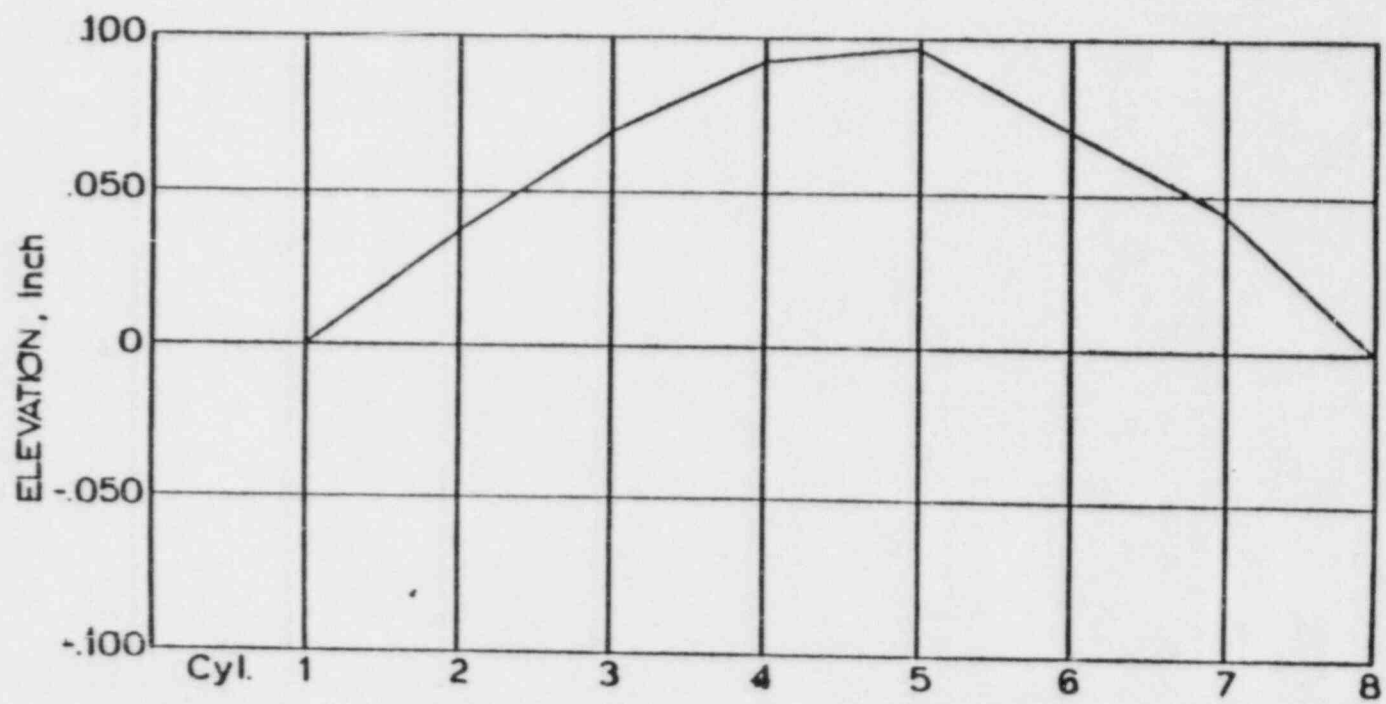
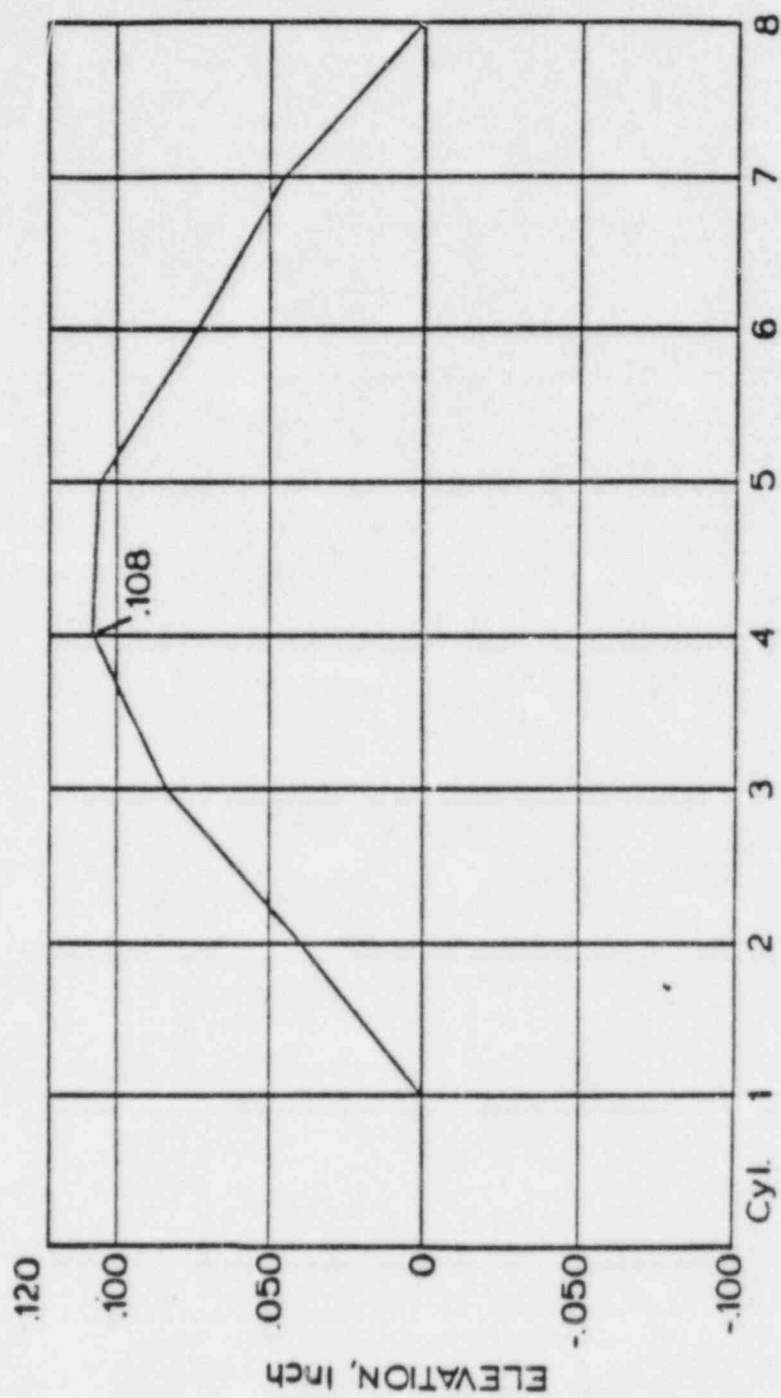
Figure 18. Elevation of the Exhaust Side of the Cylinder Block for the Left Bank, Port Main Engine

The elevations are shown in Figures 18 and 19 (pp. V-4 and V-5). The surface elevation shows the block surface was bowed upward and twisted in the center. Cylinder 4 rose .108 inch and twisted .018 inch downward in the center. Cylinder 5 showed values nearly identical to those of cylinder 4. Cylinders on either side of the center taper to a uniform elevation at each end. All curves

return to zero at the ends because the measurements were taken using the ends as reference points. This bowing upward was a concern in the rebuilding. Upward bowing was removed in the preliminary alignment procedure and it must be remembered for future maintenance procedures.

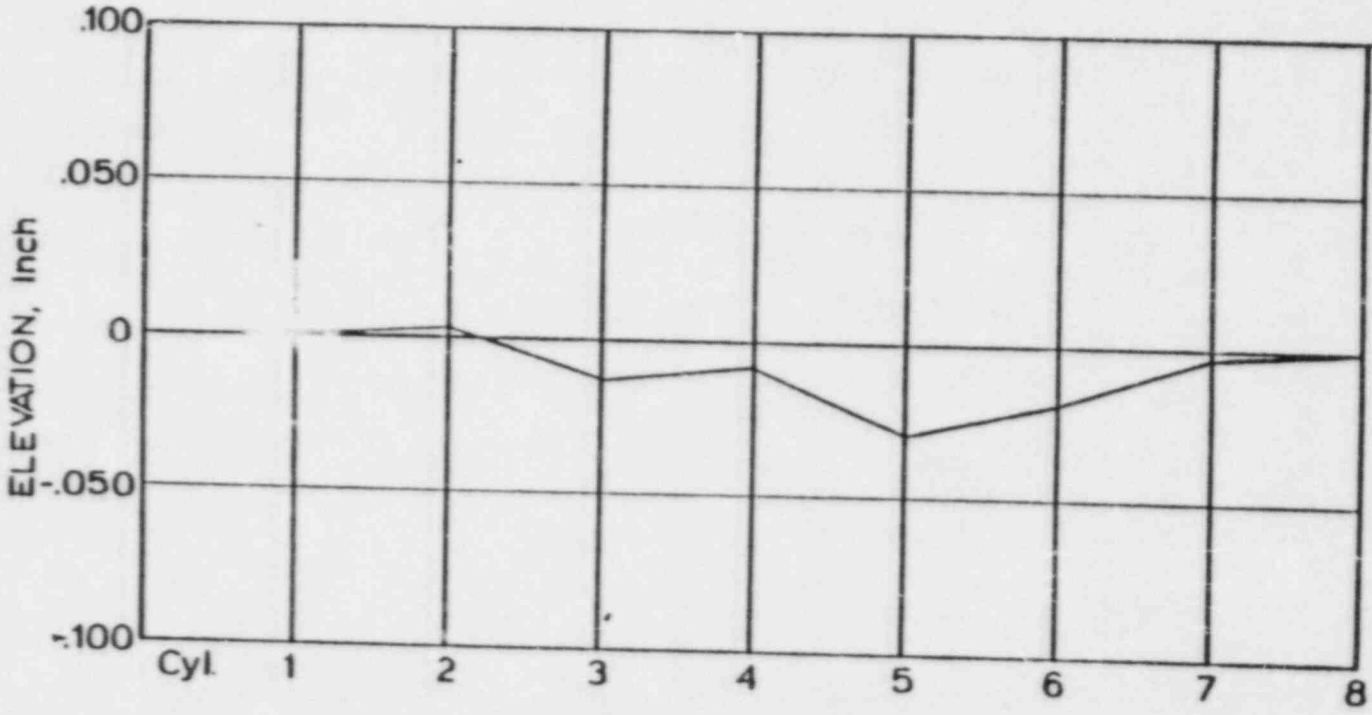
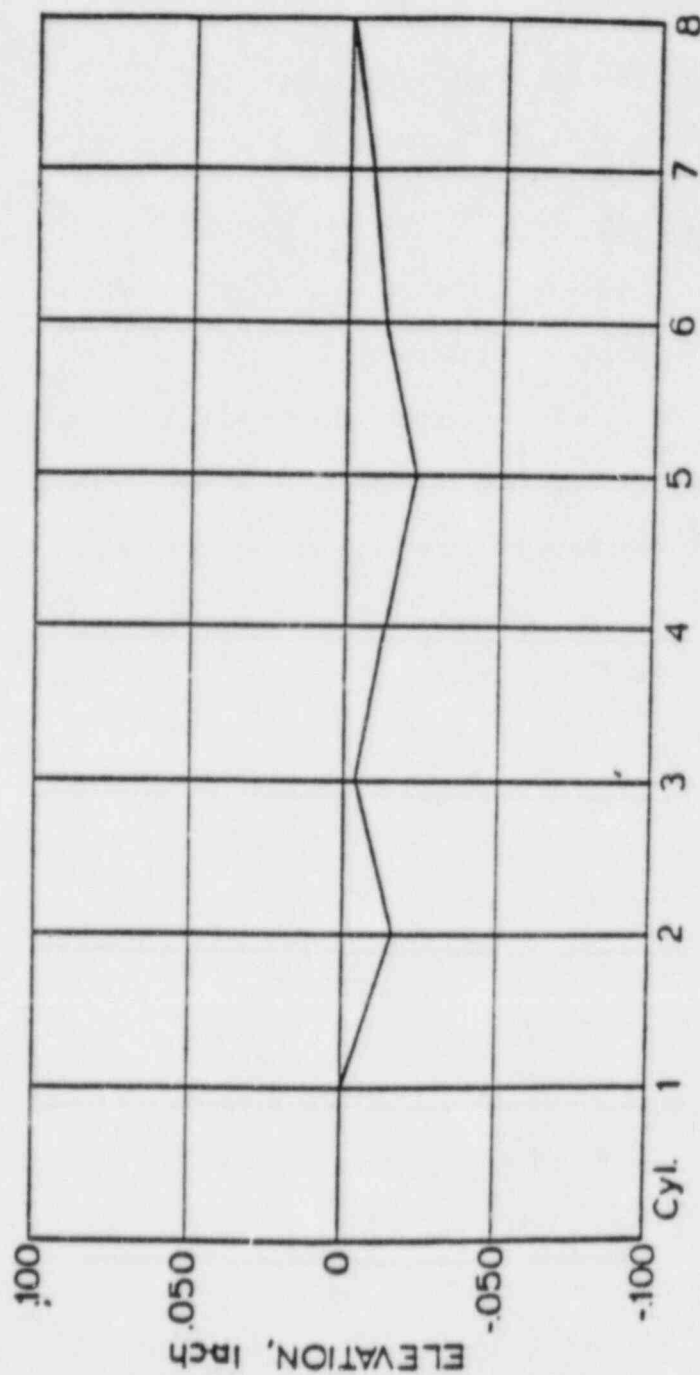
Figure 22. Elevation of the Exhaust Side of the Cylinder Block for the Left Bank, Starboard Main Engine

The left bank drops in the center and is similar to the right bank for the rear half of the engine. See Figures 22 and 23 (pp. V-8 and V-9). The front half of the engine is significantly different from the front half of the right bank. It warped severely where the surface had some s-twists. Severe delamination of the counterbore lip occurred in this region. The combination of metal failure, loosened tie rods, and warped surfaces may be interrelated.

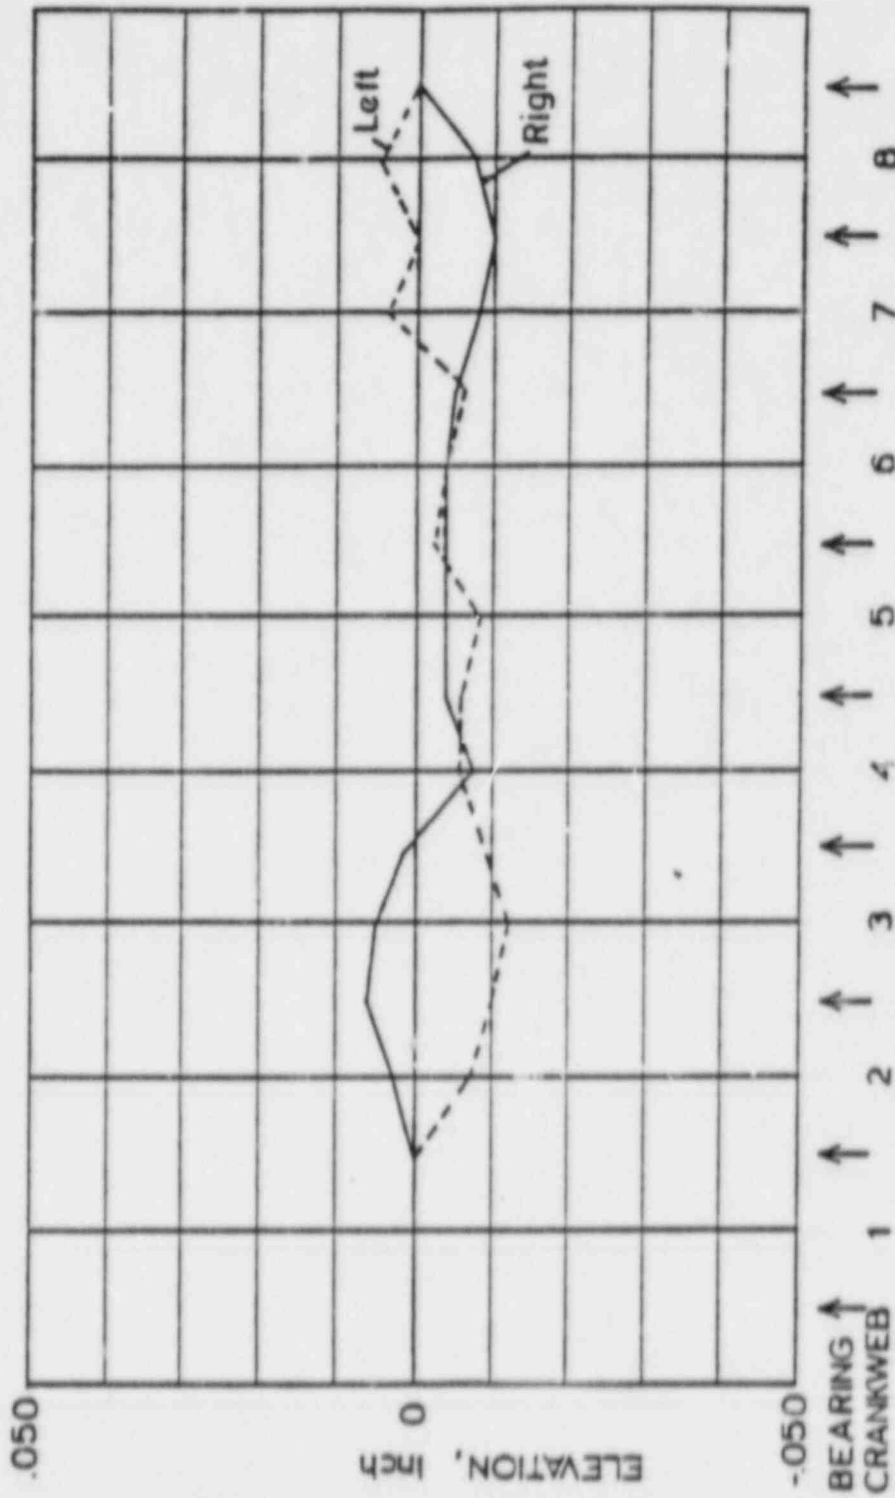
Figure 28. Elevation of Cylinder Blocks for Port Main Engine After Relaxing and Retorquing All Structural Bolts

Figure 28 (p. V-16) shows the optical sighting of the port main engine blocks after relaxing and properly retorquing all the base and block bolts. Both block surfaces have a maximum of .010 inch of deflection and the previous bowing, sagging and warping had been removed.

A major portion of the misalignment was due to inaccurate prestress within the engines resulting from a relaxation of torque in the nuts and an improper retorquing procedure during repair operations. The critical effect of proper torque on all structural bolts mandates that proper torque be maintained in the future.

The preliminary report (Appendix) recommended properly retorquing the block bolts of the engines during rebuilding. While the engines were accessible, the base bolts were checked for proper torque and were found to be below acceptable limits. All structural bolts in the port engine were relaxed and retorqued according to the procedure recommended by the Enterprise Company. Retorquing was done in a proper criss-cross pattern from the center outward in three graduated steps of increasing torque. The surfaces of the blocks were checked again.
