Subject: Byron and Braidwood Stations Units 2 and 3
Response to IE Bulletin 84-03
NRC Docket Nos. 50-454/455 and 50-456/457

RESPONSE TO IE BULLETIN 84-03
REFUELING CAVITY WATER SEAL

BYRON AND BRAIDWOOD STATIONS

Evaluation of Byron/Braidwood Refueling Cavity Water Seal

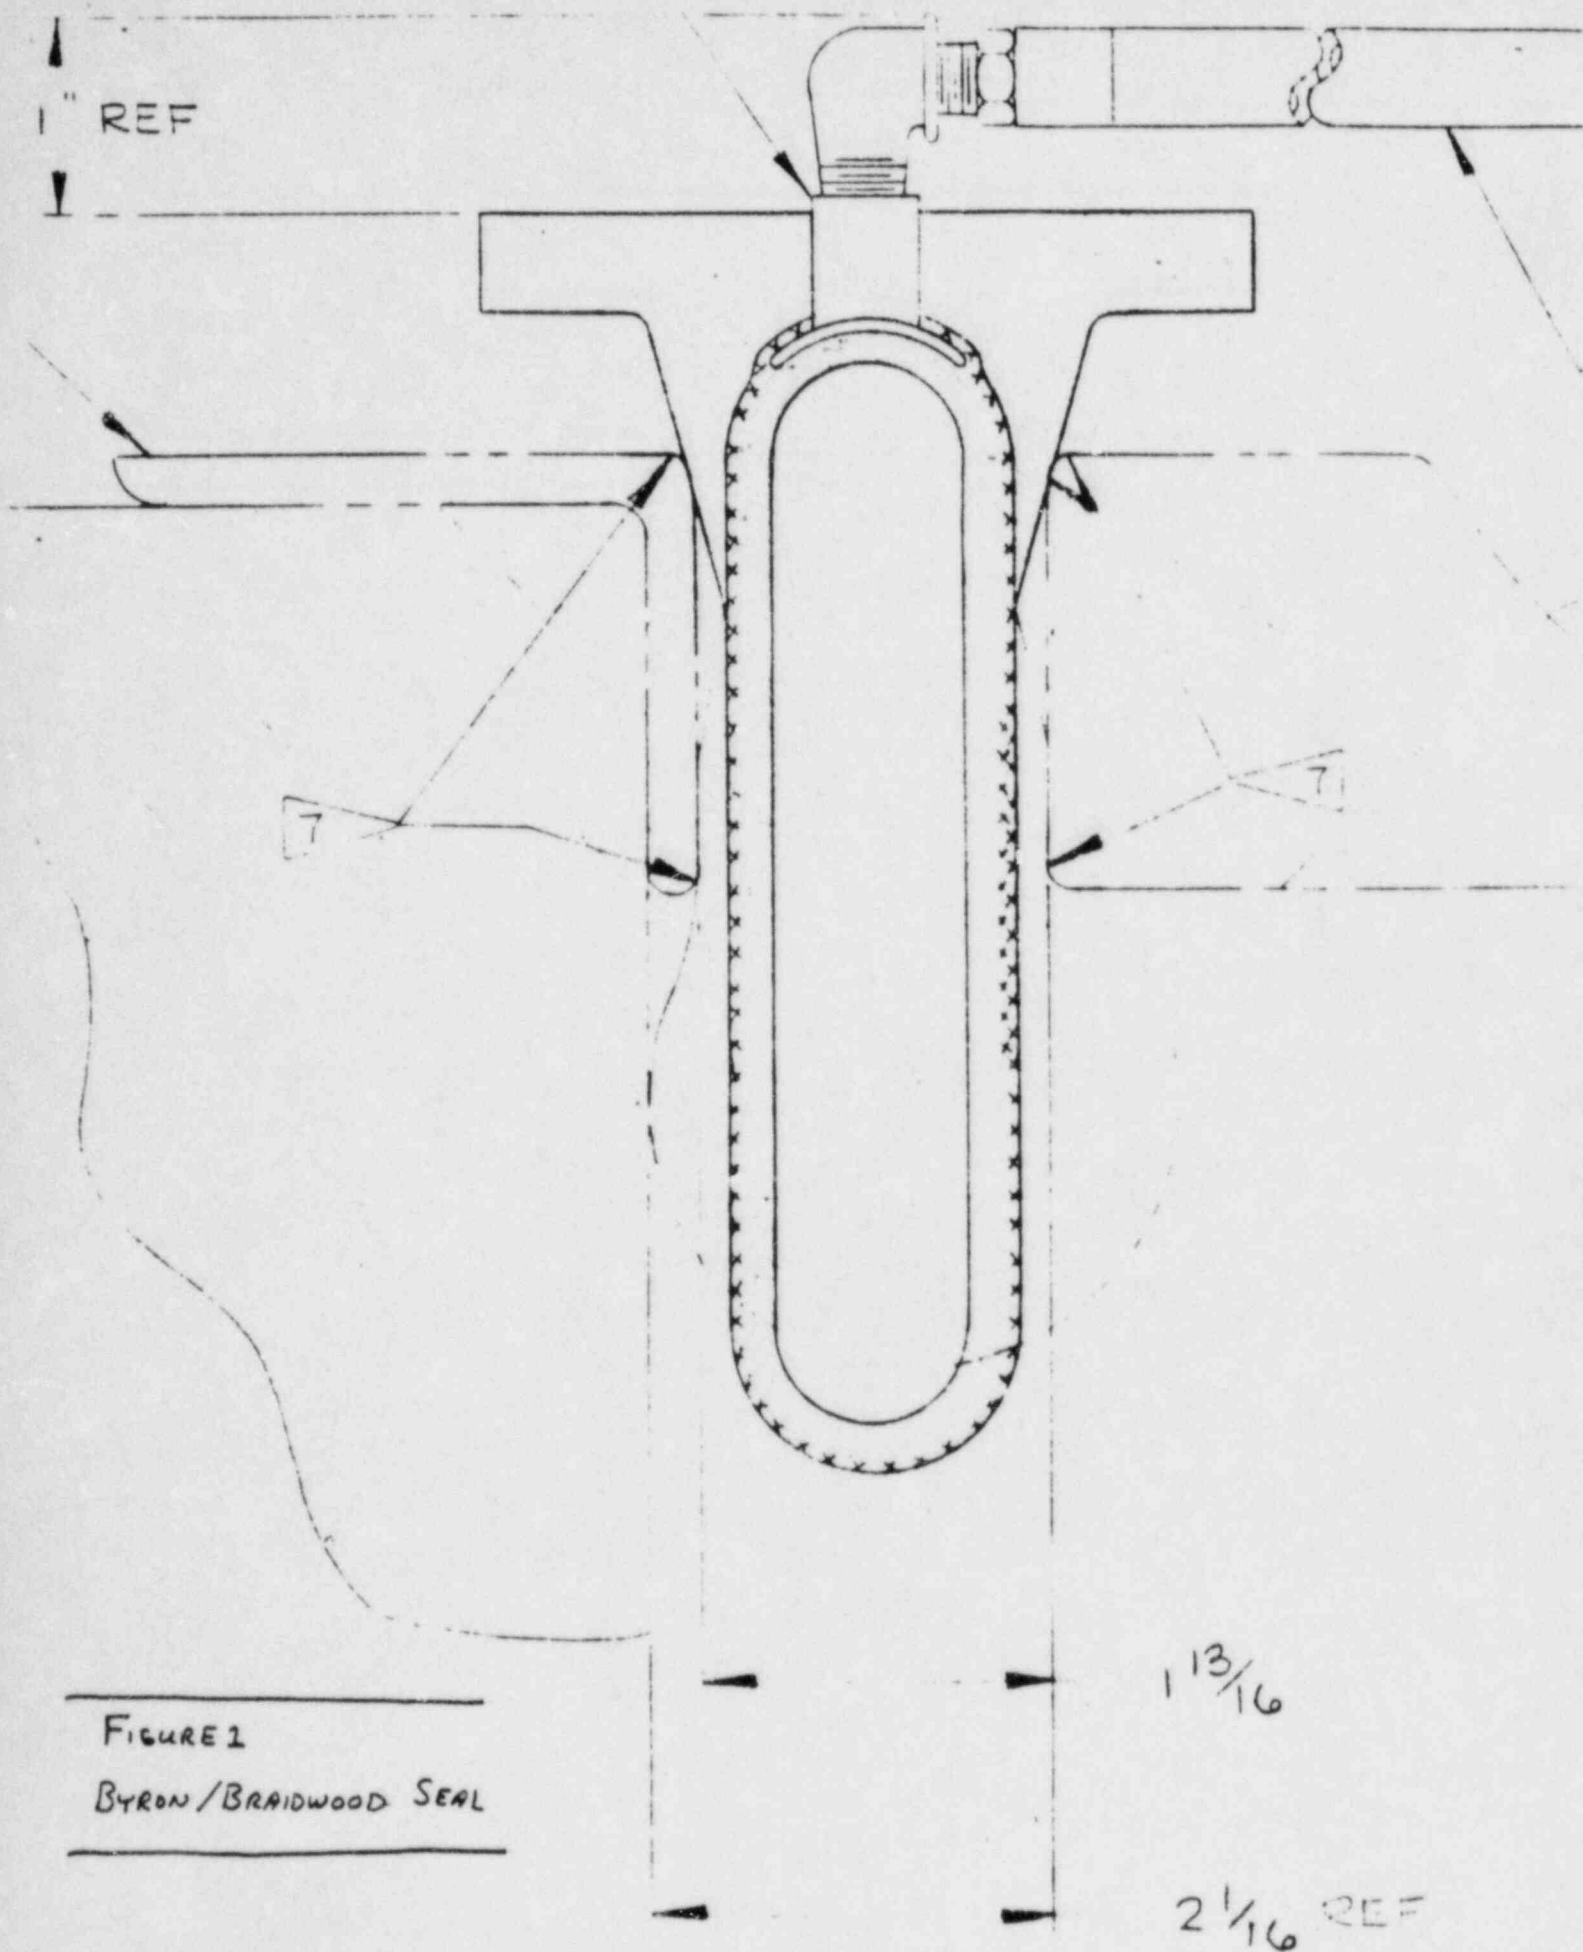
FIGURE 1

The Byron/Braidwood refueling cavity seal consists of a single split-joint type PRS 585 inflatable rubber ring supplied by the Presway Corporation. Figure 1 shows a cross section of the Byron/Braidwood seal. Figure 2 shows a cross section of the Haddam Neck seal arrangement. The major difference between the two designs is the steel ring in the HN seal which requires that two inflatable rubber seals be in place on either side of the ring. The ring is about one foot wide with a two inch gap on each side of it. The ring is supported by nine hangers (strongbacks) arranged around the reactor vessel flange. It is reported that this ring can be displaced horizontally, (there is no alignment fixture for the seal ring) thus changing the width of the gaps on each side of the ring. It is believed by Presway that this actually happened and contributed to failure of the seal. The Byron/Braidwood seal consists of a single rubber seal, similar to one of the Haddam Neck seals, but with a fixed, unadjustable gap width. The problem of misalignment therefore does not exist at Byron/Braidwood.

These dimensions are all in the conservative direction against failure of the Byron/Braidwood designs in the event of overinflation. Overinflation of the seal is thought to cause failure by causing the seal top to buckle downward. This effect combined with the water pressure from the filled cavity forces the seal through the cavity floor gap. The Byron/Braidwood seal top is made of harder rubber and is wider than the Haddam Neck design and therefore less susceptible to buckling. Also, the gaps at Byron/Braidwood are narrower than the Haddam Neck gaps, and more importantly, not adjustable.

BYRON/BRAIDWOOD SEAL

Although very unlikely to occur, this event has potentially serious consequences. Therefore we are adding precautions to the station fuel handling procedures to ensure that the seal is inflated to an acceptable pressure range. The seal dimensions and the reactor vessel/refueling cavity floor gap tolerances will be checked against design values, and the design will be reviewed with the supplier. Unless further information from the Haddam Neck event warrants it, neither we nor the seal supplier are recommending any design changes to the Byron/Braidwood seal at this time.

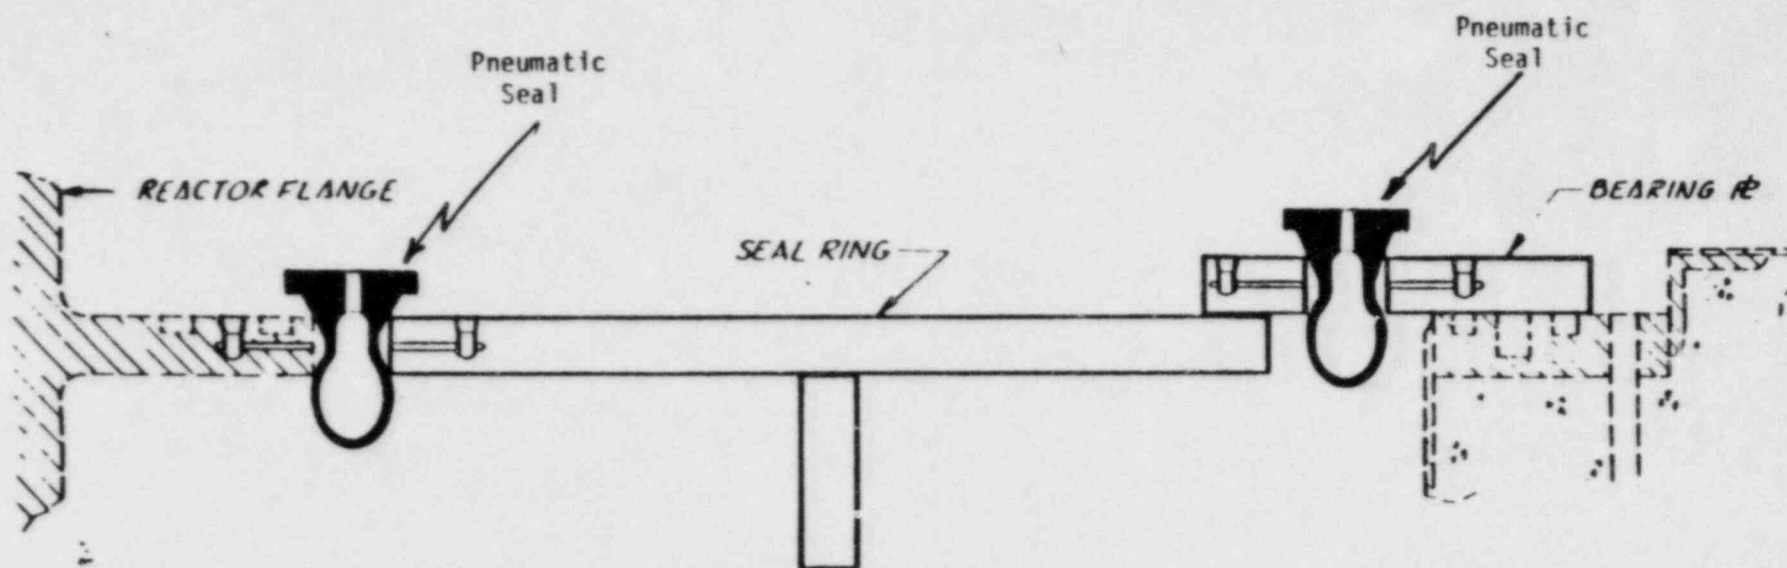
Figure 2 - Haddam Neck Refueling Cavity Water Seal

Important design differences between the Byron/Braidwood refueling cavity seal and the Haddam Neck seal make a loss-of-seal integrity event at Byron/Braidwood significantly less likely to occur. Discussions with the seal supplier and the Haddam Neck staff indicate the cause of the seal failure to be misalignment and/or overinflation of the seal bladder, or improper design tolerances. Based upon these discussions and the evidence to date, it is our opinion that overinflation of the seal to the pressure reported at Haddam Neck without a corresponding misalignment or out-of-tolerance problem with the seal would not cause a seal failure at Byron/Braidwood. Since the Byron/Braidwood design does not require alignment of any sort, we conclude that occurrence of this event at Byron/Braidwood remains very unlikely.

- (1) There are two gaps in the Haddam Neck seal arrangement as shown in Figure 2.
- (2) The durometer readings of the seal top are 60 and 40 for the Byron/Braidwood and Haddam Neck seals respectively.
- (3) The Haddam Neck seal was reportedly inflated to about 40 psig at the time of failure.
