Subject: Final Report - DER 84-38
A 50.55(e) Reportable Condition Relating To Improperly Welded
Flange In Unit 2.
File: 84-019-026; D.4.33.2

FINAL REPORT - DER 84-38
DEFICIENCY EVALUATION 50.55(e)
ARIZONA PUBLIC SERVICE COMPANY (APS)
PVNGS UNIT 2

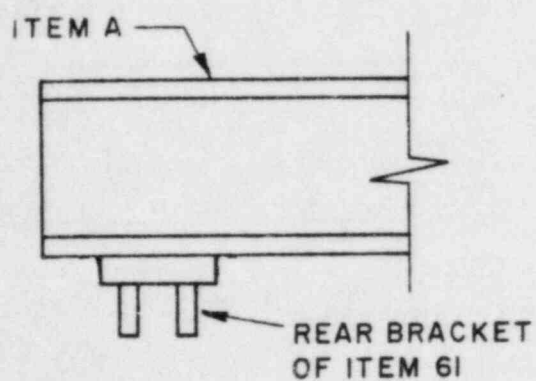
PARTIAL SECTION LOOKING WEST
DESIGN CONDITION

Pipe support #13-AF-005-H-007, Rev. 1, was installed and accepted in Unit 2 by Field Engineering and Quality Control in November of 1981. The existing documentation required the miscellaneous steel (Item A) to be installed at an evaluation of 85'-0 3/4" and the beam attachment of sway strut (Item 61) to be welded to Item A on the north and south sides (see Figure 1). Documentation was prepared in March of 1984 to partially disassemble this support for piping rework. Upon completion of the piping work and reassembly of the support, two discrepancies in the original installation were noted in NCR PC-8250:

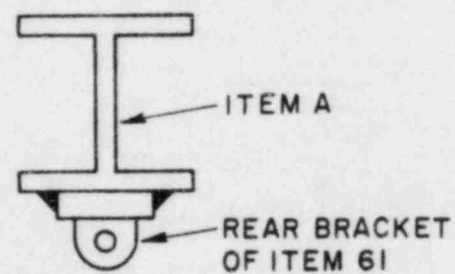
SECTION LOOKING NORTH
INSTALLED CONDITION

1. The miscellaneous steel (Item A) is installed at elevation 85'-3".
2. The rear bracket (of Item 61) is welded on the east and west sides.

The root causes of the deficiency described herein are (a) the craftsman did not install the pipe support per design drawings and (b) the field engineer and the quality control inspector approved the incorrect installation. A recent investigation revealed that none of the people responsible for this deficiency are presently employed at the PVNGS jobsite.

The change in elevation of miscellaneous steel (Item A) also lengthened the overall dimension from beam bracket to centerline of pipe of sway strut (Item 61) from 2'-8 3/4" to 2'-11". This causes no additional loading or induced stresses in Item A and the existing sway strut length is still within vendor requirements for the design loading condition so the structural integrity of the pipe support is not degraded.

However, with the beam attachment welded on the east and west sides, the bottom flange of Item A will not induce loads to the structural member as intended. This results in exceeding the structural capacity of the bottom flange during a DBE. Once the capacity of the support has been exceeded, piping stresses will reach unacceptable levels. Based upon the above, this condition is evaluated as reportable under the requirements of 10CFR50.55(e); since, if left uncorrected, it would be a significant safety hazard.

- A. NCR PC-8290 will be dispositioned repair to add additional weld on the north and south sides of the beam attachment.
- B. As part of the corrective action identified in the response to the NRC Enforcement Letter and Notice of Violations, dated 12/12/83 (Violations II.B.3 and II.B.4), Bechtel Construction initiated a comprehensive reinspection program established under WPP/QCI 543.0. This reinspection program included 2199 pipe supports and pipe racks in Unit 1. All nonconforming conditions noted during the reinspection program were documented on NCRs PX-7370 and PA-7313. The "as-built" calculations indicate that the installed conditions of all welding nonconformances are sufficient to carry the project design loads. Therefore, the installed pipe supports were found to be acceptable without repair.
