SUBJECT: Calvert Cliffs Nuclear Power Plant  
Unit Nos. 1 and 2; Docket Nos. 50-317 and 50-318;  
License Nos. DPR 53 and DPR 69  
Licensee Event Report 92-004

## LICENSEE EVENT REPORT (LER)

TITLE (4) Inoperable Fire Dampers Due to Conflicting Design Information

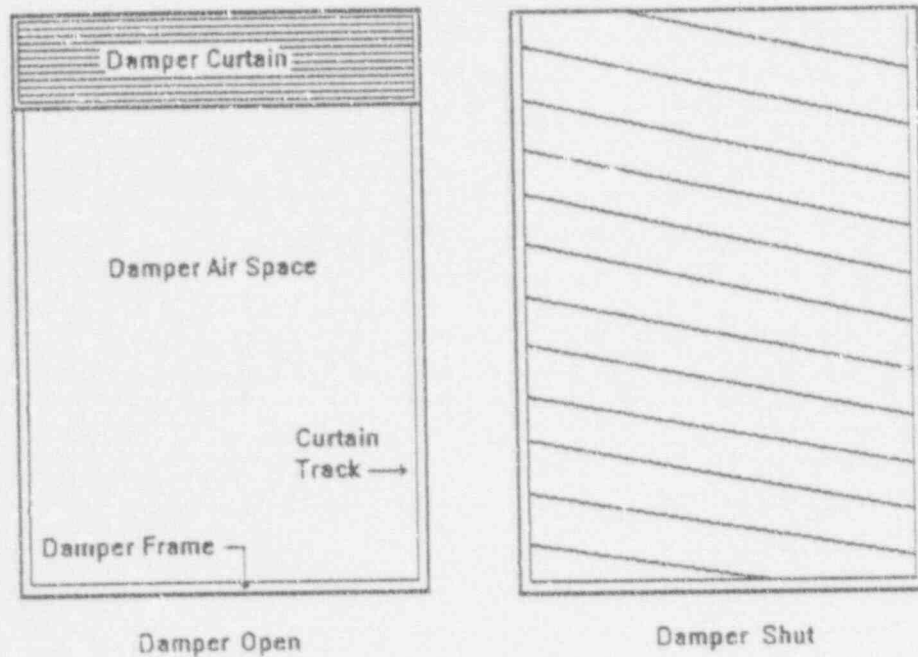
FIGURE 1

These are curtain-type dampers. Several hinged leaves fold and strap securely into the stored position. At high temperatures, a fusible link melts, releasing the straps. This allows the leaves to expand outward, shutting off the duct. Vertically mounted dampers are gravity driven while horizontal dampers are spring loaded. (See Figure 1)

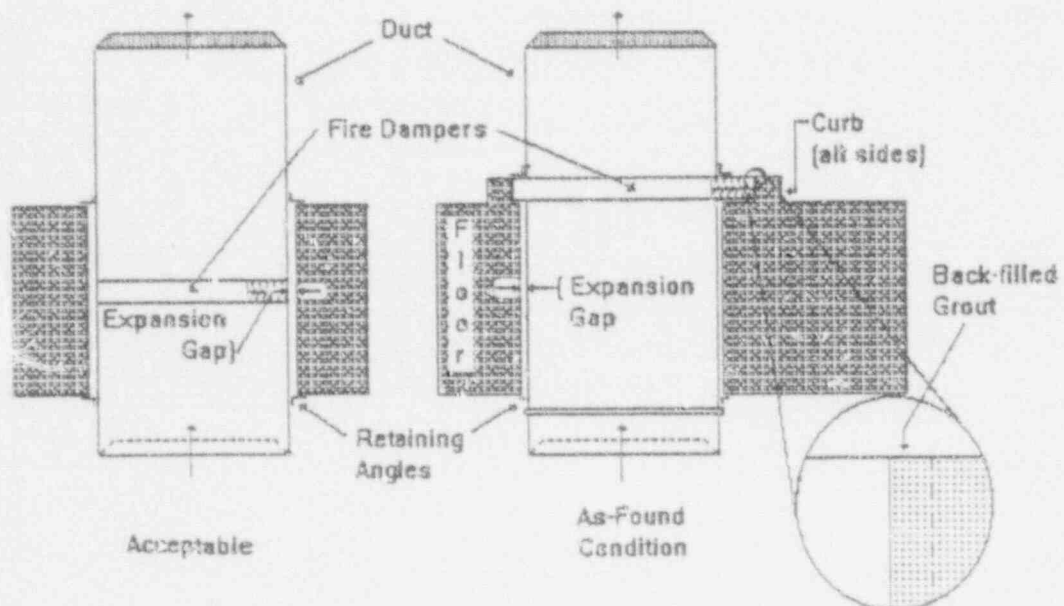
FIGURE 2

During construction, we built up a concrete curb around some dampers to retain their UL listing and rating. When we removed the curbs, we found they had pressed against the dampers, removing the expansion gaps. When we removed the duct retaining angles, we found that critical 1/8 inch expansion gaps had been back-filled with grout. (See Figure 2)

The critical clearance required to ensure proper operation is a 1/4 inch gap between the curtain and its track. The curb grouting constrained the dampers. We also know, from testing, that high duct temperatures thermally affected the dampers. These two elements worked together to reduce the curtain-to-track clearances and resulted in mechanical binding and damper failures. We have concluded that these dampers do not conform to the installation requirements for meeting the UL listing.

The root cause of this event is incomplete and inadequate design information. The Architect Engineer provided design drawings inconsistent in their treatment of the critical clearances. For these dampers, different drawings contradict themselves. One drawing's notes require expansion gap retention. Another's notes has them backfilled.

- A. We declared three fire dampers INOPERABLE, verified automatic fire detection, and established fire-watch patrols in accordance with the TSs.
- B. We investigated similar Unit 1 and 2 fire dampers, declared eight INOPERABLE, and similarly established fire-watch patrols.
- C. We are performing a design review. We will revise drawings, as required, to show proper installation details.

- D. We will repair or replace all failed dampers.
