Subject: Clinton Power Station - Unit 1
Licensee Event Report No. 92-002-01

TITLE (4) Manufacturing Deficiencies and Inadequate Maintenance Procedures Result in Reactor Feed Pump Control Valve Lockup, Feedwater Level Transient, and Low Reactor Water Level SCRAM.

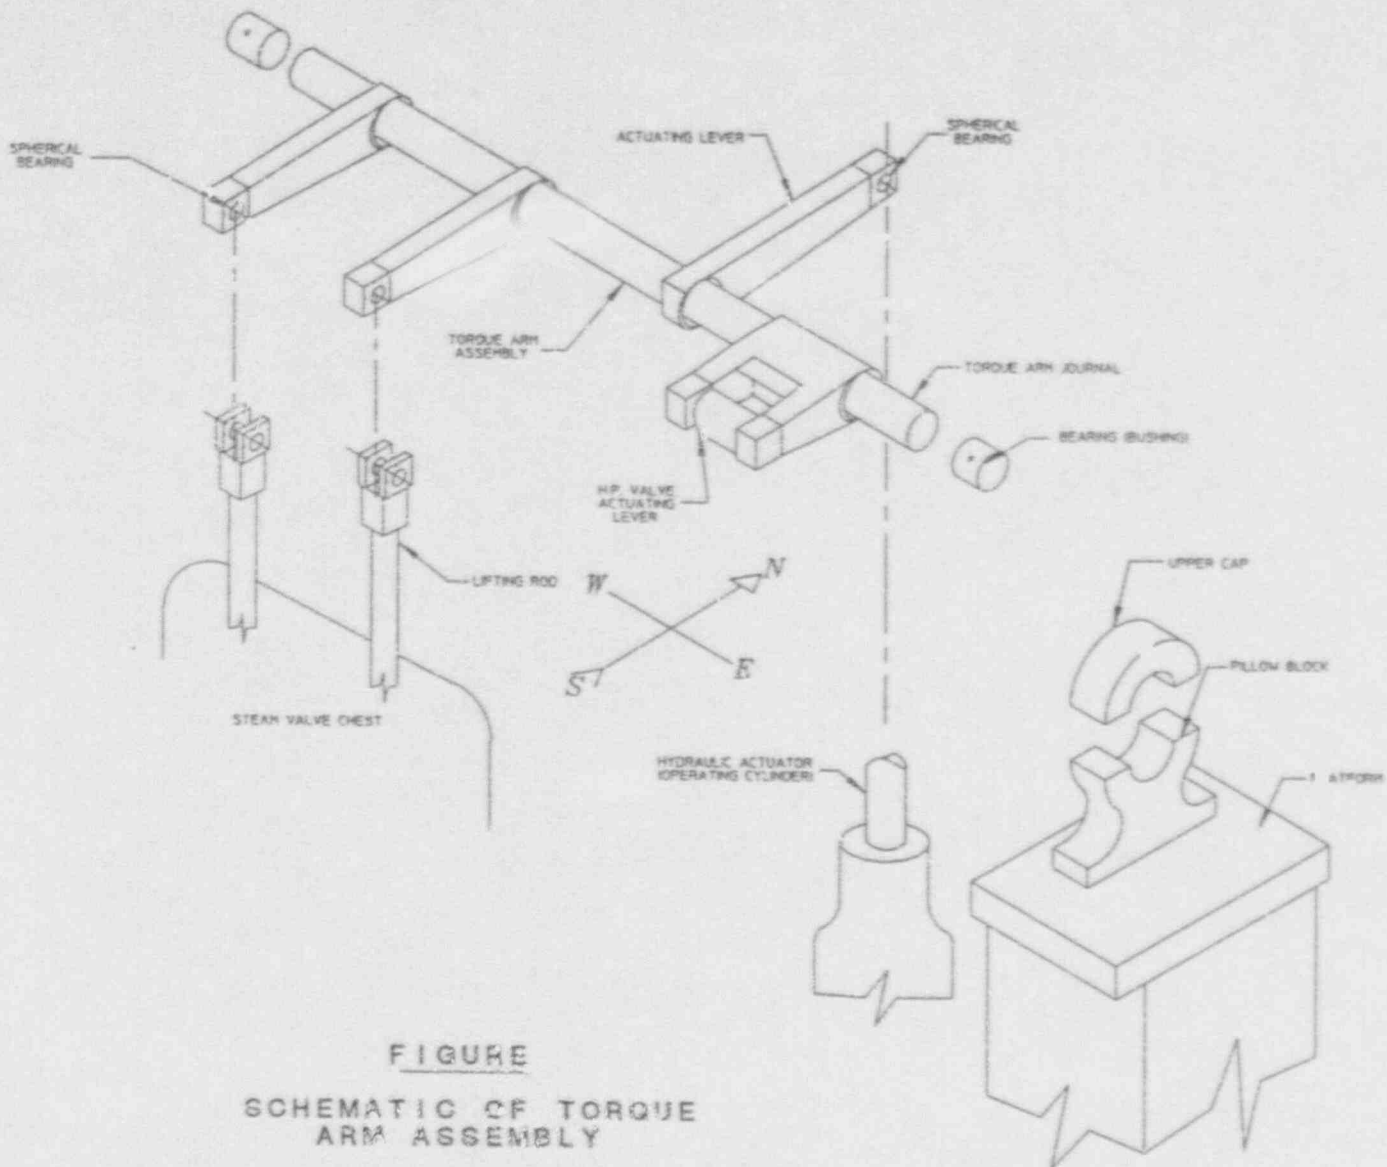
FIGURE
SCHEMATIC OF TORQUE
ARM ASSEMBLY

The lockup of the "B" TDRFP control valve caused the feedwater transient and the low reactor water level scram. The cause of the "B" TDRFP lockup is attributed to manufacturing deficiencies compounded by inadequate procedural guidance for maintenance of the TDRFP turbine actuating linkages. Factors which contributed to the cause of the lockup were application of improper lubrication which was specified by the TDRFP vendor, General Electric; misalignment of pillow blocks; out-of-round torque arm journals; inadequate surface finish on torque arm journals; high spots on the bores of the pillow blocks; reduction of bearing-to-journal clearance when the pillow blocks were tightened to specifications; and lack of periodic maintenance tasks to verify actuator assembly condition. (Reference figure for sketch of TDRFP turbine torque arm assembly components.)

A detailed investigation of the cause of the repeated "B" TDRFP control valve actuating mechanism failures was performed during RF-3. The investigation traced the failures to the pillow block bearings. As discussed above, these bearings were found worn in September, 1991 and were replaced in November, 1991. The investigation determined that the pillow block bearings failed because of insufficient clearance between the bearing and journal and the bearing and pillow block. The clearance problem was exacerbated by a crush or distortion produced when the pillow block upper cap was tightened to specifications.

An immediate investigation identified that the cause of the June 13, 1992 occurrence was the lockup or physical binding of the torque arm assembly between the pillow block bearings and the torque arm journal. A detailed plan was developed to investigate the cause of the premature failure of the "B" TDRFP. The investigation found severe galling on both pillow block bearings and significant scoring of the torque arm journals. Further investigation identified the torque arm journals were slightly out-of-round; the pillow block bearings had high spots on the inside wall when the pillow block was in the tightened position; the pillow block bores had high spots; and the pillow block alignment was inaccurate.

An evaluation concluded that these surface imperfections decreased the established clearances of 0.003 to 0.004 inches to virtually zero clearance with the pillow block tightened to specifications. The resulting clearances allowed metal to metal contact between the journal and the bearing causing the surfaces to rub without lubrication and thereby creating metal fragments, increased friction and, finally, bearing failure.

Following the June 13, 1992 occurrence and determination of its cause, the "B" TDRFP actuating linkage was reworked and reassembled. The torque arm journals were machined and ground to a fine surface finish (16 RMS). New pillow block bearings were measured and machined to fit, and the high spots in the pillow block bores were removed. The pillow blocks were aligned using the laser alignment instrument.
