# NORTHEAST UTILITIES

MP-92-822

Millstone Nuclear Power Station Unit 3

Both Trains of Auxiliary Building Filters Inoperable

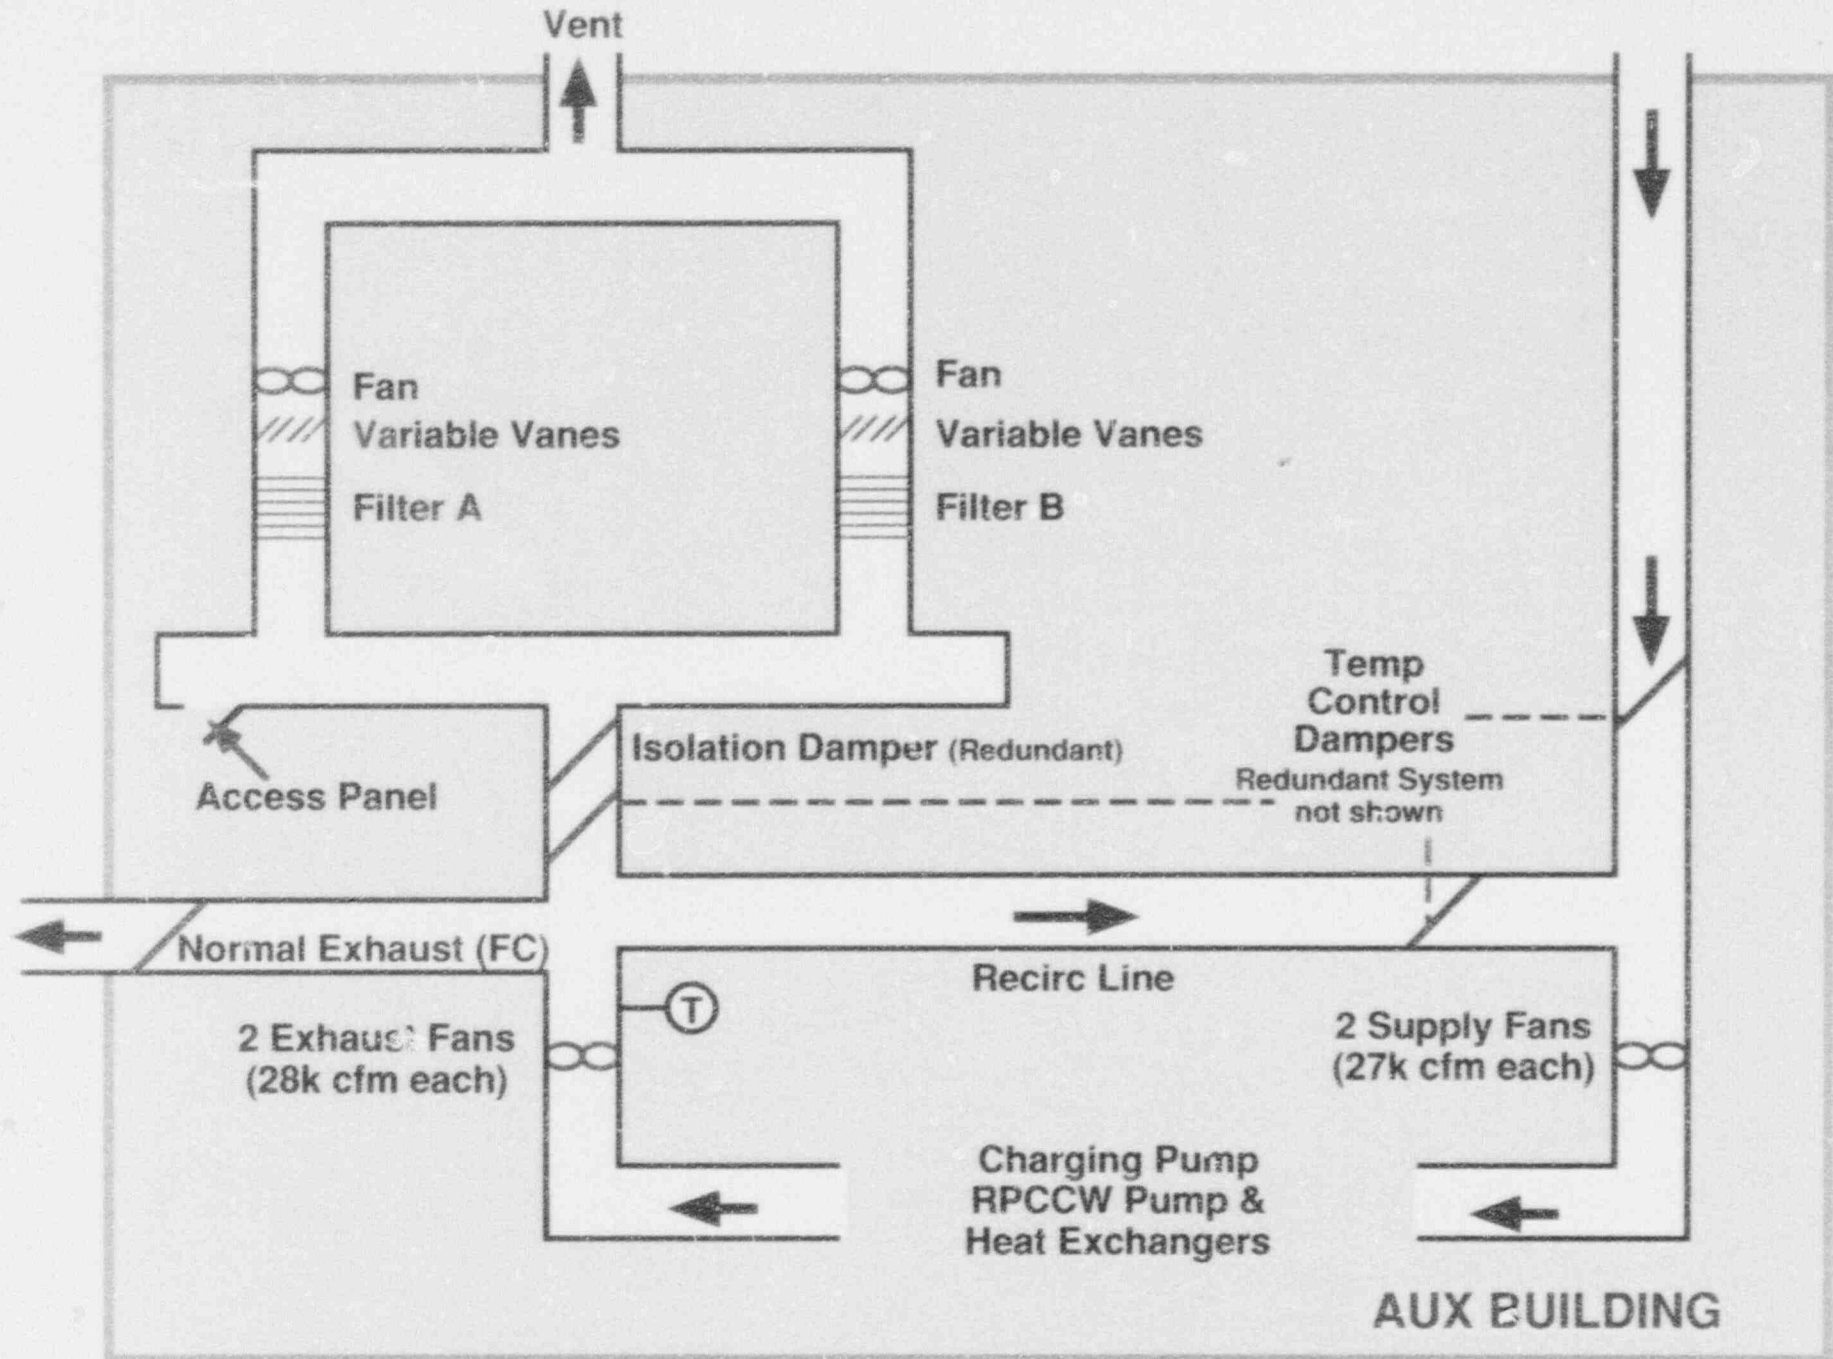
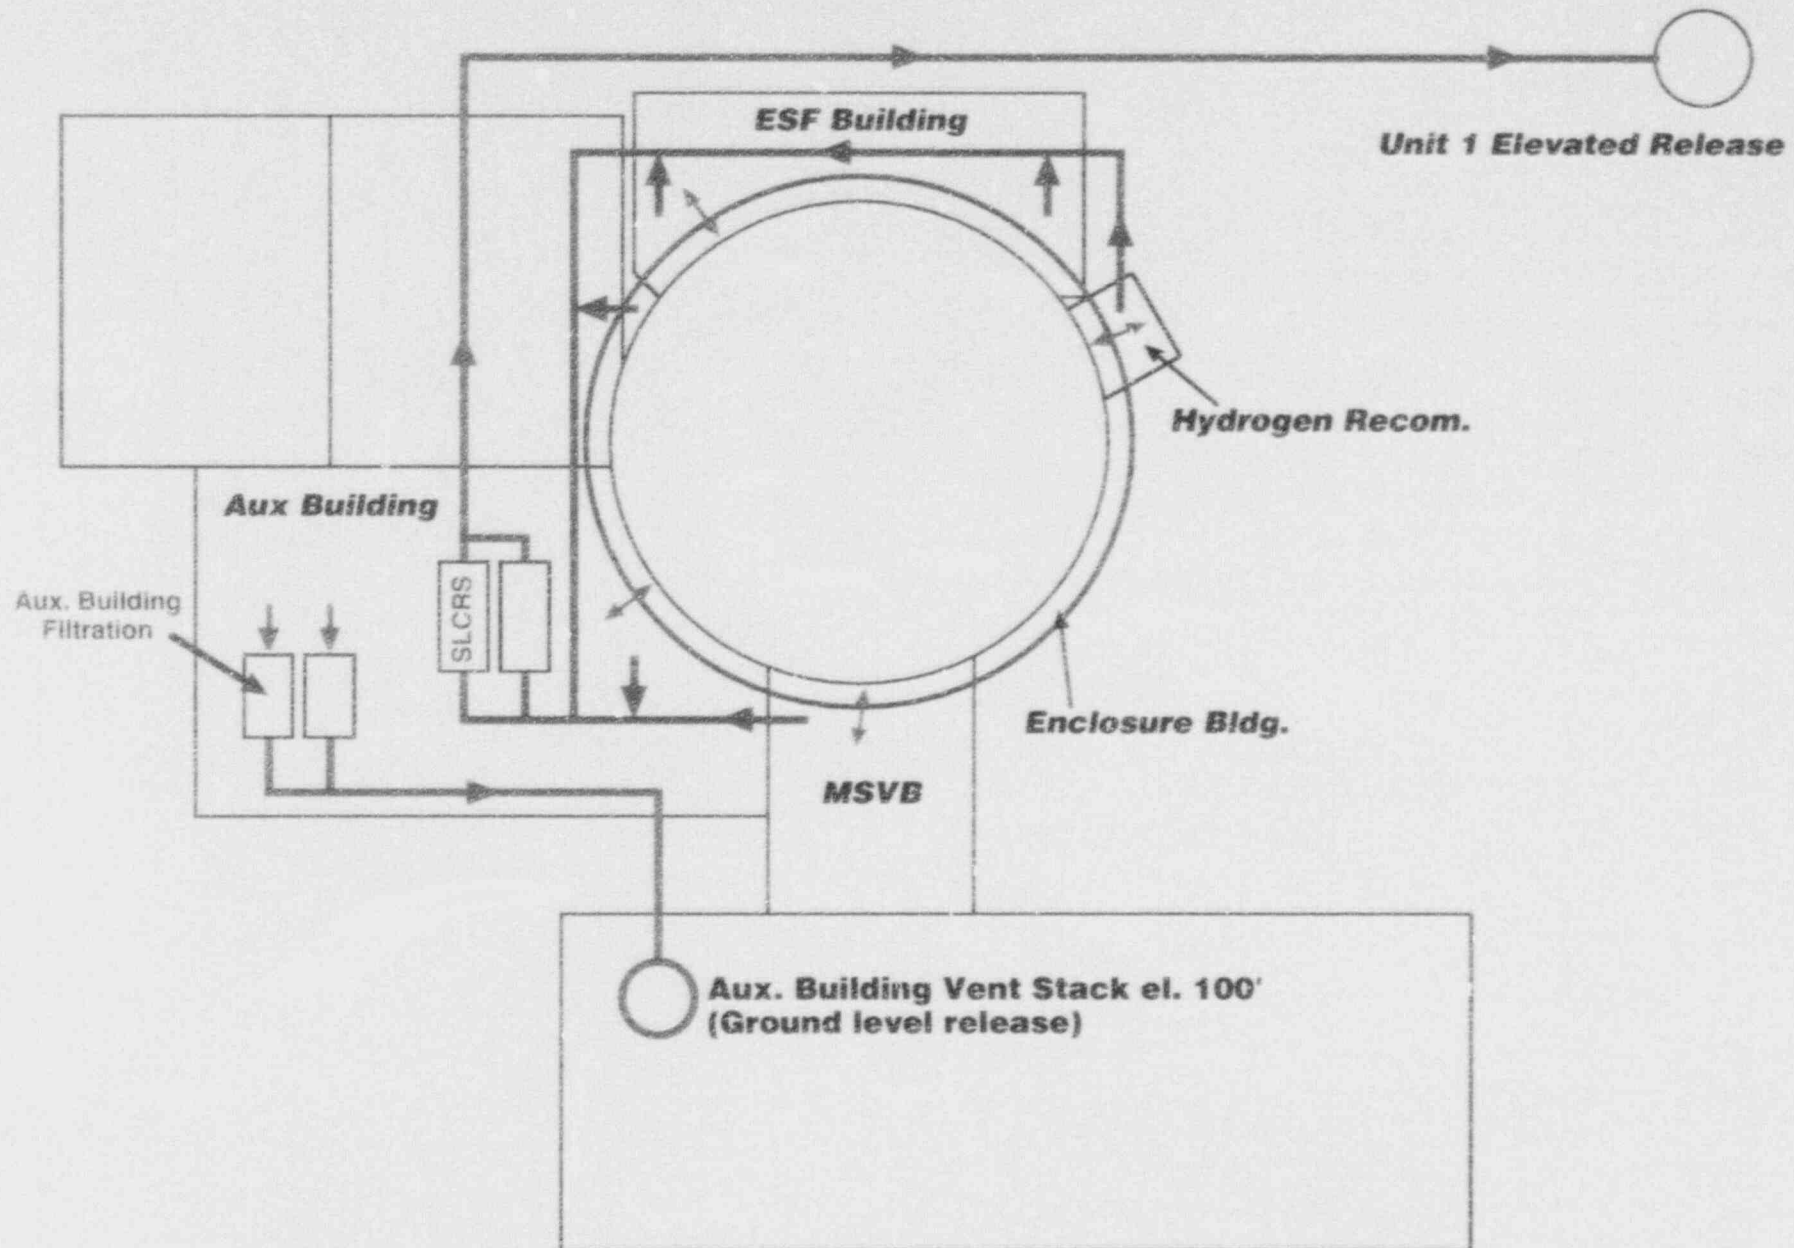
## Secondary Containment Drawdown

- filter the air in the Auxiliary Building before discharge to the atmosphere. This is accomplished by passing the discharge of the Charging Pump and Component Cooling Water Area Ventilation exhaust fans (see attached drawing) through the filters.
- assist the Supplemental Leak Collection and Release System (SLCRS) in maintaining a negative pressure in the Auxiliary Building. This is accomplished by exhausting more air than is brought into the building by the Charging Pump and Component Cooling Water Area Ventilation supply fans (see attached drawing).

The open access door is assumed to have a non-conservative effect on the amount of air removed by the Auxiliary Building Filter System. The section of duct where the access door is located is pressurized in the accident alignment. Opening the access door may reduce the inlet pressure to the Auxiliary Building Filter System fans with a subsequent reduction in flow.

To prevent recurrence of this event the door has been lock wired shut.
