## LICENSEE EVENT REPORT (LER)

FACILITY NAME (1) Fort St. Vrain, Unit No. 1										DOCKET NUMBER (2) 0 5 0 0 0 2 6 7										PAGE (3) 1 OF 0 7															
TITLE (4) Ultrasonic Detectors Inoperable Due To Instrument Drift																																			
EVENT DATE (5)						LER NUMBER (6)						REPORT DATE (7)						OTHER FACILITIES INVOLVED (8)																	
MONTH			DAY			YEAR			YEAR		SEQUENTIAL NUMBER		REVISION NUMBER		MONTH			DAY			YEAR			FACILITY NAMES						DOCKET NUMBER(S)					
DETERMINED																								N/A						0 5 0 0 0					
1 0			1 2			8 4			8 4		0 1 1		0 0		1 1			1 1			8 4									0 5 0 0 0					
OPERATING MODE (9) N						THIS REPORT IS SUBMITTED PURSUANT TO THE REQUIREMENTS OF 10 CFR 5: (Check one or more of the following) (11)																													
POWER LEVEL (10) 0 0 0						20.402(b)						20.406(a)						50.73(a)(2)(iv)						73.71(b)

During the performance of a scheduled Surveillance Test, five of twelve ultrasonic detectors for steam pipe rupture under the prestressed concrete reactor vessel (PCRVR), and one of twelve ultrasonic detectors for steam pipe rupture outside the PCRVR were found out of tolerance limits.

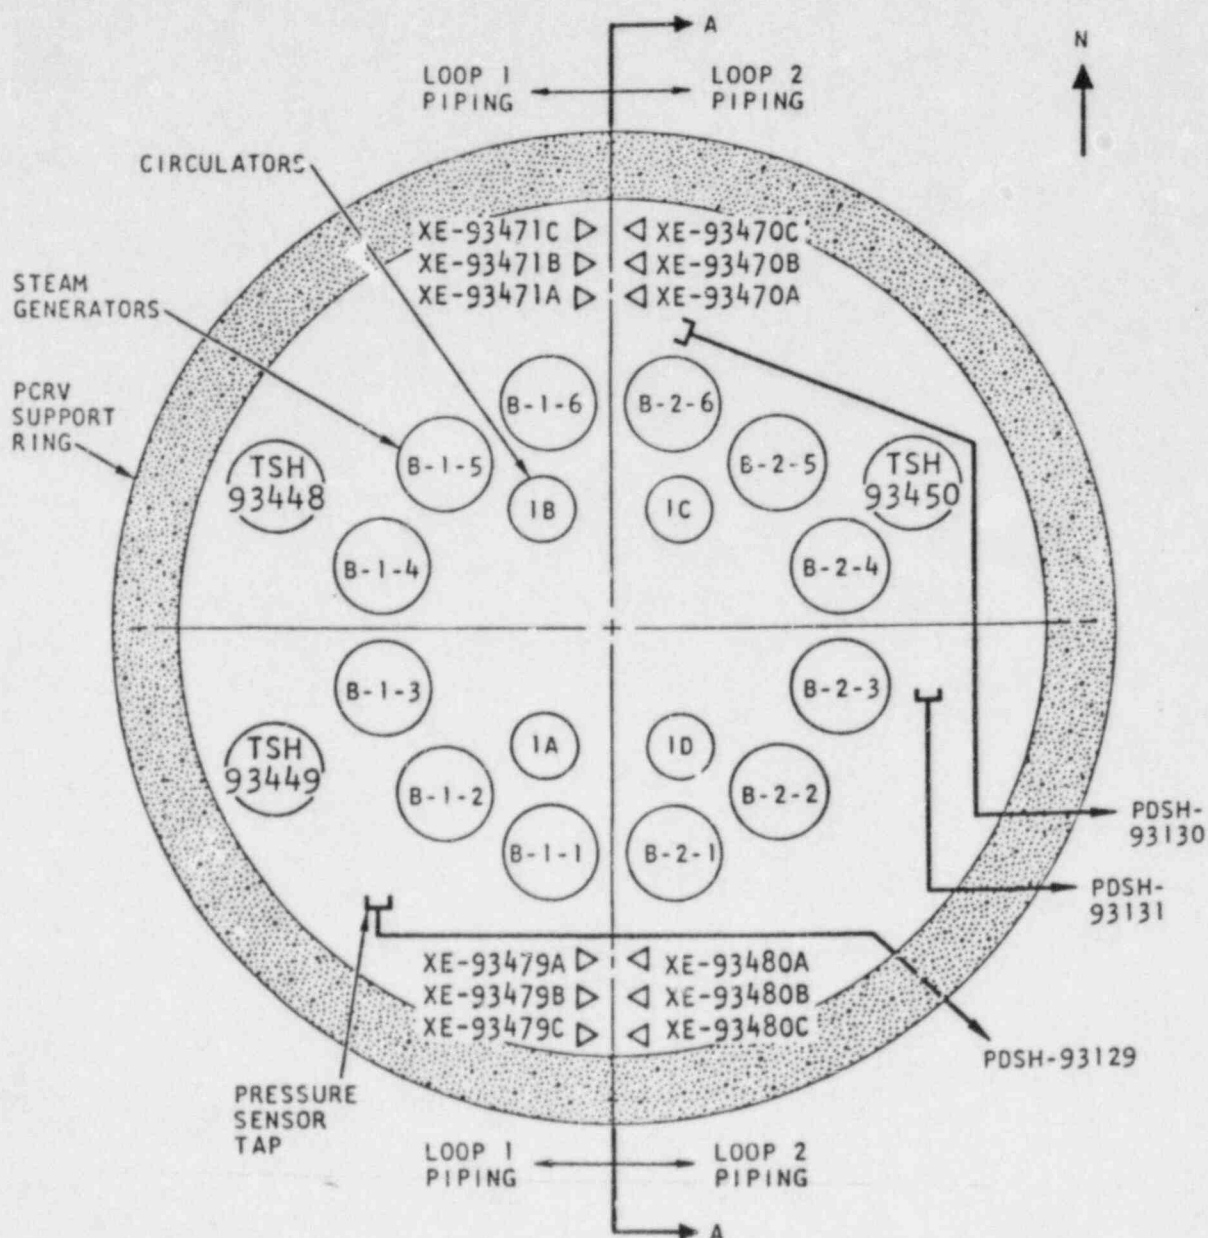
Pipe Rupture Detection System Below PCR - Plan View

The steam pipe rupture detection system involves a combination of ultrasonic detectors, differential pressure switches, and temperature switches (Figures 1 and 2). The basic system utilizes the ultrasonic detectors to establish in which of two secondary coolant loops a steam leak exists and differential reactor building pressure or temperature switches to confirm that the magnitude of the leak is such that automatic action is necessary. The logic system requires two out of three ultrasonic detectors to trip in the same area plus either a high building pressure or temperature trip.
