James A. FitzPatrick
Nuclear Power Plant
P.O. Box 41
Lycoming, New York 13093
315 342-3840

SUBJECT: DOCKET NO. 50-333
LICENSEE EVENT REPORT: 90-025-02
Service Water Check Valves

FACILITY NAME (1) JAMES A. FITZPATRICK NUCLEAR POWER PLANT										DOCKET NUMBER (2) 0 5 0 0 0 3 3 3 1										PAGE (3) 1 OF 1 2		
TITLE (4) FIVE SERVICE WATER TO EMERGENCY SERVICE WATER SWING CHECK VALVES FAIL TO CLOSE DURING TESTING																						
EVENT DATE (5)			LER NUMBER (6)				REPORT DATE (7)			OTHER FACILITIES INVOLVED (8)												
MONTH	DAY	YEAR	YEAR	SEQUENTIAL NUMBER	REVISION NUMBER	MONTH	DAY	YEAR	FACILITY NAMES					DOCKET NUMBER(S)								
														0 5 0 0 0								
1	1	5	9	0	9	0	0	2	5	0	2	0	6	2	6	9	2	0 5 0 0 0				
OPERATING MODE (9)		THIS REPORT IS SUBMITTED PURSUANT TO THE REQUIREMENTS OF 10 CFR 5. (Check one or more of the following) (11)																				
N		20.402(a)				20.406(a)				60.73(a)(2)(iv)				73.71(b)								
POWER LEVEL (10)		20.406(a)(1)(i)				60.36(a)(1)				60.73(a)(2)(v)				73.71(c)								
1		20.406(a)(1)(ii)				60.36(a)(2)				60.73(a)(2)(vi)				OTHER (Specify in Abstract below and in Text, NRC Form 365A)

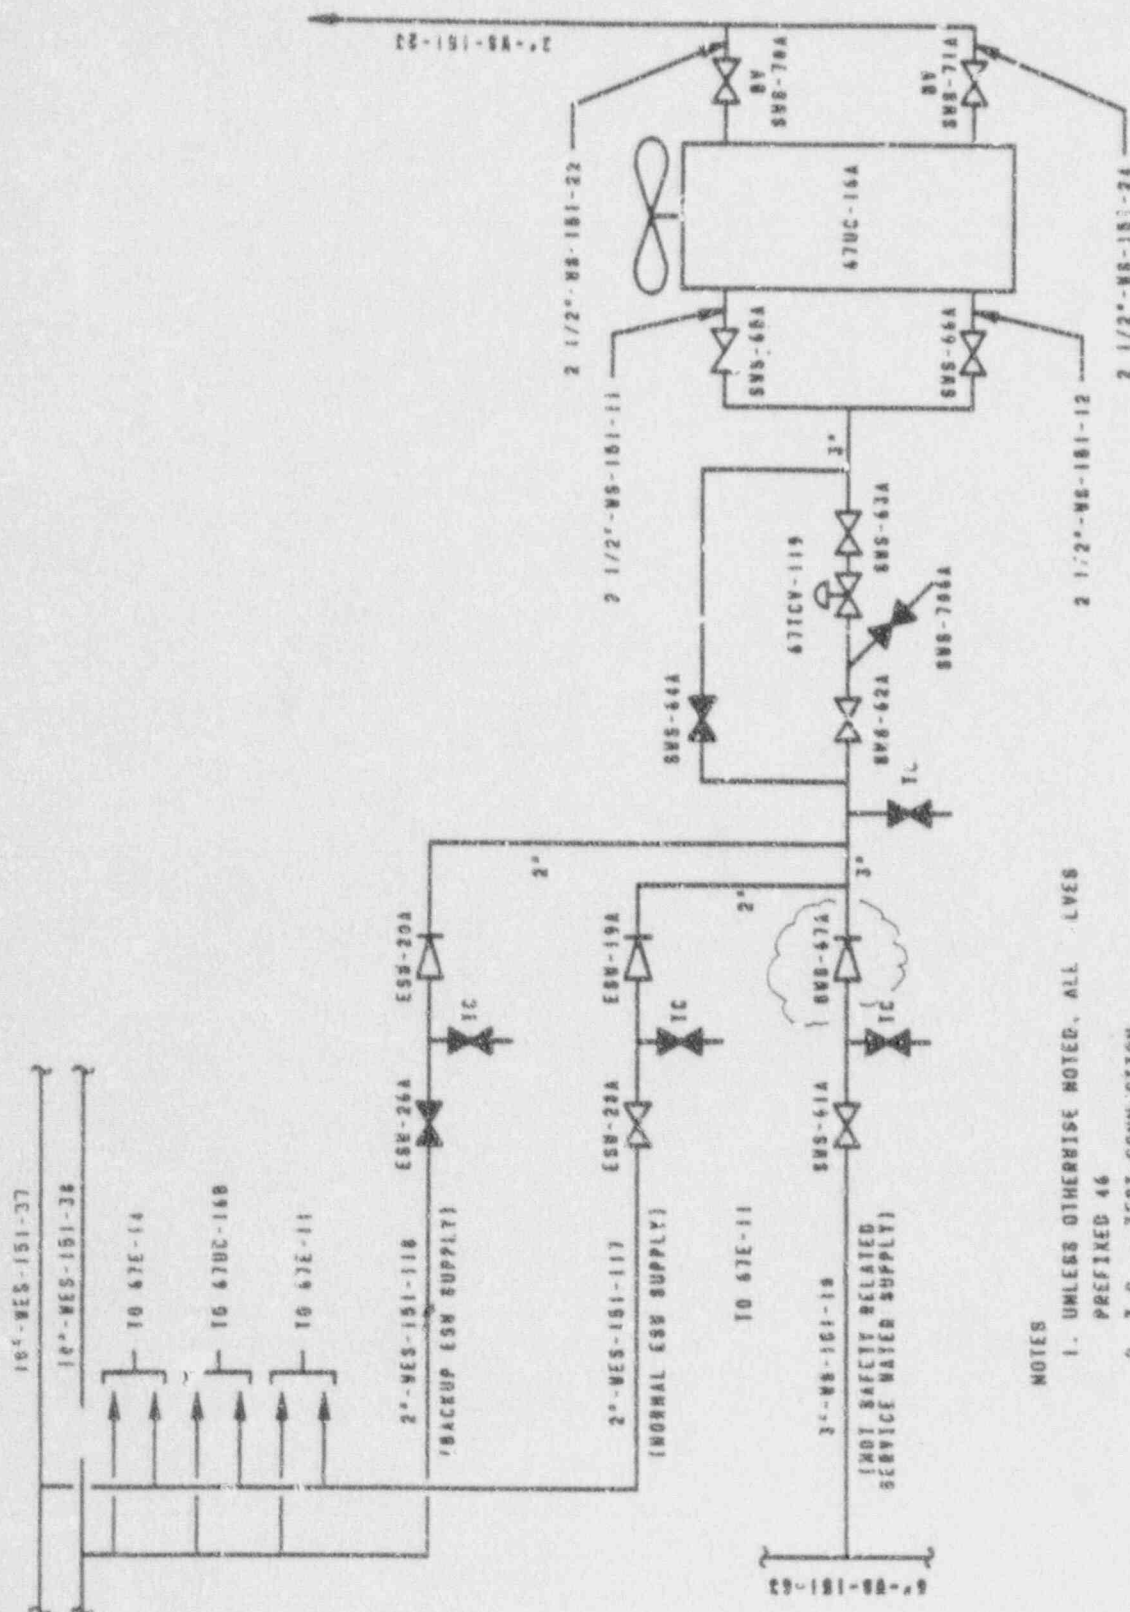
67UC-16A

ELECTRIC BAY UNIT COOLERS

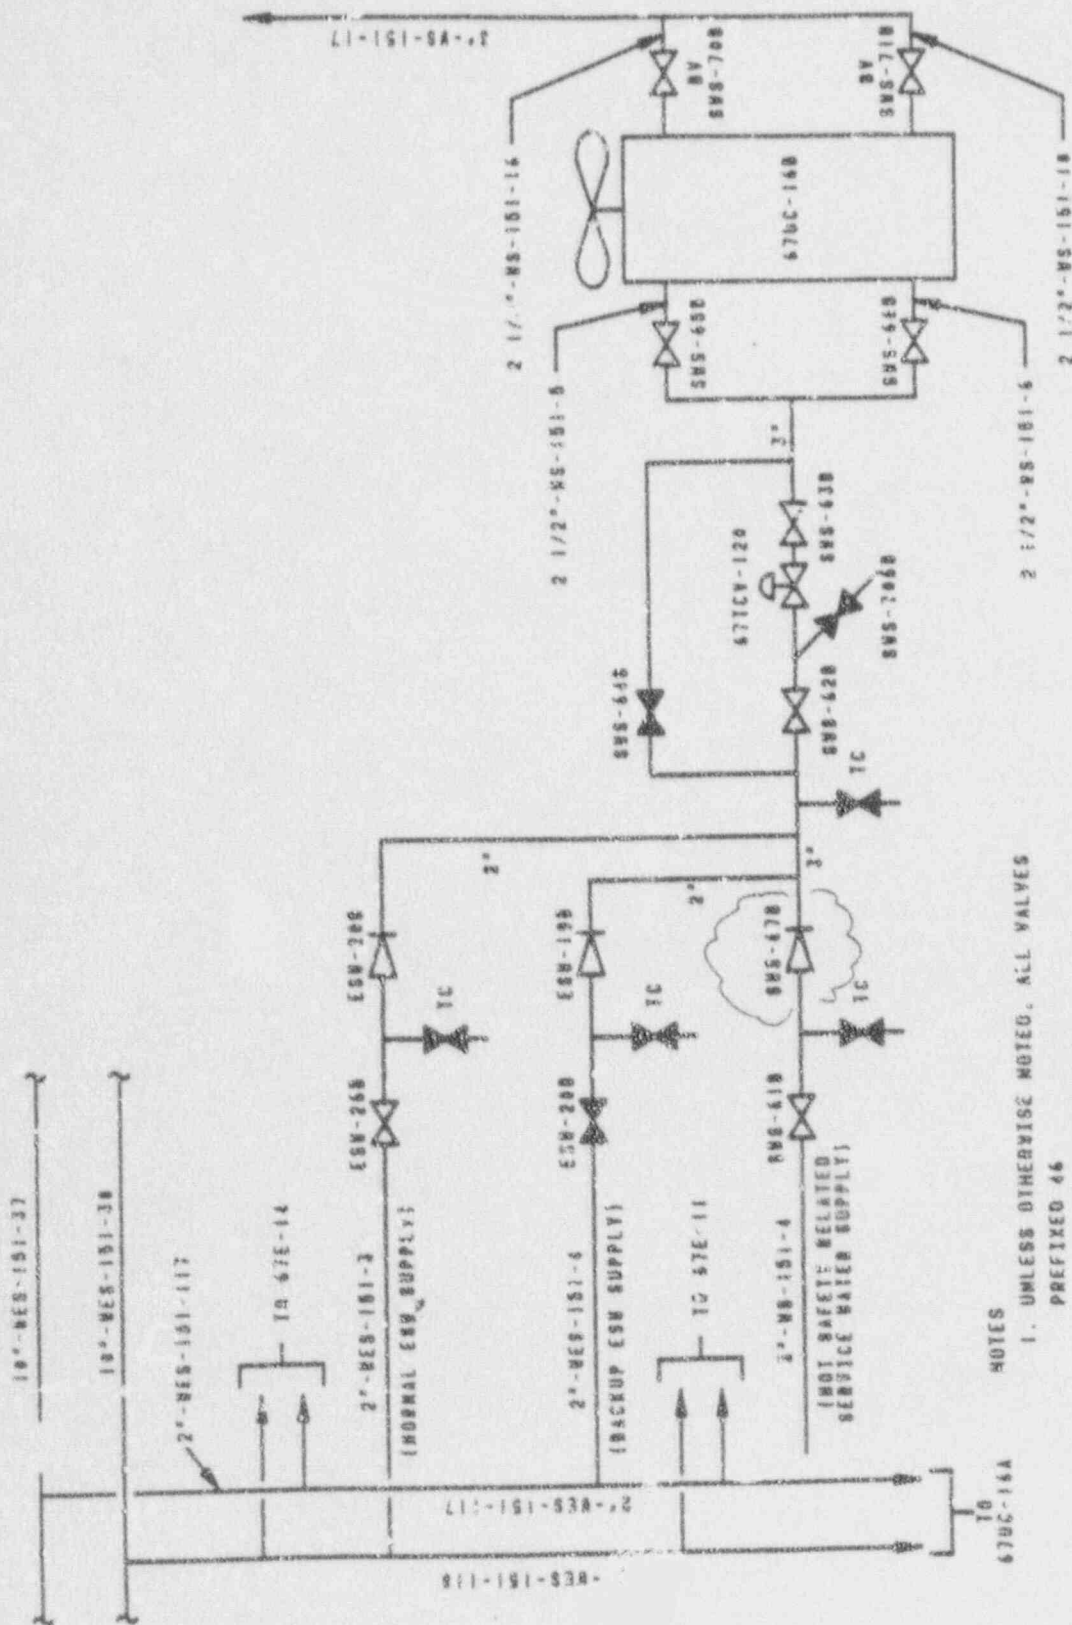
67UC-16B

ELECTRIC BAY UNIT COOLERS

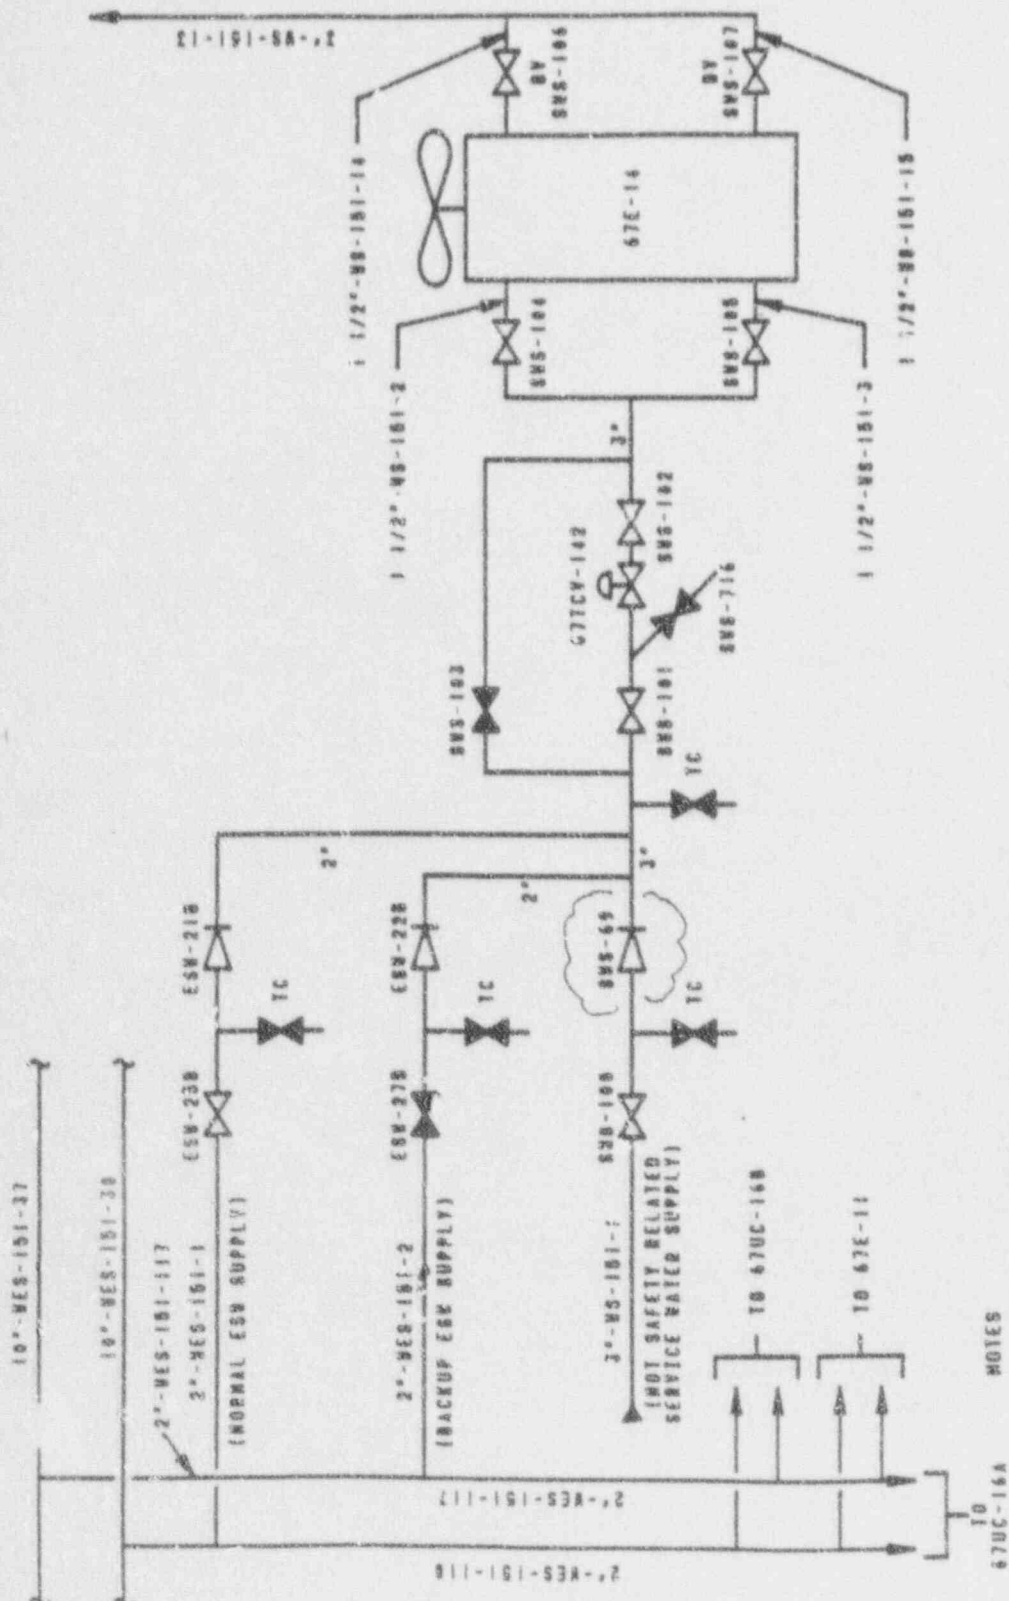
67E-14

CABLE TUNNEL/SWITCHGEAR ROOM COOLER

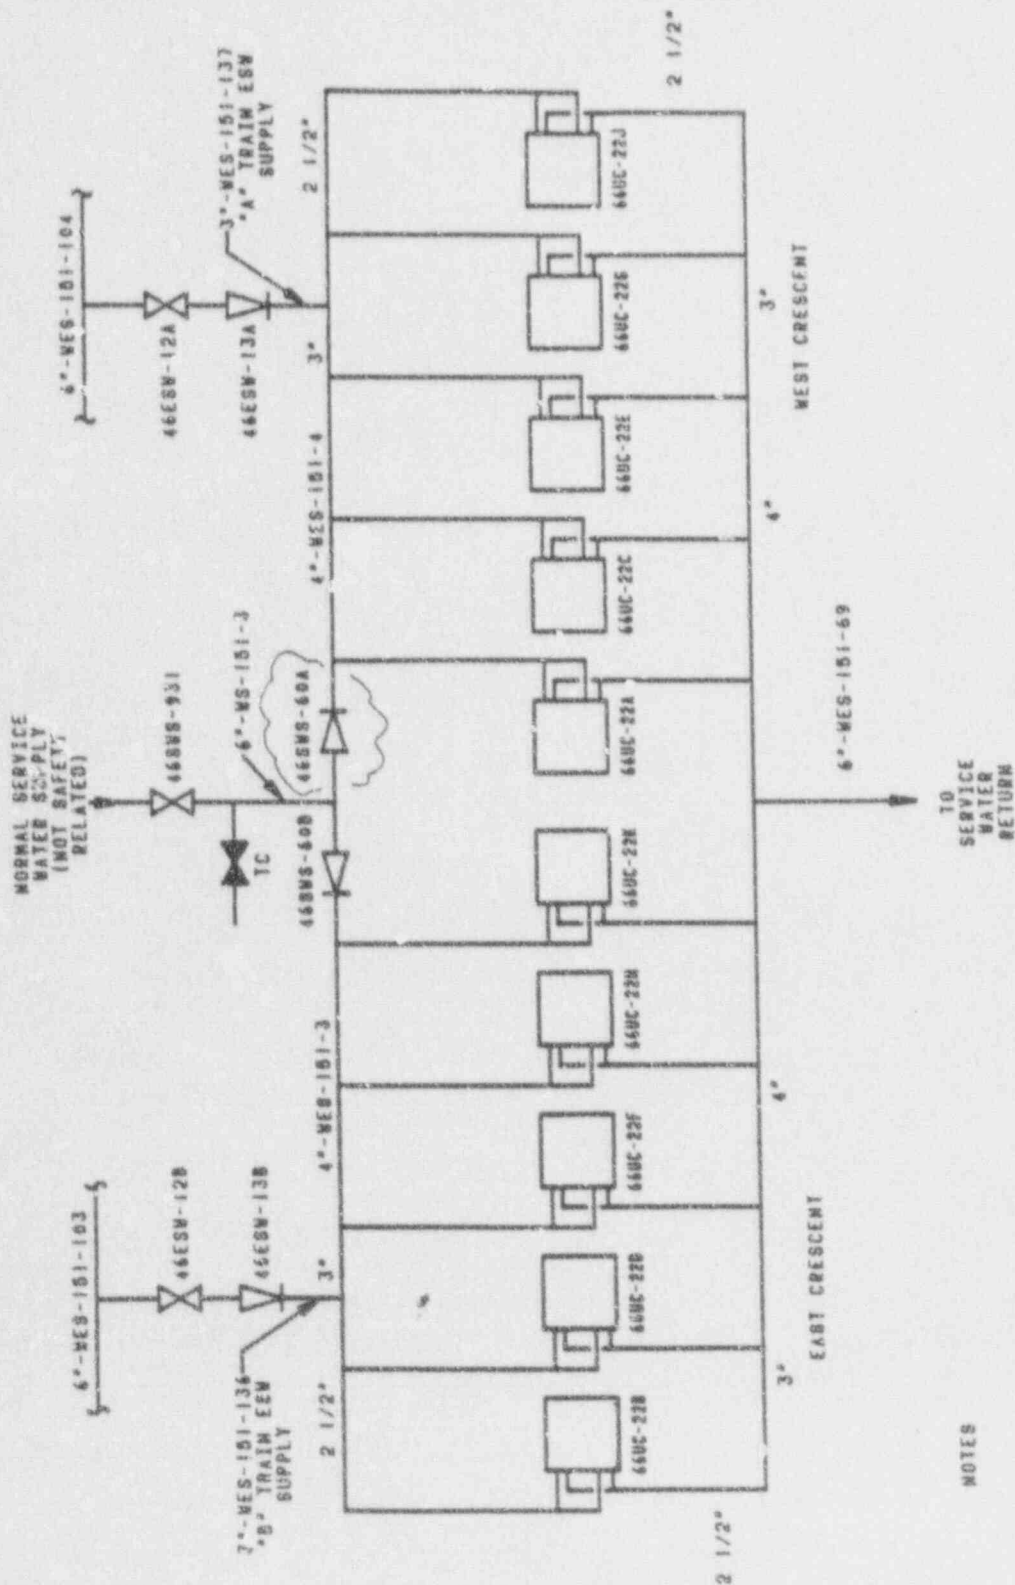
CRESCENT UNIT COOLERS

The crescent area unit cooler heat exchangers provide cooling for portions of the emergency core cooling system (ECCS) [BJ, BM, BN, BO] equipment located in the reactor building west crescent (Safety Division 1) (see Page 12). The coolers are arranged in a bank of five (5).

Each cooler approximates a counterflow air to water heat exchanger. The tubes of each heat exchanger are normally provided with service water through a 6-inch header that tees off in two 4-inch headers (1 per division). The 4-inch header contains the 4-inch swing check valve (46SWS-60A) which initially failed to close under test conditions. Downstream of this valve the header has five tee connections into 2-1/2-inch supply lines to each cooler. The ESW supply also ties into the same header downstream of the failed check valve. Upon initiation of the ESW, the service water check valve 46SWS-60A is designed to close to prevent diversion of ESW from the unit coolers.
