Reference: Facility Operating License No. DPR-65  
Docket No. 50-336  
Licensee Event Report 92-011-00

## LICK/SEE EVENT REPORT (LER)

FACILITY NAME (1)	DOCKET NUMBER (2)	LER NUMBER (3)			PAGE (5)		
		YEAR	SEQUENTIAL NUMBER	REVISION NUMBER			
Millstone Nuclear Power Station Unit 2	0500033692	01	11	00	02	OF	04

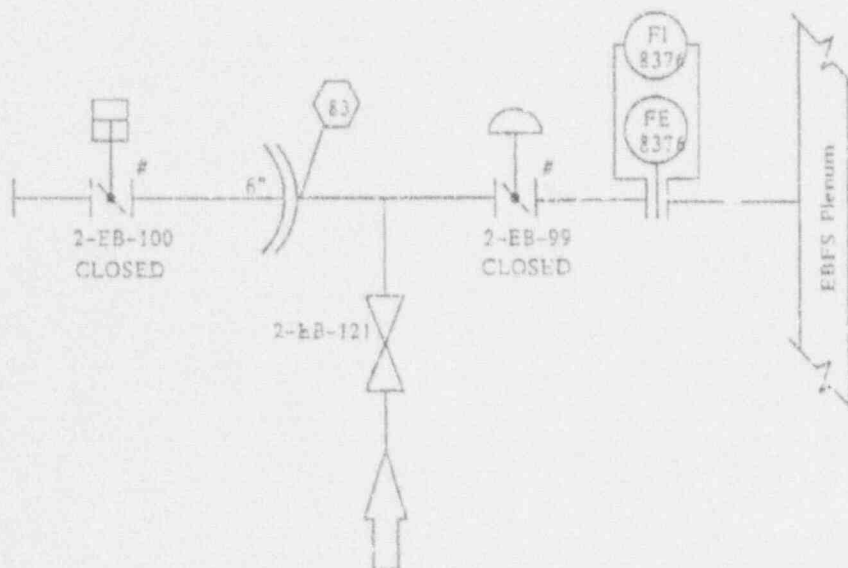
Figure 9.8

LOCAL LEAK RATE TEST  
VALVE LINEUP

Penetration L3  
2-EB-99, 100
