LICENSEE EVENT REPORT (LER)

FACILITY NAME (1) Duane Arnold Energy Center										DOCKET NUMBER (2) 0 5 0 0 0 3 3 1 1					PAGE (3) 1 OF 6		
TITLE (4) Degraded Offsite Voltage																	
EVENT DATE (5)			LER NUMBER (6)				REPORT DATE (7)			OTHER FACILITIES INVOLVED (8)							
MONTH	DAY	YEAR	YEAR	SEQUENTIAL NUMBER	REVISION NUMBER	MONTH	DAY	YEAR	FACILITY NAMES				DOCKET NUMBER(S)				
0	7	1	4	8	4	0	2	8	0	1	1	1	6	8	4	None	0 5 0 0 0 0
OPERATING MODE (9)		THIS REPORT IS SUBMITTED PURSUANT TO THE REQUIREMENTS OF 10 CFR §. (Check one or more of the following) (11)															
N		20.402(b)				20.406(c)				<input checked="" type="checkbox"/> 50.73(a)(2)(iv)				73.71(b)			
POWER LEVEL (10)		0 0 0				20.406(a)(1)(i)				<input checked="" type="checkbox"/> 50.73(a)(2)(v)				73.71(c)

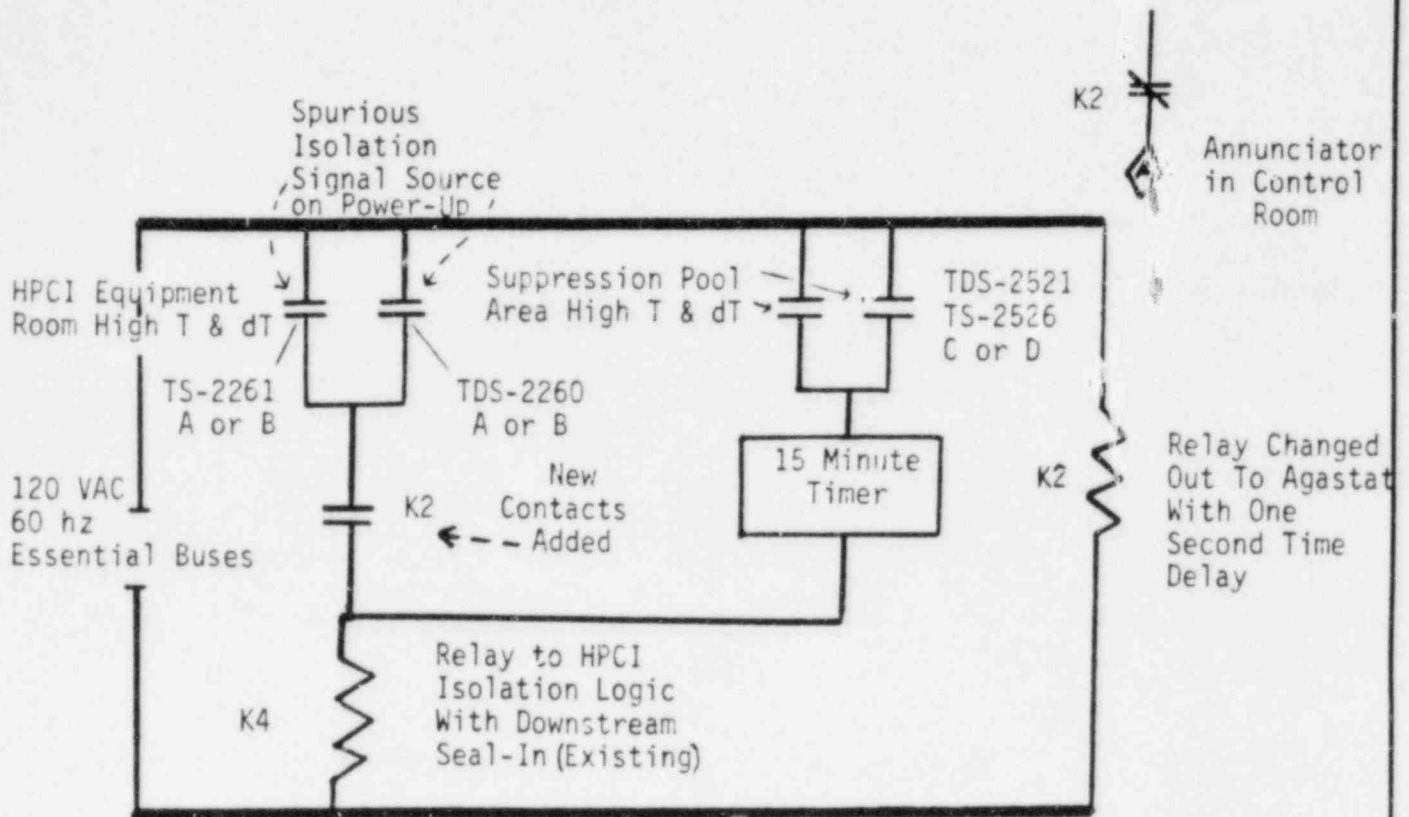
FIGURE 1: HPCI STEAM LEAK DETECTION SYSTEM - Following Design Change (A and B Sides are Identical)

By design, each logic train for the HPCI SLDS consists of two temperature switches and two differential temperature switches, each a permissive for energizing a downstream relay (JM-94-K4A or B). This relay closes contacts in the HPCI isolation logic, which energize another relay that in turn results in the isolation signal for the associated HPCI Steam Supply Containment Isolation Valve being sealed in (see Figure 1). Half of each logic side consists of a HPCI Equipment Room High Differential Temperature Switch (JM-TDS-2260A or B) in parallel with a HPCI Equipment Room High Temperature Switch (JM-TS-2261A or B). The momentary closure of either switch in a logic train energizes relay K4 (A or B), resulting in isolation of the associated HPCI Steam Supply Containment Isolation Valve. The other half of each logic side consists of a Suppression Pool Area High Temperature Switch (JM-TS-2526C and D) in parallel with a Suppression Pool Area Differential Temperature Switch (JM-TDS-2521C or D). As there is a 15 minute timer immediately downstream of these switches, either switch must remain closed for a minimum of fifteen minutes to energize relay K4. Due to this significant time delay, these instruments were eliminated as the cause of the spurious HPCI isolation on 7/14/84. The test procedure run on 10/15/84 de-energized the instruments in the "A" SLDS logic, which controls the inboard HPCI steamline isolation valve that isolated, and restored power approximately ten seconds later, simulating the conditions of 7/14/84.

Three trials of the test procedure were performed. On the first and third trials the suspected switches (TS-2261A and TDS-2260A) closed and quickly reopened upon restoration of power. The result was an isolation signal of short duration which was sealed into the HPCI isolation logic. The second test produced no isolation signal. The test results proved a random signal could be expected from the two suspect instruments in the HPCI "A" SLDS logic upon re-energizing after loss of offsite power. The instruments are both Riley Pan Alarm Model 86, and appear in the identical configuration in the HPCI "B" SLDS logic, which signals for closure of the outboard HPCI steamline isolation valve. It is believed these "B" instruments did not trip during the 7/14/84 event due to the random nature of the spurious signal, as demonstrated by the test. Discussions with the manufacturer have also indicated that a short isolation signal upon re-energizing is not unexpected for these instruments due to their internal design.

After review, a minor design change was instituted to eliminate the random HPCI AC power dependency that results from powering up the HPCI SLDS logic. The design change implemented in both the "A" and "B" logic trains was to introduce a short time delay of approximately one second on restoration of AC power. (See Figures 1 and 2.) Prior to the design change, a power monitor relay (JM-30-K2A or B) for each side, connected in parallel to the HPCI SLDS instruments, activated a Control Room annunciator on loss of logic power. The design change involved replacing this relay with an Agastat (Control Products Division - Amerace Corporation) relay with time pickup controls (JM-2-K2), retaining the annunciation contacts and adding an additional set of closed when energized contacts in series with the two instruments in question. This design results in the following; a) with no loss of offsite power there is no time delay introduced for HPCI isolation from the SLDS; b) with a loss of offsite power the logic and instruments themselves are de-energized. On restoration of power the spurious isolation signals are prevented from energizing the downstream relay (K4) by the open contact controlled by the power monitor relay (K2). When this contact closes approximately one second later, the temperature switches have stabilized internally and the isolation signal is no longer present unless it is a genuine signal.

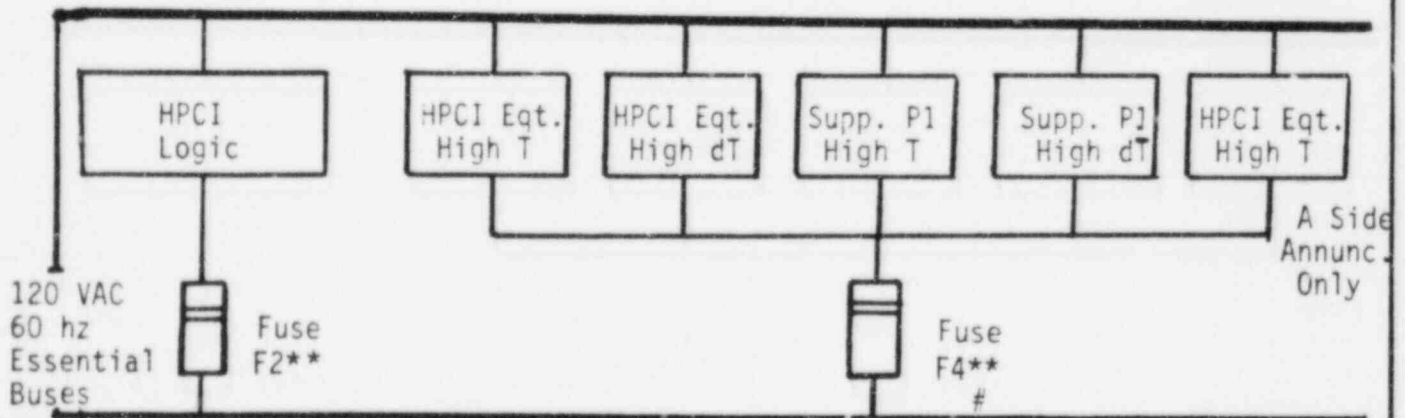
FIGURE 2: HPCI STEAM LEAK DETECTION SYSTEM - Power Supplies (No Design Change) A or B Sides.

On 10/15/84, a special test procedure was run on the "A" logic of the HPCI Steam Leak Detection System (HPCI SLDS). The reactor was in the shutdown mode for a planned maintenance outage, with reactor vessel pressure below that at which HPCI is required to be operable by Technical Specifications. A review of the isolation logic for the HPCI Inboard Steam Supply Valve indicated that the spurious isolation of this valve following the loss of offsite power on 7/14/84 most likely originated in the HPCI SLDS isolation logic. Within the HPCI SLDS logic (see Figures 1 and 2), the "A" logic controls the AC Inboard Steam Supply Containment Isolation Valve (BJ-ISV-2238) and the "B" logic controls the DC Outboard Steam Supply Containment Isolation Valve (BJ-ISV-2239). Power for each HPCI SLDS train is provided by a separate AC essential bus.

#Pulled During First Test - 10/15/84

**Pulled During Second Test - 10/21/84
