## LICENSEE EVENT REPORT (LER)

FACILITY NAME (1) Robinson Nuclear Project Department, Unit No. 2										DOCKET NUMBER (2) 0 5 0 0 0 2 6 1										PAGE (3) 1 OF 0 3	
TITLE (4) Loss of MCC-5																					
EVENT DATE (5)			LER NUMBER (6)				REPORT DATE (7)			OTHER FACILITIES INVOLVED (8)											
MONTH	DAY	YEAR	YEAR	SEQUENTIAL NUMBER	REVISION NUMBER	MONTH	DAY	YEAR	FACILITY NAMES			DOCKET NUMBER(S)									
0 2	0 3	8 5	8 5	0 0 8	0 0	0 3	0 4	8 5				0 5 0 0 0									
OPERATING MODE (9)		THIS REPORT IS SUBMITTED PURSUANT TO THE REQUIREMENTS OF 10 CFR § (Check one or more of the following) (11)																			
POWER LEVEL (10)		20.402(b)				20.406(c)				50.73(a)(2)(v)				73.71(b)							
0 0 0		20.406(a)(1)(i)				50.38(e)(1)				50.73(a)(2)(v)				73.71(c)

H. B. ROBINSON STEAM ELECTRIC PLANT, UNIT NO. 2  
DOCKET NO. 50-261  
LICENSE NO. DPR-23  
LICENSEE EVENT REPORT 85-008

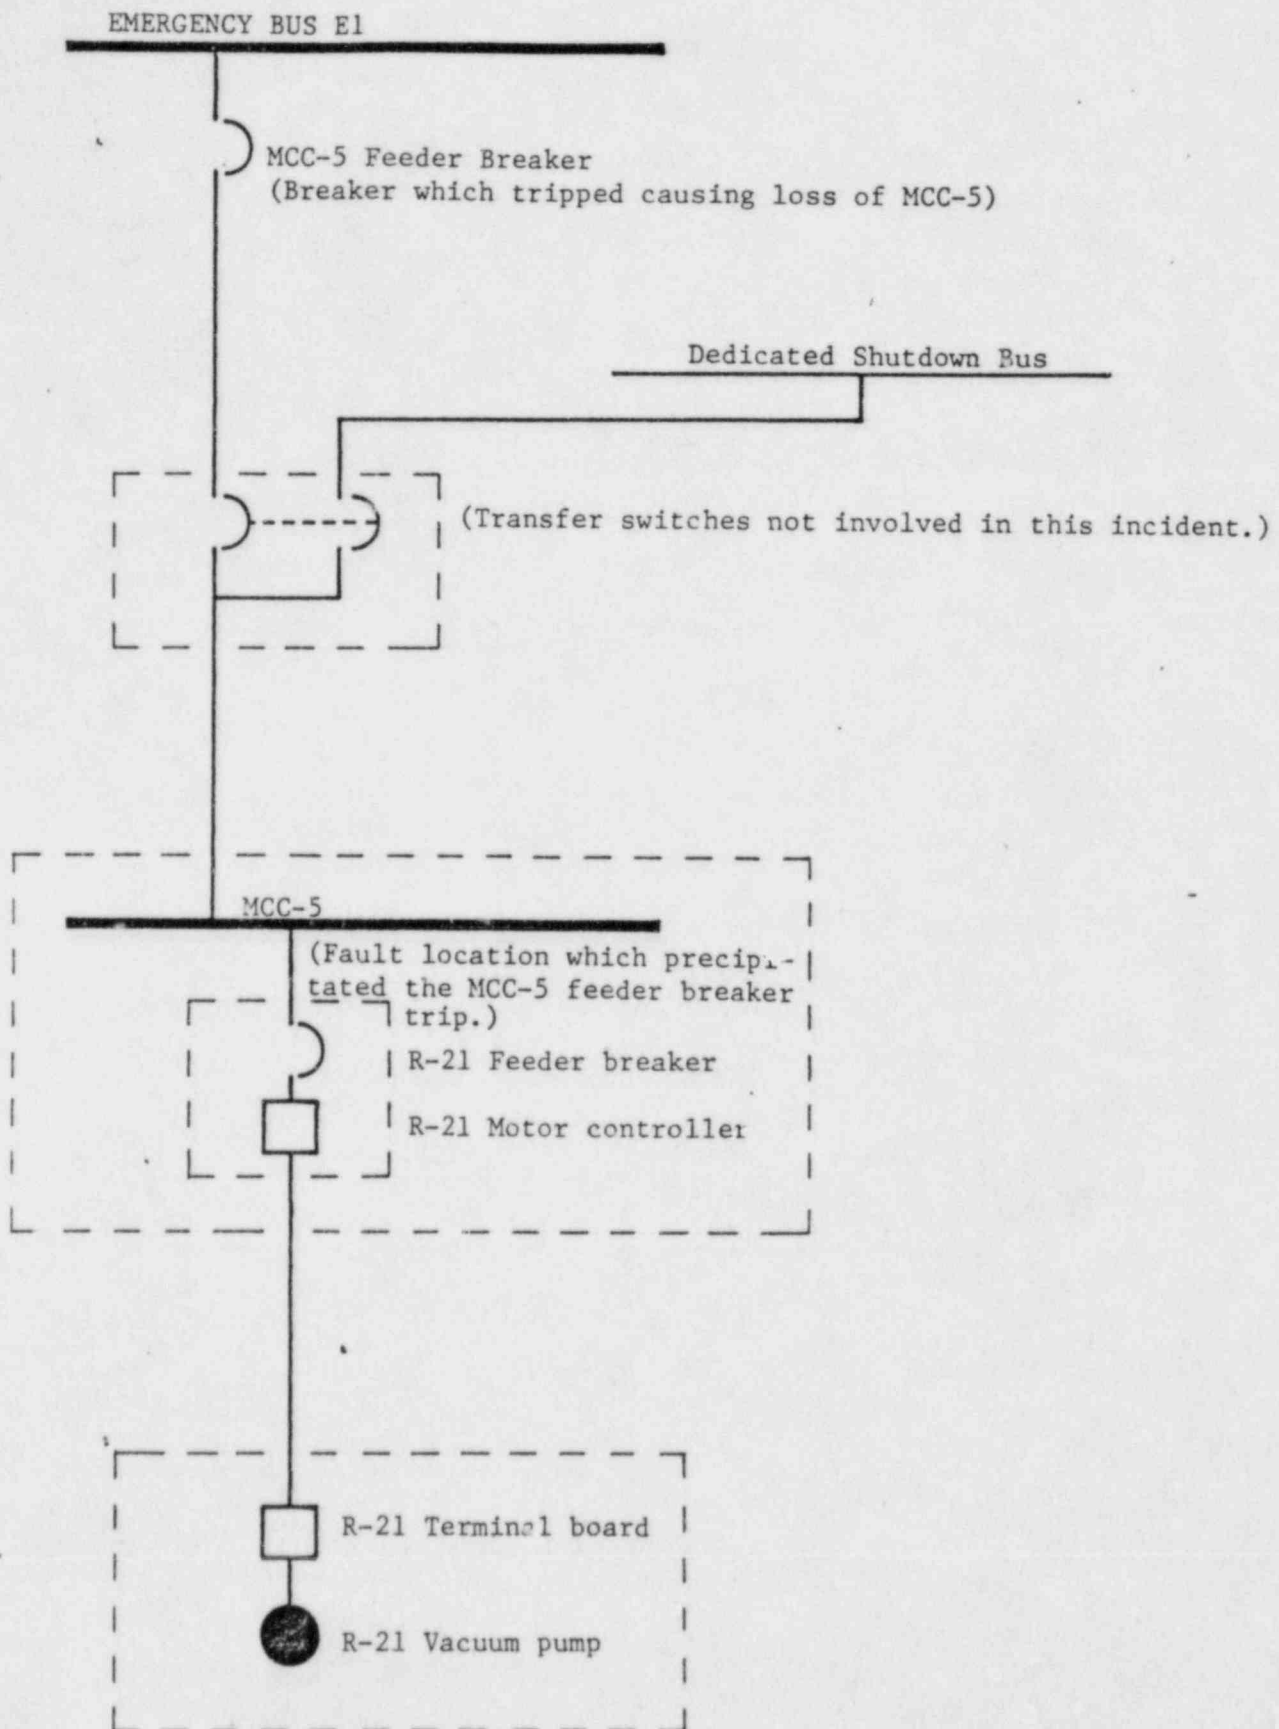
FIGURE 1

Evaluation of this event determined that the R-21 motor feeder breaker instantaneous overcurrent trip device was oversized and unable to adequately protect the R-21 motor controller. The overcurrent condition caused a supply side breaker (MCC-5 feeder breaker) to trip on overcurrent.

Detailed Electrical Description of Incident (Refer to Figure 1)

Water was inadvertently sprayed into the terminal board for the 2 horsepower vacuum pump motor for R-21 (name plate full load running current 3.1 amps). This caused a short circuit between two phases. The high current generated by this fault caused the immediate failure of one phase of the motor starter overload. The current in the other two phases was in excess of the maximum interrupting capacity of the motor controller contactor, caused a flash in the motor controller cubicle and caused failure of the contactor. The motor controller contactor having failed resulted in a short circuit on the line side of the motor feeder breaker. Short circuit protection for the R-21 motor circuit was now bypassed, and fault current from the additional short circuit rose to the overcurrent trip point of the MCC-5 feeder breaker (2800 amps). This device tripped, deenergizing MCC-5.

The magnetic instantaneous trip feature of the 100 amp R-21 breaker was ineffective below 1200 amps (low value of trip band). The 27 amp R-21 motor controller contactor was incapable of interrupting current in excess of 300 amps. Therefore, it has been concluded that no protection was provided by these trips. Additionally, the event was too short in duration for the inverse time protective trip available from the motor feeder breaker to function. The R-21 feeder breaker was found in the tripped position following the incident; however, this could have been from heat generated from the short circuit in the cubical or from the inverse time trip.

The R-21 motor circuit was analyzed, and a more suitable overload size for the motor circuit was established. A 20 amp overload breaker was installed which will provide an interrupt at 240 amps. This breaker also provides a more favorable inverse time characteristic for the motor circuit.

All three improperly sized motor controllers were changed to the 20 amp overload breaker.
