PACIFIC GAS AND ELECTRIC COMPANY

May 17, 1984

PGandE Letter No.: DCL-84-186

Re: Docket No. 50-275, OL-DPR-76
Docket No. 50-323
Diablo Canyon Units 1 and 2
Responses to SSER 22

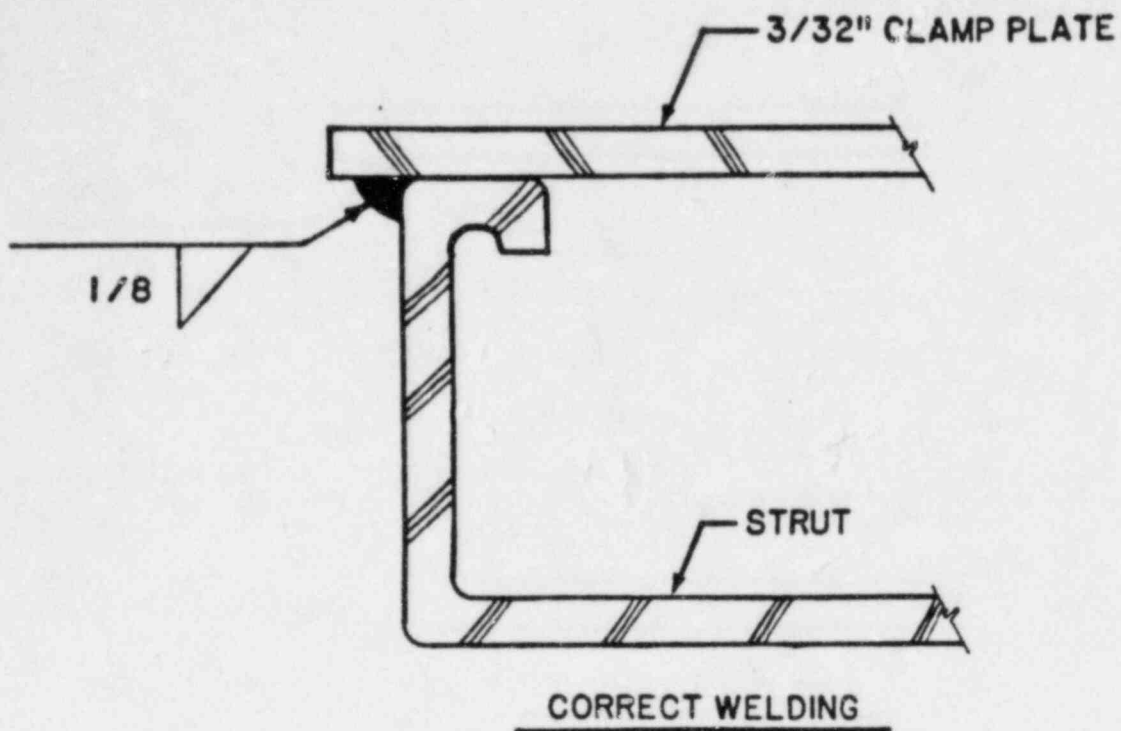
FIGURE 1

This clamp modification was specified for only a few raceway cable tray supports in Unit 2. When Foley began construction of these modifications, they found that the existing clamps were not wide enough to place the specified weld as the joint configuration shown in Figure 2 of Exhibit 2, attached, actually existed. For the Figure 2 joint configuration, placement of a 1/8" weld on the end of the 3/32" clamp plate would have been inappropriate. However, in the course of the normal DCN review process, Foley initiated an Engineering Disposition Request, notifying Engineering of the

actual condition. Engineering then revised the design. The existing clamp plates were replaced with wider clamp plates, restoring the Figure 1 joint configuration. Proper welds were then made. Alternately, in a few cases, the clamp was replaced with a clip angle that bolted to both the tray and the strut, thus eliminating the need for welding.
