LER 92-006

Davis-Besse Nuclear Power Station, Unit No. 1
Date of Occurrence - July 23, 1992

Deficient RPS Calibrating Procedures

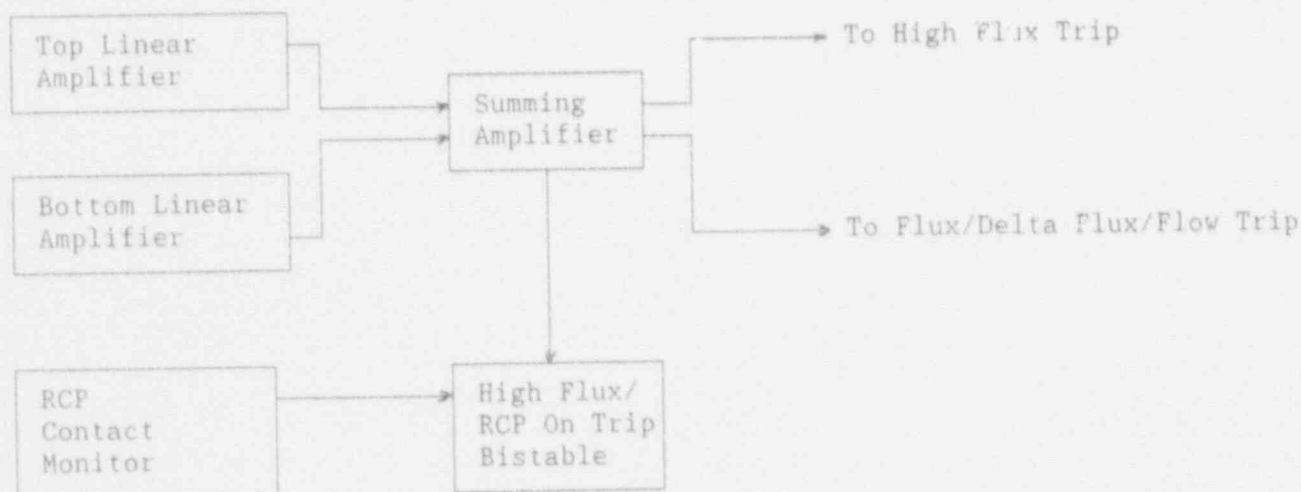
Common circuitry, consisting of the Top Linear Amplifier, the Bottom Linear Amplifier, and the Summing Amplifier provides input to the High Flux/Number of RCPs On trip function, the TS Table 2.2-1, Item 2, "High Flux" trip function, and the TS Table 2.2-1, Item 4, "Flux/Delta Flux/Flow" trip function. Figure 1 provides a simplified schematic of the affected circuitry.

TS Table 4.3-1 requires quarterly calibration of the High Flux and the Flux/Delta Flux/Flow trip functions and an 18-month calibration of the High Flux/Number of RCPs On trip function. The existing procedures require the circuitry common to all three trip functions to be calibrated quarterly. The High Flux/Number of RCPs On trip function is not functionally tested during the quarterly tests. This testing scheme may allow non-conservative values of the High Flux/Number of RCPs On trip setpoint to go undetected.

The apparent cause of this event can be attributed to deficiencies in the procedures used for calibrating the High Flux, the Flux/Delta Flux/Flow, and the High Flux/Number of RCPs On trip functions. These procedures do not properly account for the impact that adjustments and instrument drift of the circuitry common to all three trip functions may have on the High Flux/Number of RCPs On trip function setpoint.

Plant procedures DB-MI-03057 through DB-MI-03060, governing quarterly calibration of the High Flux and the Flux/Delta Flux/Flow trip functions, will be revised to incorporate calibration of the High Flux/Number of RCPs On trip function and procedures DB-MI-03025 through DB-MI-03028 will be canceled. The High Flux/Number of RCPs On trip function will be calibrated quarterly in conjunction with calibration of the other two trip functions. These procedure revisions will be completed prior to the next required quarterly calibration for each channel. In addition, to properly account for instrument drifts, the Contact Monitor output voltages acceptance criteria will be revised.
