# Public Service Company of Colorado

November 8, 1984  
Fort St. Vrain  
Unit #1  
P-84460

SUBJECT: Status of Fort St. Vrain  
Control Rod Refurbishment

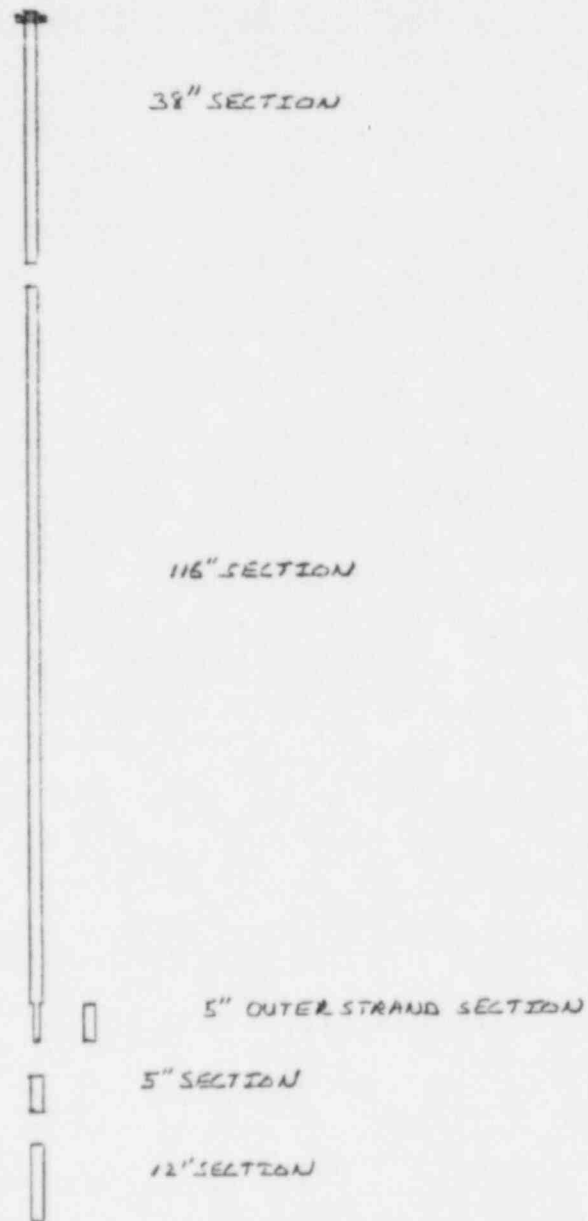
FIGURE 1

Upon removal of the cable seal a single strand of the cable (7 wires per strand, 19 strands per cable) was found to have failed and become entangled around the cable in the cable seal area. Apparently, as the control rods were being retracted in the mechanism, the failed strand became jammed in the seal, thus increasing the tension on the cable and causing it to fail approximately one foot above the seal. The upper portion of the failed cable then became entangled between the cable drum and gear train housing causing it to sever into five separate sections when the drive system was later activated.

Starting from the end of the cable, attached to the cable drum, a 38 inch section (including the anchor) was found to be wrapped around the drum. The next section, 116 inches in length, was entangled around the drum and jammed in the cable channel at the bottom of the drum. It was observed that one end of this long section matched to the 38 inch section. The other end of the 116 inch section had a 5 inch section of the outer strands missing. The inner strands were still intact. A 5 inch section, which had fallen while the 200 Assembly was raised, consisted of the outer strands and fit around the inner strands of the 116 inch section. Another 5 inch section, fully intact but slightly distorted, matched the end of the inner strands from the 116 inch section and the outer strands of the other 5 inch section. Finally a 12 inch section, found on the orifice motor plate, matched the end of the 5 inch section. The other end of the 12 inch section matched the end of the remaining cable stuck in the cable seal. Figure 1 shows the five different sections and the manner in which they were pieced back together. Including the remaining cable still attached to the control rod, all cable has been accounted for.

SEVERED CABLE FROM CDDA #25

The discovery of a second strand failure initiated an extensive investigation into the possible mechanisms causing the failures. In addition to the removal of the failed cable, the sister cable of CRDOA #25 was also removed for detailed testing and examination. CRDOA #25 was then reassembled using new cable that was swaged onto the remaining cables attached to the control rods. This enabled the two absorber strings to be fully retracted for removal from the hot service facility and temporarily stored in an equipment storage well. Refurbishment of the CRDOA will be completed at a later date in order to expedite additional cable examinations.
