## LICENSEE EVENT REPORT (LER)

FACILITY NAME (1) McGuire Nuclear Station Unit 2										DOCKET NUMBER (2) 0 5 0 0 0 3 7 0					PAGE (3) 1 OF 05							
TITLE (4) Reactor Trip on Inadvertent Control Bank Drop																						
EVENT DATE (5)			LER NUMBER (6)				REPORT DATE (7)			OTHER FACILITIES INVOLVED (8)												
MONTH	DAY	YEAR	YEAR	SEQUENTIAL NUMBER	REVISION NUMBER	MONTH	DAY	YEAR	FACILITY NAMES				DOCKET NUMBER(S)									
1	0	2	3	8	4	8	4	0	2	6	0	0	1	1	2	6	8	4	0 5 0 0 0 0			
OPERATING MODE (9)		THIS REPORT IS SUBMITTED PURSUANT TO THE REQUIREMENTS OF 10 CFR §: (Check one or more of the following) (11)																				
1		20.402(b)				20.405(e)				<input checked="" type="checkbox"/> 50.73(a)(2)(iv)				73.71(b)								
POWER LEVEL (10)		20.406(a)(1)(i)				50.36(a)(1)				50.73(a)(2)(v)				73.71(e)								
1 0 0		20.406(a)(1)(ii)				50.36(a)(2)				50.73(a)(2)(vii)				OTHER (Specify in Abstract below and in Text, NRC Form 305A)

On October 23, 1984, the Unit 2 reactor tripped due to a power range negative high flux rate. This occurred when Instrument and Electrical (IAE) personnel caused Group One of Control Rod Bank B to fall into the core while troubleshooting the Full L

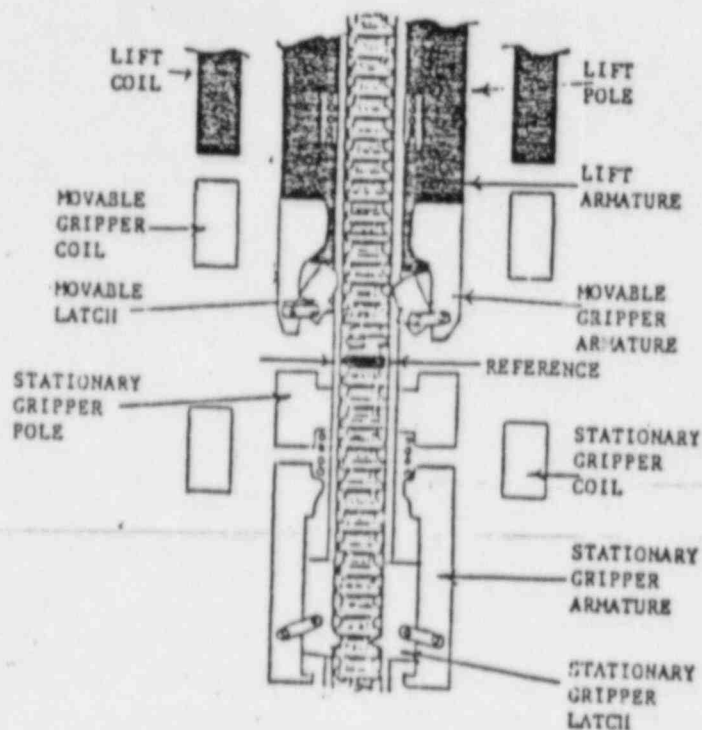
Figure 1

Each control and shutdown rod is controlled by a mechanism as shown on Figure 1. If the rod is not being moved, the stationary gripper coil is energized and the moveable gripper coil is deenergized. If a Rod Control Urgent alarm exists, a reduced current is sent to the stationary and moveable gripper coils to maintain them in an energized position. The stationary gripper coils can also be maintained energized with a latching switch located in its associated power cabinet.

IAE Specialist A was troubleshooting the problem with Control Rod Bank B when a logic card (the firing circuit card) was disconnected which was associated with the stationary gripper coils of Group One of Control Rod Bank B. This caused the control rod stationary gripper coils to deenergize. Prior to pulling this card, IAE Specialist A failed to verify that either the control rod moveable gripper coils were energized or the stationary gripper coils were latched in an energized condition by the latching switch. The moveable gripper coils had been deenergized prior to troubleshooting. When the stationary gripper coils were deenergized, the control rods in Group One of Bank B (4 rods) dropped into the core.
