LICENSEE EVENT REPORT (LER)

FACILITY NAME (1)
Davis-Besse Unit 1

TITLE (4)
VELAN CHECK VALVE ANTIROTATION BINDING

Report No: NP-33-84-16

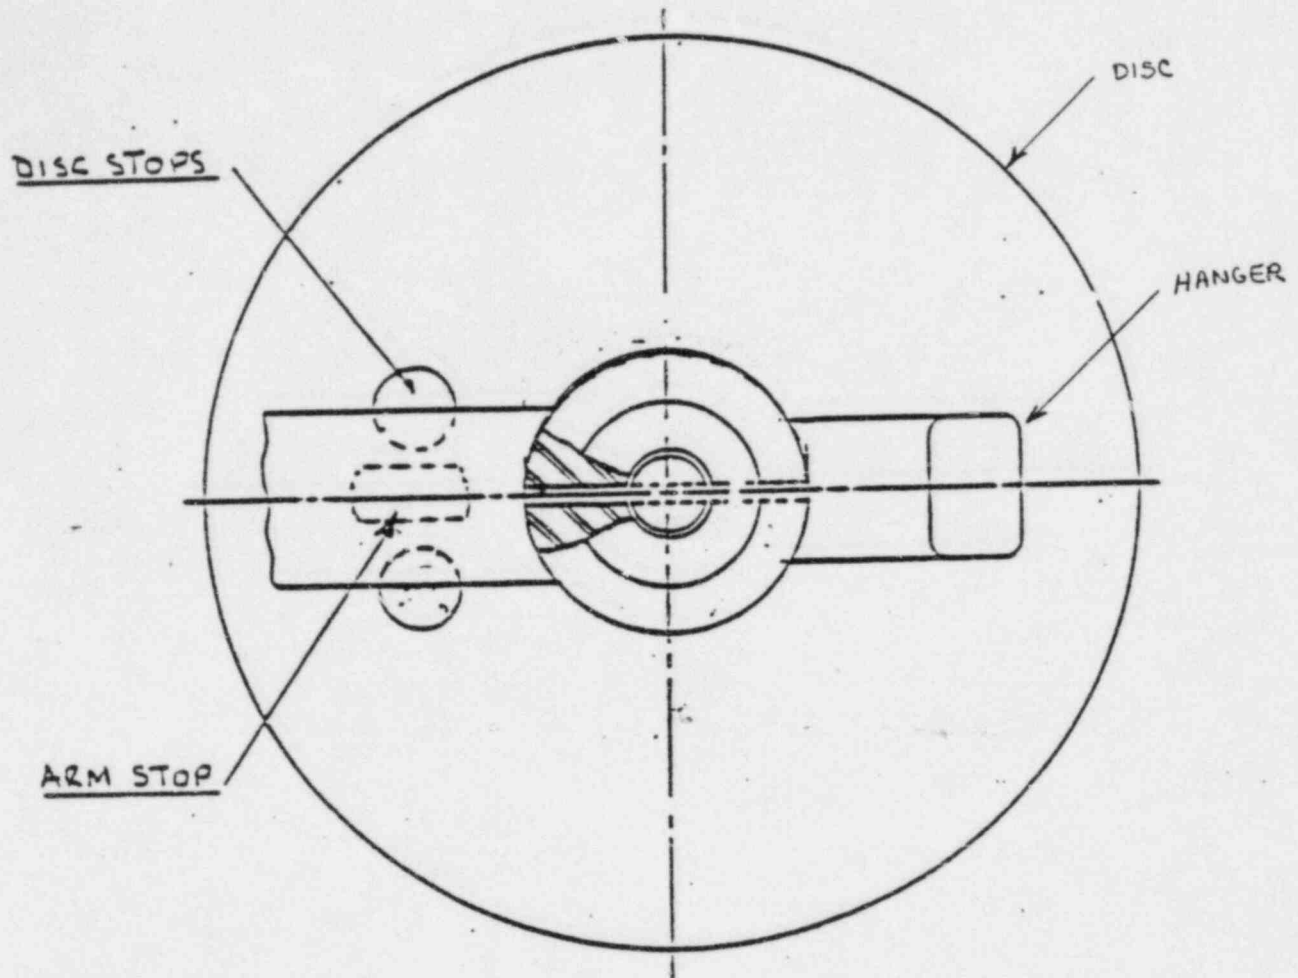
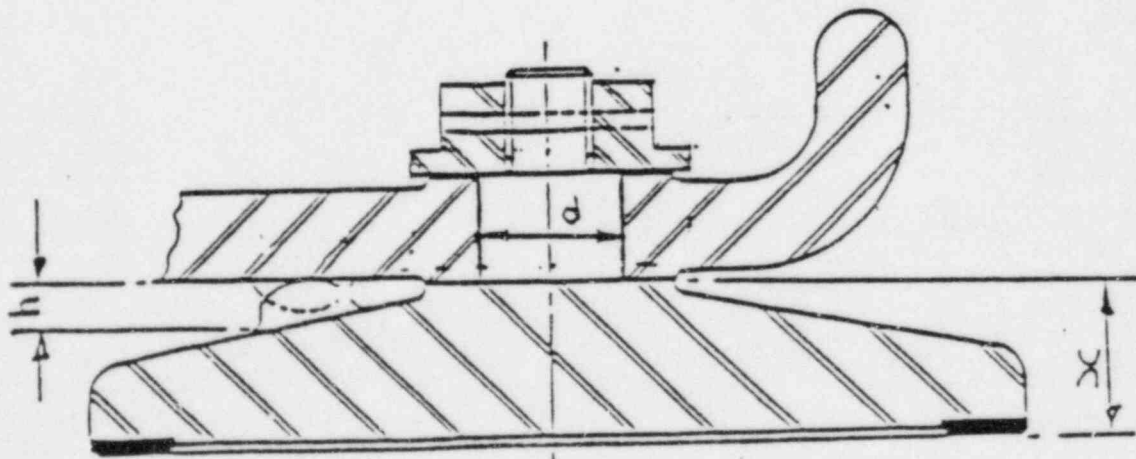
FIG 1

On October 25, 1984, Valve HP 59 was disassembled and inspected. The disc in HP 59 was found to be seated properly. However, it was discovered that the disc could be rotated with sufficient force by hand to cause the anti rotation stop on the disc to ride up on the hanger arm stop (See Figure 1). If the disc was to rotate into this position during normal operation, the valve disc should be prevented from properly aligning with the valve seat and some back leakage could occur.

Designation of Apparent Cause of Occurrence: The apparent cause of the anti-rotation stop jamming is due to the design of the anti rotation stops. The four HP swing check valve discs were manufactured by casting. The anti rotation stops on the disc were also part of the casting. As a result, the stop tended to be short and rounded. The resulting dimensions of the disc stop allows the disc stop to slide under the hanger arm and to interfere with the hanger stop when flow through the valve causes the disc to rotate. This contact between the disc stop and hanger stop causes wearing of the stop surfaces. After significant wear of the stop surfaces has occurred, the disc stop can be jammed up onto the hanger stop and lock in this position, basically "cocking" the disc. The disc is then unable to seat properly, allowing reverse flow past the valve to occur.
