November 26, 1984

Docket Nos. 50-348  
50-364

Joseph M. Farley Nuclear Plant - Units 1 and 2  
IE Bulletin No. 84-03, Refueling Cavity Water Seal

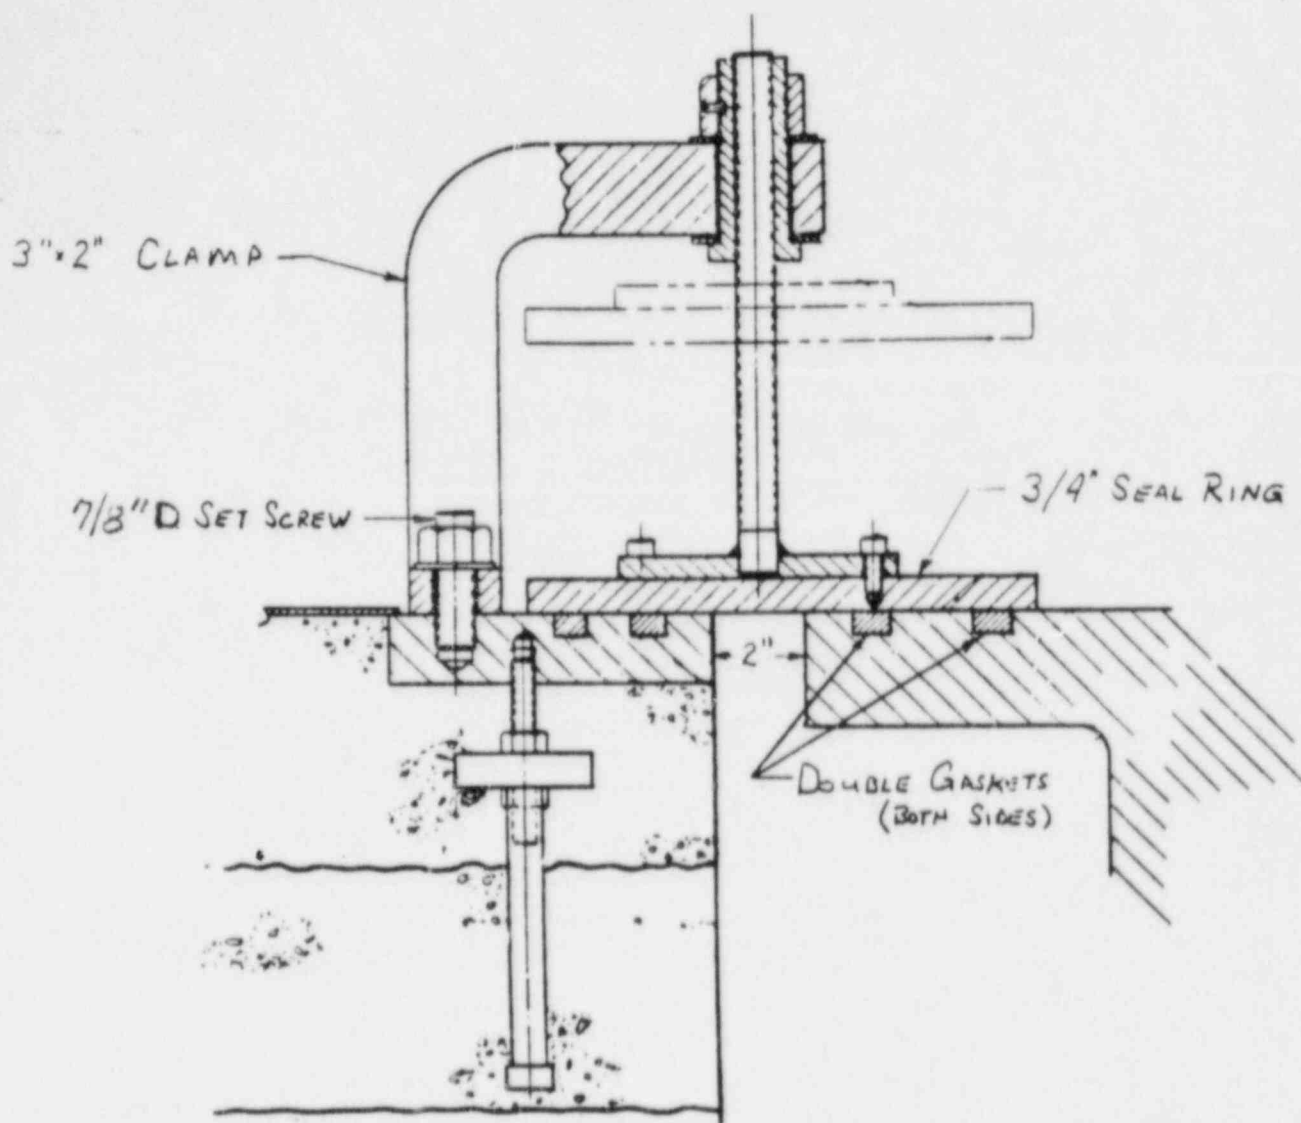
FIGURE 1

A comparison of the refueling cavity water seal in use at Farley Nuclear Plant (Figure 1) and the seal that failed at Haddam Neck Nuclear Plant reveals that the two seals have no design similarities. The Farley seal consists of a 3/4 inch stainless steel ring, 11 inches wide and approximately 17 feet in diameter, spanning a two inch gap between the vessel flange and the seal support ring. This steel ring rests on four elastomer O-Ring seals (double gaskets): two on the vessel flange and two on the seal support ring. The seals are in grooves to prevent their moving out of place and are compressed by 18 holddown clamps acting on the seal ring, only nine of which are required by design. Each clamp is made of a 3 inch by 2 inch steel bar which is anchored to the seal support ring by two 7/8 inch set screws. There are no active

components and the weight of water above the 11 inch ring is approximately 37 tons which acts to make the seal tighter (not to displace the seal as in the Haddam Neck design). In addition, the double gaskets on both the reactor flange and the cavity floor provide a means of leak testing the seal configuration prior to the flooding of the refueling cavity. The leak testing procedure provides for pressurizing the area between the seals to detect leakage. Observation of the ability of the seal to maintain air pressure provides the required assurance that no leakage will be experienced after flooding.

REACTOR CAVITY SEAL CROSS SECTION  
(TYPICAL 18 LOCATIONS EQUALLY SPACED)

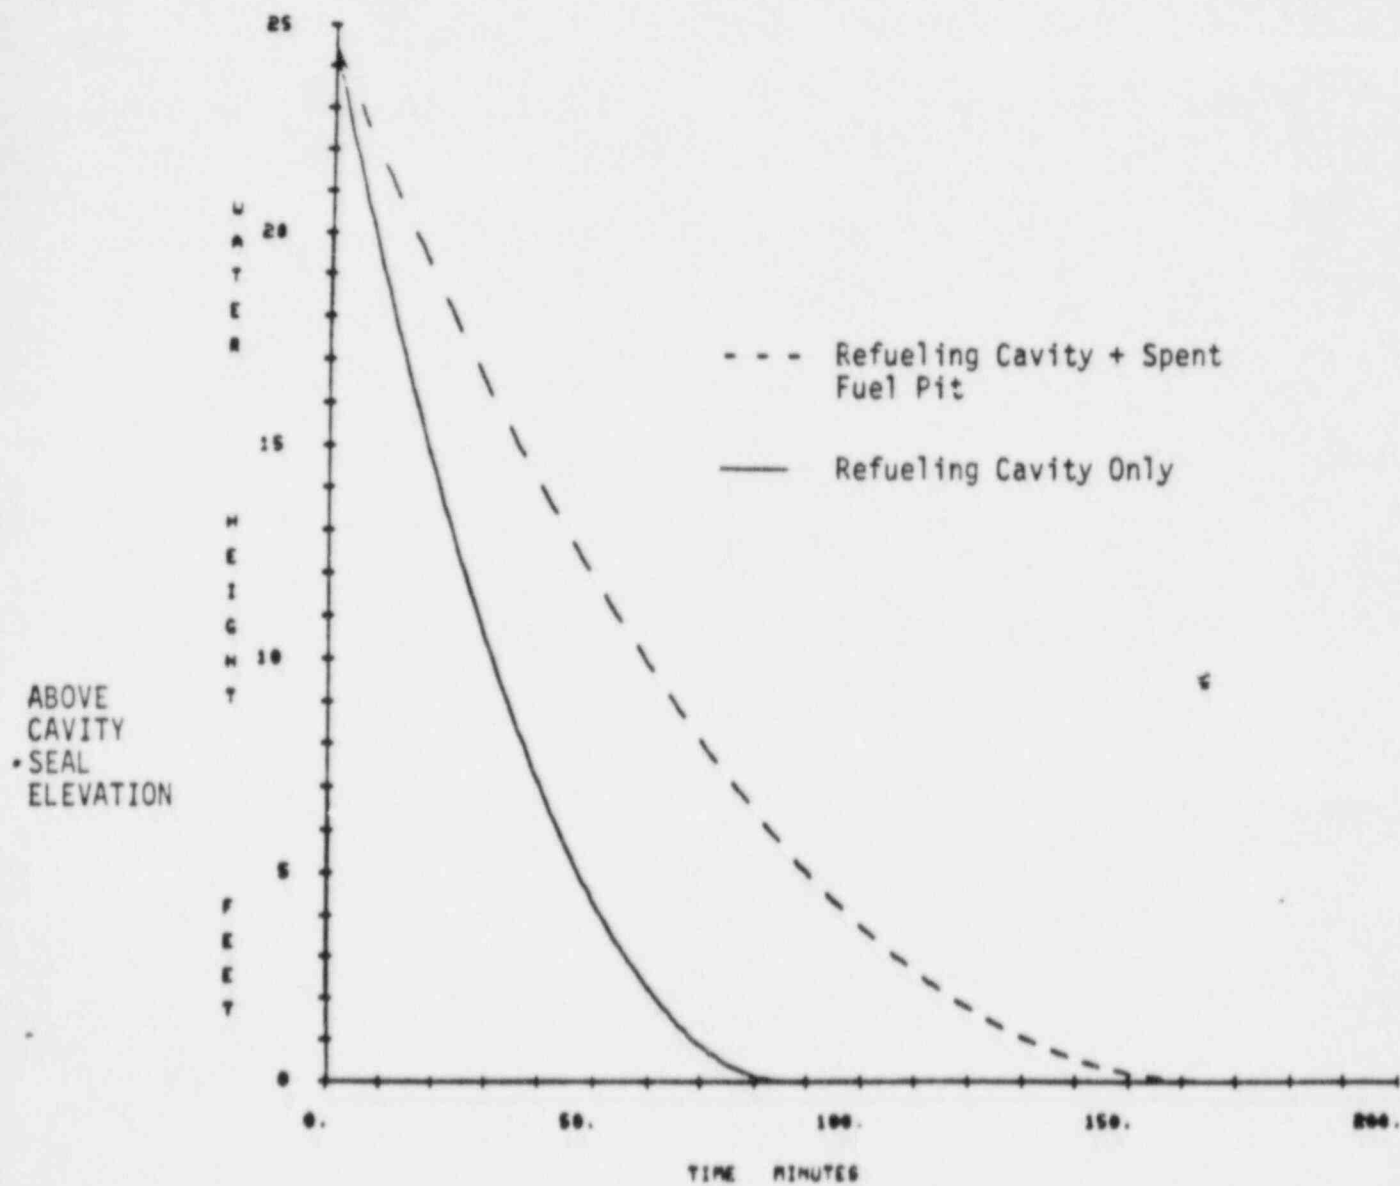
FIGURE 2

For such a hypothetical event where seal deformation could be experienced, a sixty (60) mil gap has been postulated between the seal ring and the reactor vessel flange/refueling cavity floor assuming that the double gaskets were not in place. In addition, the gap was conservatively assumed to be on both the inside (reactor vessel flange side) and the outside (refueling cavity side) of the seal ring. Figure

2 shows the reduction in water level with respect to time, with and without communication between the spent fuel pit and the refueling cavity. Even though this postulated sixty (60) mil leak is extremely unlikely, Figure 2 indicates that eighty-six (86) minutes is required to drain the refueling cavity to the level of the seal ring with the spent fuel pit isolated and one hundred sixty-four (164) minutes to drain to the same level with the transfer canal open. Figure 3 illustrates the leakage rate over time with and without communication between the spent fuel pit and the refueling cavity. Figure 3 also shows that the maximum leak rate is 5500 gpm when the refueling cavity is filled. As the level decreases, the leak rate will also decrease because of a decrease in hydrostatic pressure exerted by the water column above the seal ring.

ALA REFUELING CAVITY WATER HEIGHT AFTER SEAL FAILURE WITH NO MAKEUP WATER

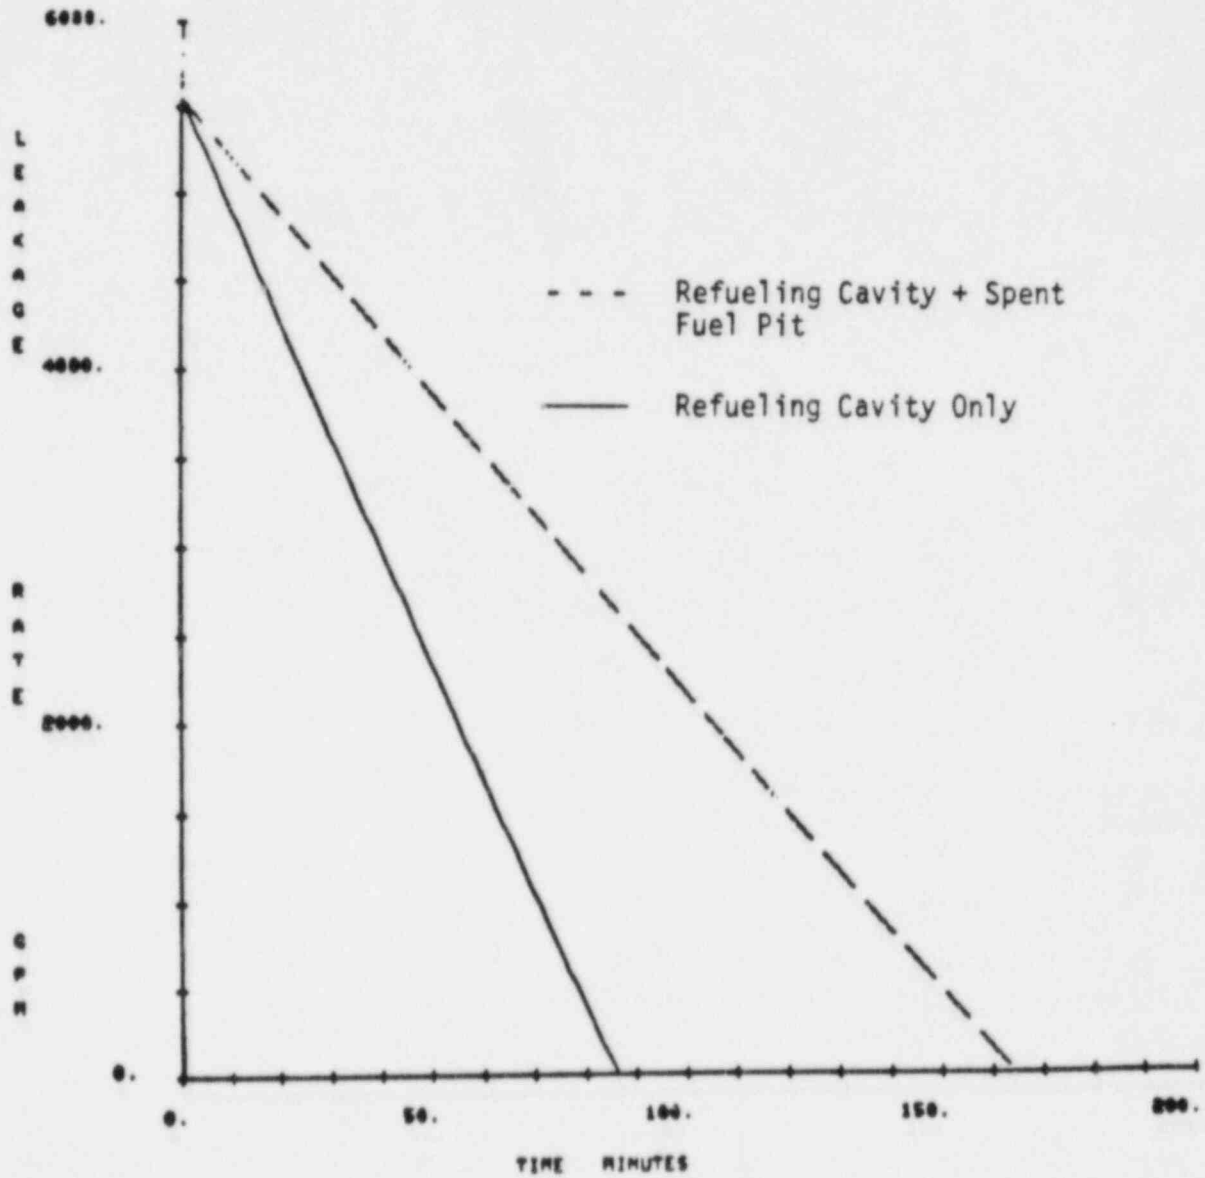
FIGURE 3

ALA REFUELING CAVITY SEAL LEAKAGE RATE AFTER SEAL FAILURE
