INDIANA & MICHIGAN ELECTRIC COMPANY

AEP:NRC:0898A

Donald C. Cook Nuclear Plant Unit Nos. 1 and 2
Docket Nos. 50-315 and 50-316
License Nos. DPR-58 and DPR-74
REFUELING CAVITY WATER SEAL
(IE BULLETIN 84-03)

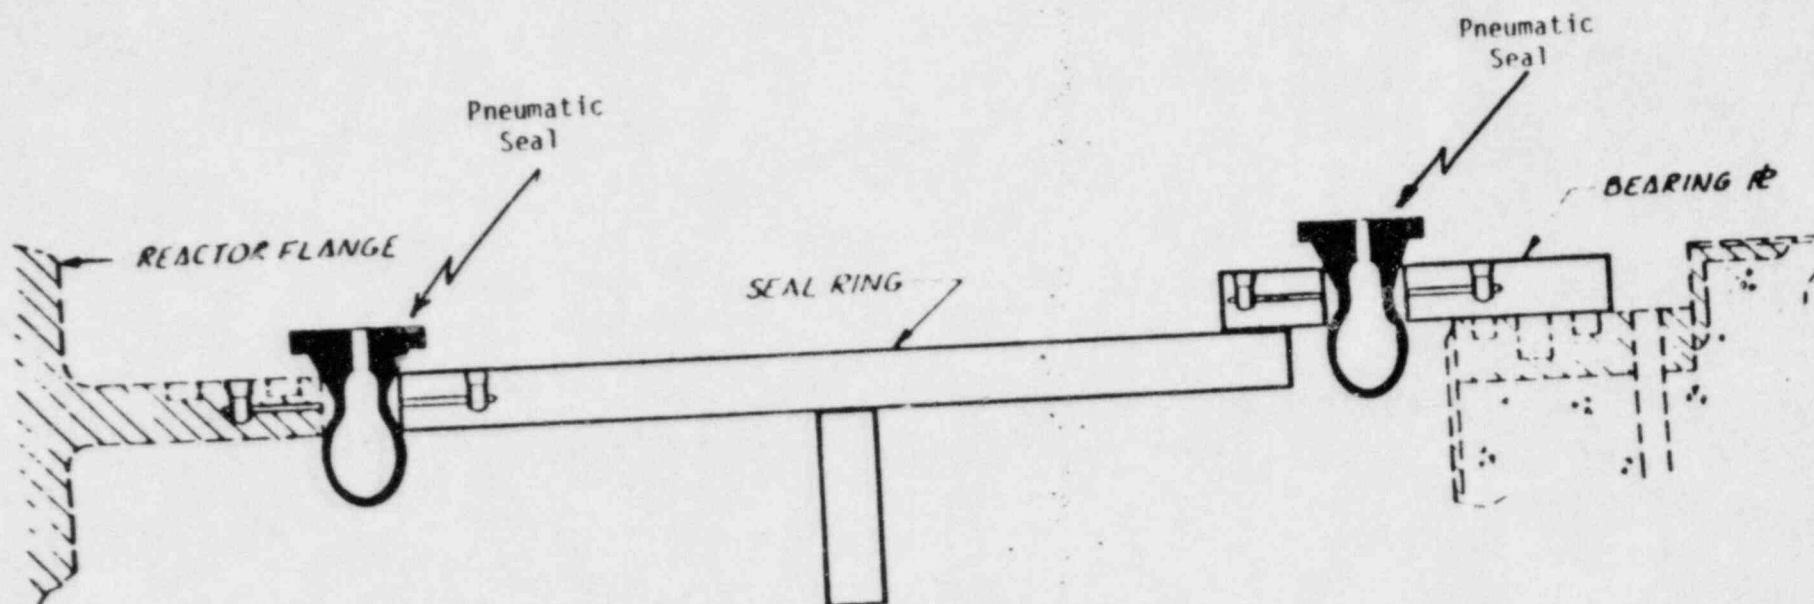
Figure 1 - Haddam Neck Refueling Cavity Water Seal

The refueling cavity seal arrangement at the Donald C. Cook Nuclear Plant is a one piece seal inserted in a nominal two inch annular opening between the reactor vessel flange and the refueling cavity wall. This arrangement is different than that depicted in Figure 1 of NRC IE Bulletin 84-03 (Attachments 1, 2, and 3).

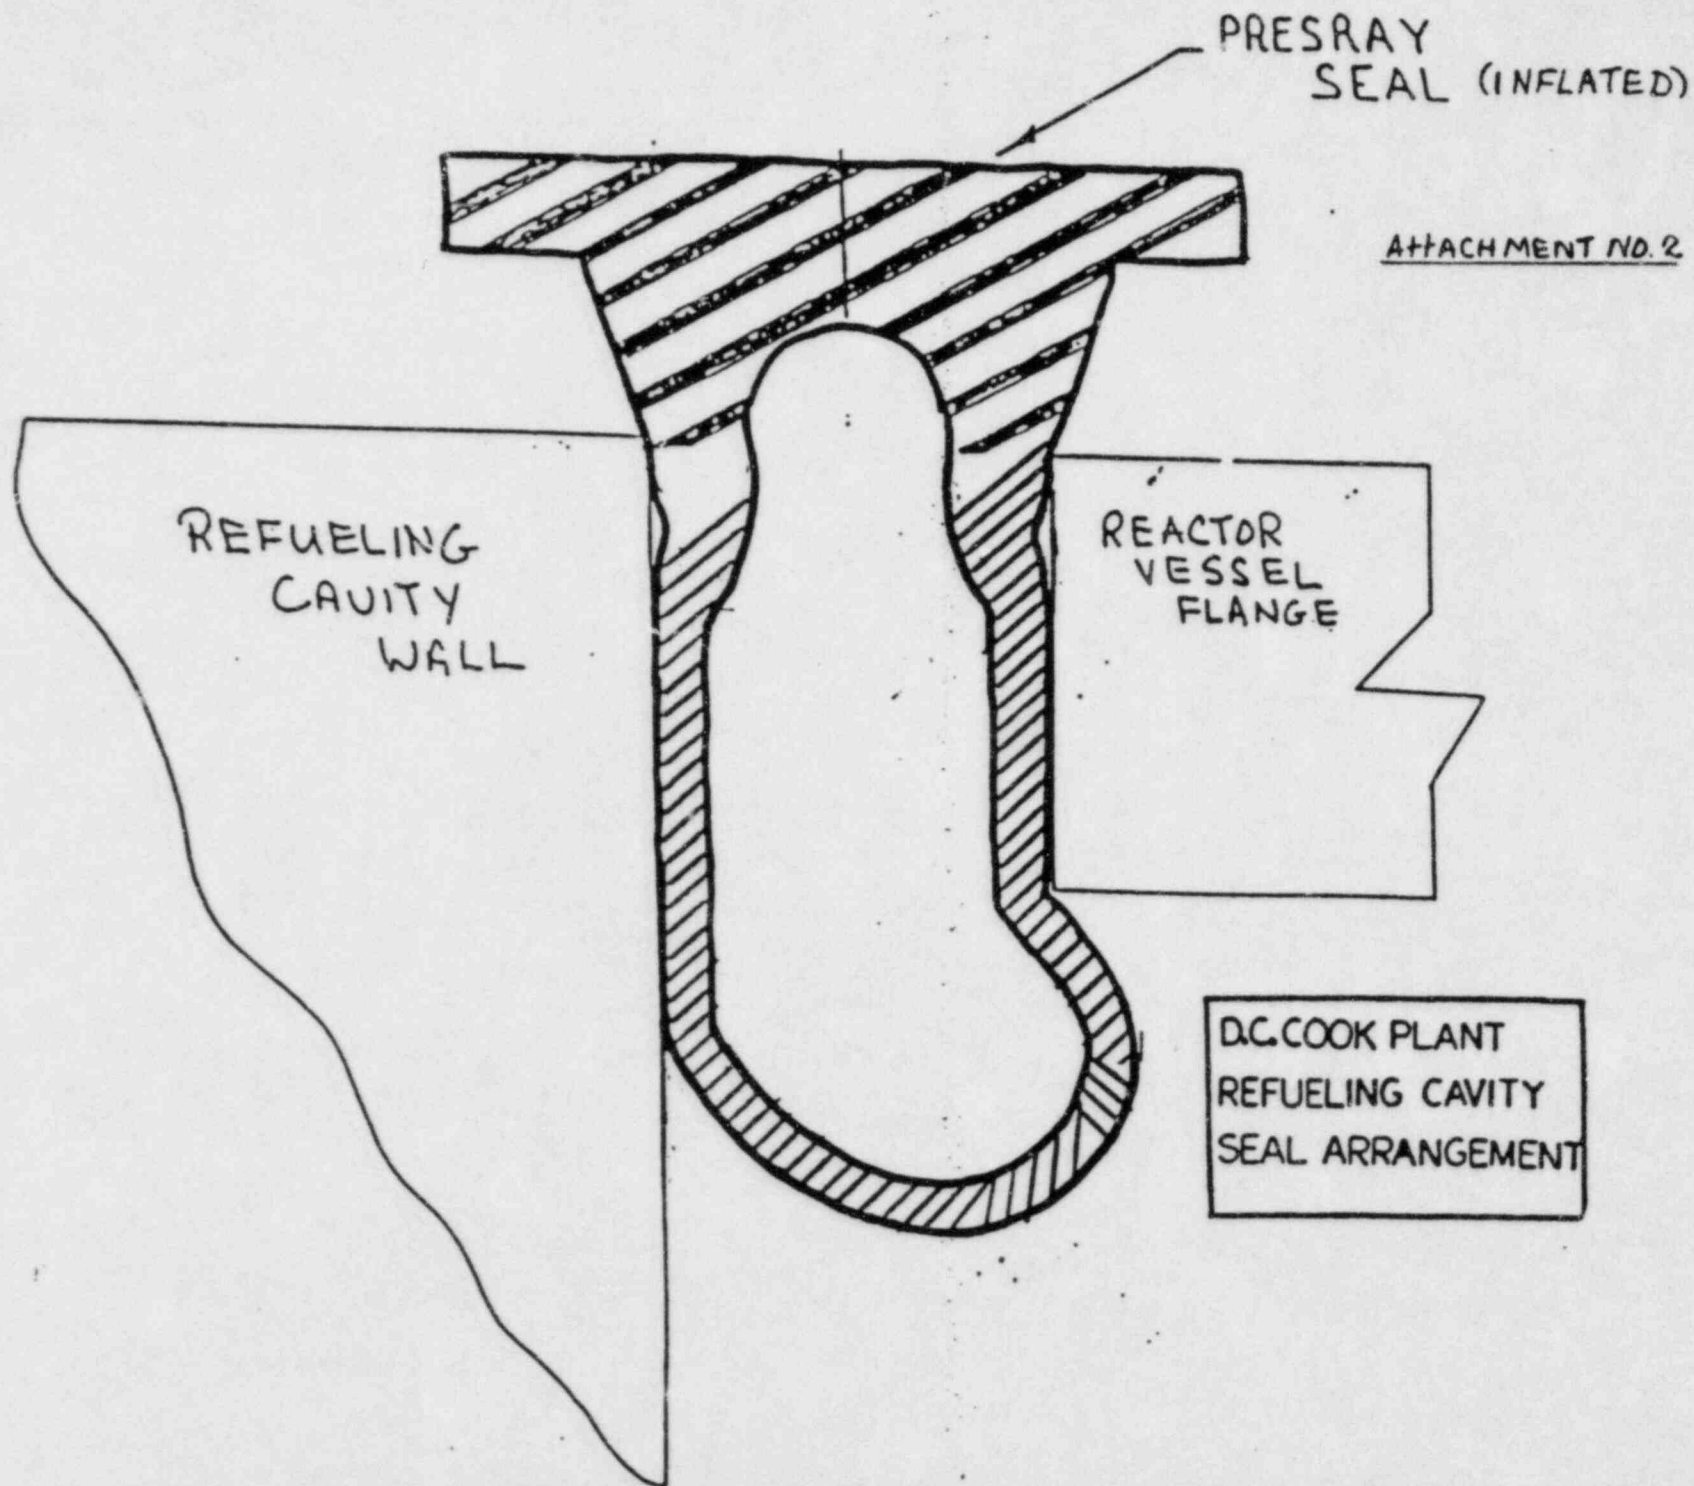
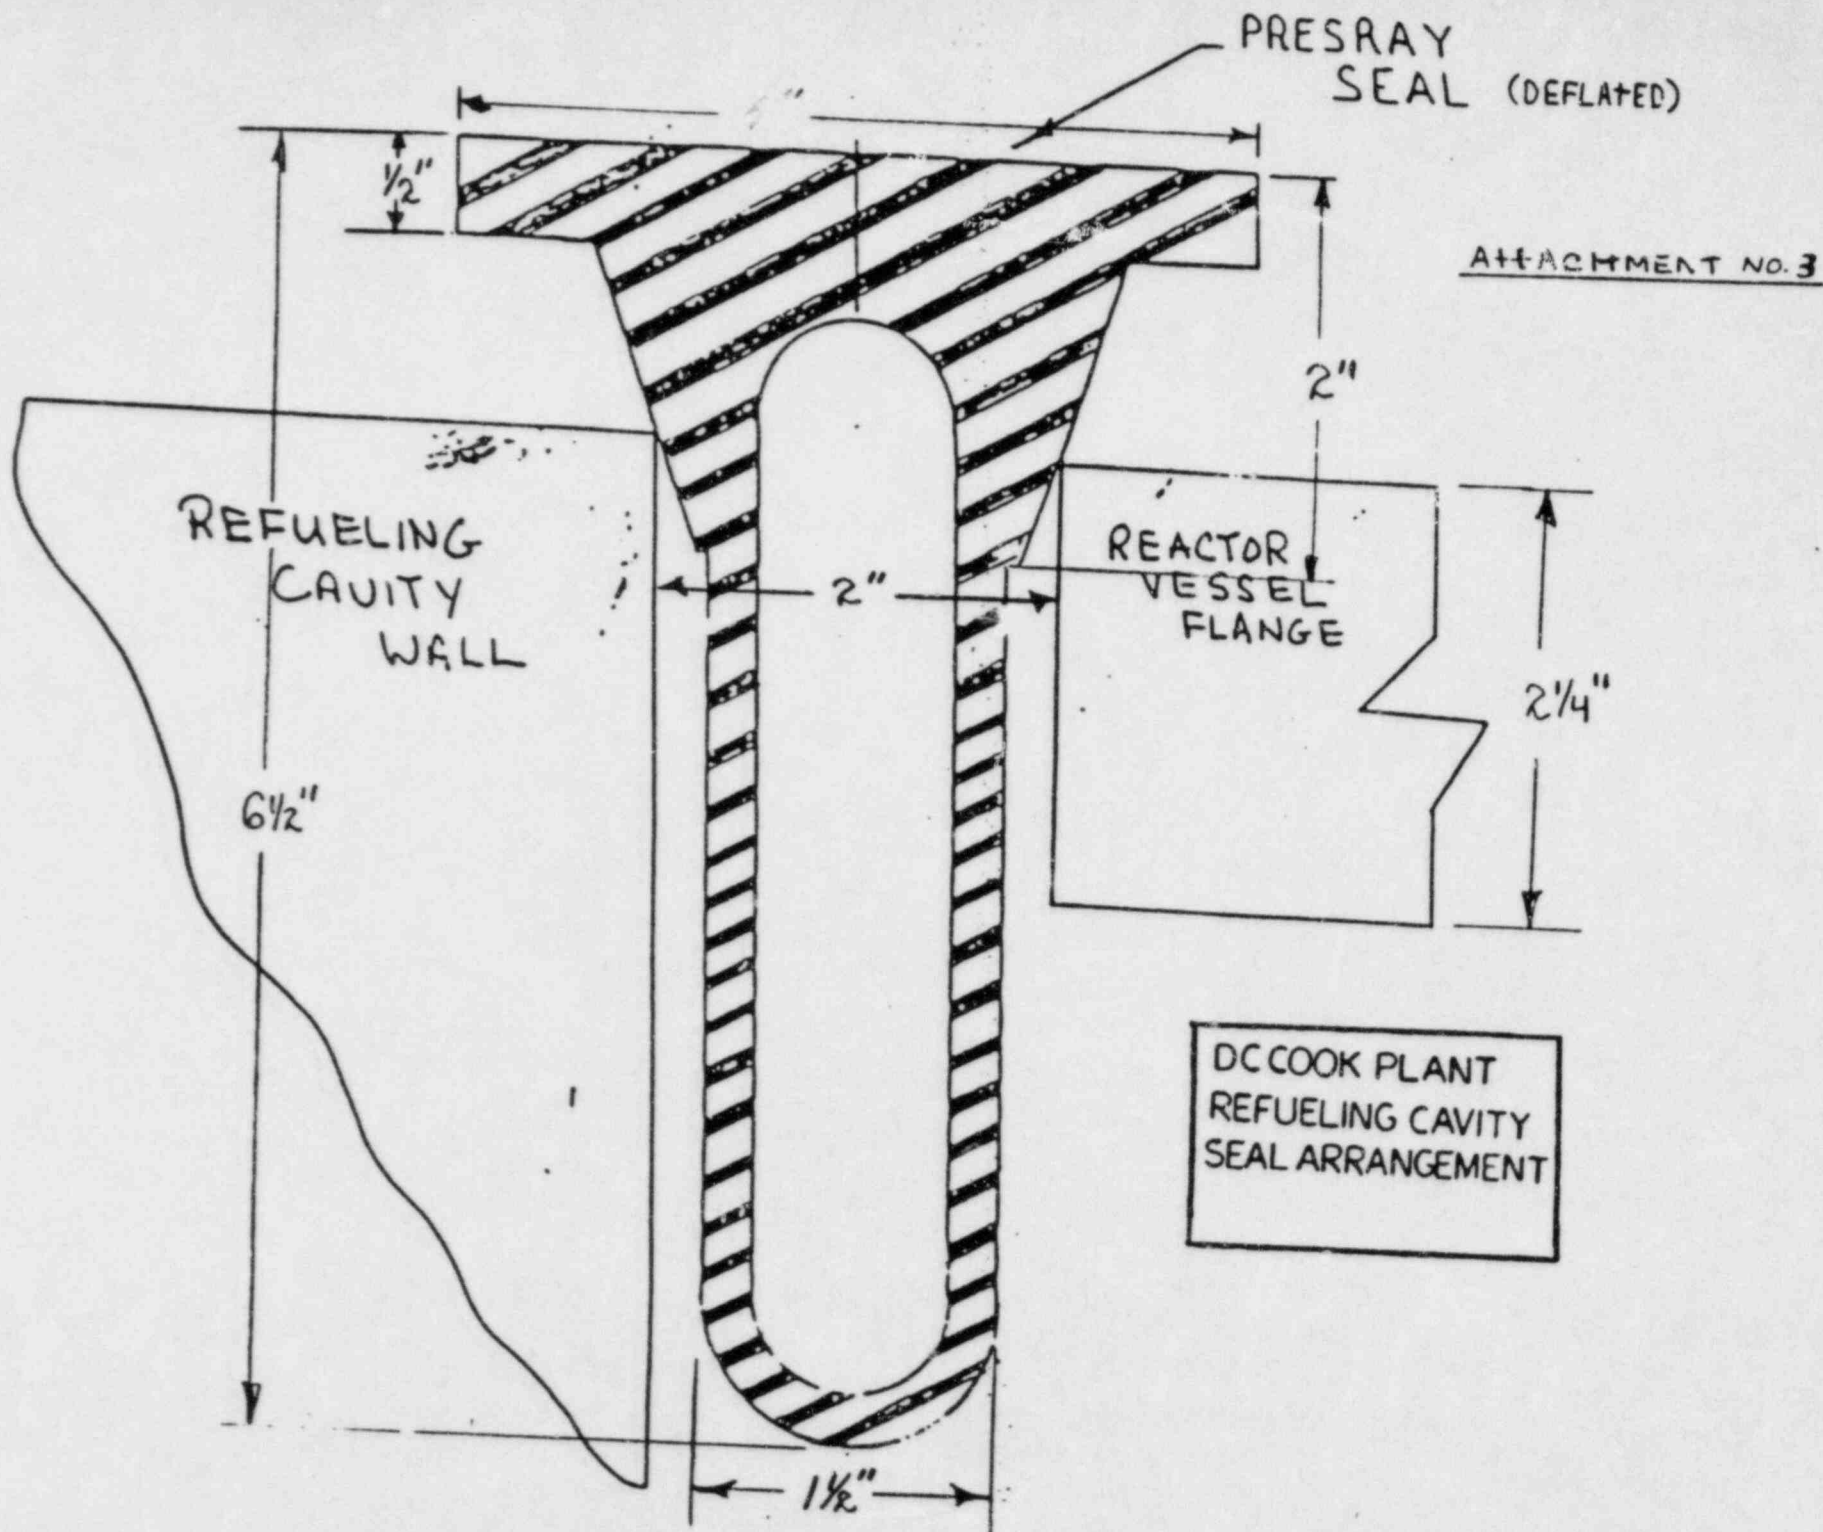
Inflation of the seal at normal pressure (15-30 psig) results in a slight downward force on the seal which tends to draw it into the annulus. Overpressurization would have a tendency to increase this downward force, but the rigid annulus configuration at Cook, and the rigidity of the seal rubber, prevent the 4 inch section of the seal from being pulled through the 2 inch annulus opening. In addition, the annulus configuration offers more surface contact with the cavity wall than the Haddam Neck design. In discussions with the Presray Corporation, manufacturer of both the Cook and Haddam Neck refueling cavity seals, it was determined that the upper section of the Cook seal is wider than the type used at the Haddam Neck plant. Also, the seal used at Cook has a greater rubber hardness, a 60 durometer, versus Haddam Necks 40 durometer, seal.

Based on the above review, we conclude that failure of the active seal component (i.e., the inflated lower portion of the rubber seal) will not result in a gross seal failure or gross leakage because of the passive seal component (i.e., the solid wedge-shaped upper portion of the rubber seal), and we believe the gross failure of the refueling cavity seal in a manner cited in IE Bulletin No. 84-03 to be highly improbable.
