DESIGN REVIEW OF TDI R-4 AND RV-4 SERIES  
EMERGENCY DIESEL GENERATOR CYLINDER BLOCKS AND LINERS

Prepared by  
Failure Analysis Associates  
Palo Alto, California

TDI Diesel Generator Owners Group

June 1984

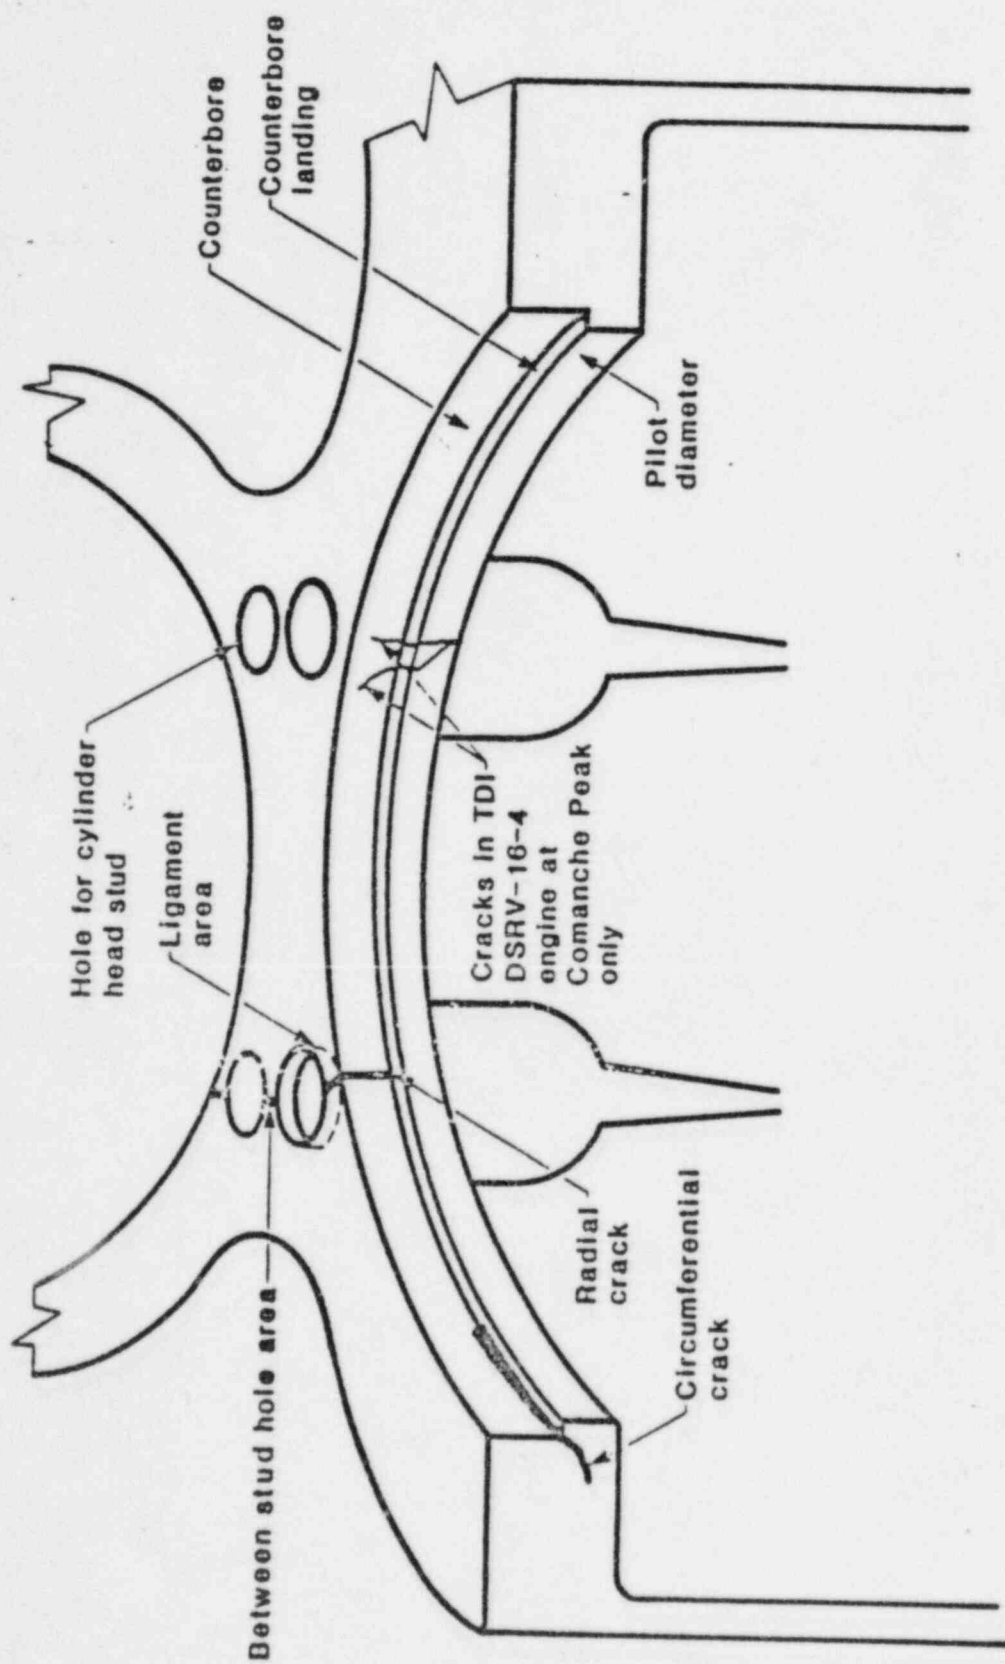
Figure i-1. Location of cracks.

Two types of cracks have been found to occur in cylinder block tops of this design: cracks in the radial/vertical plane at the stud holes, and circumferential cracks in the liner counterbore at the liner landing ledge [1-1]. Figure 1-1 depicts the potential location of block top radial and circumferential cracks. In addition, for the in-line engines, cracks have occurred in the cam gallery above the cam shaft bearing supports. The survey of industry experience with TDI R-4 and RV-4 engines summarized in this section has not been independently confirmed by FaAA, and therefore is not subject to FaAA's usual quality assurance procedures.

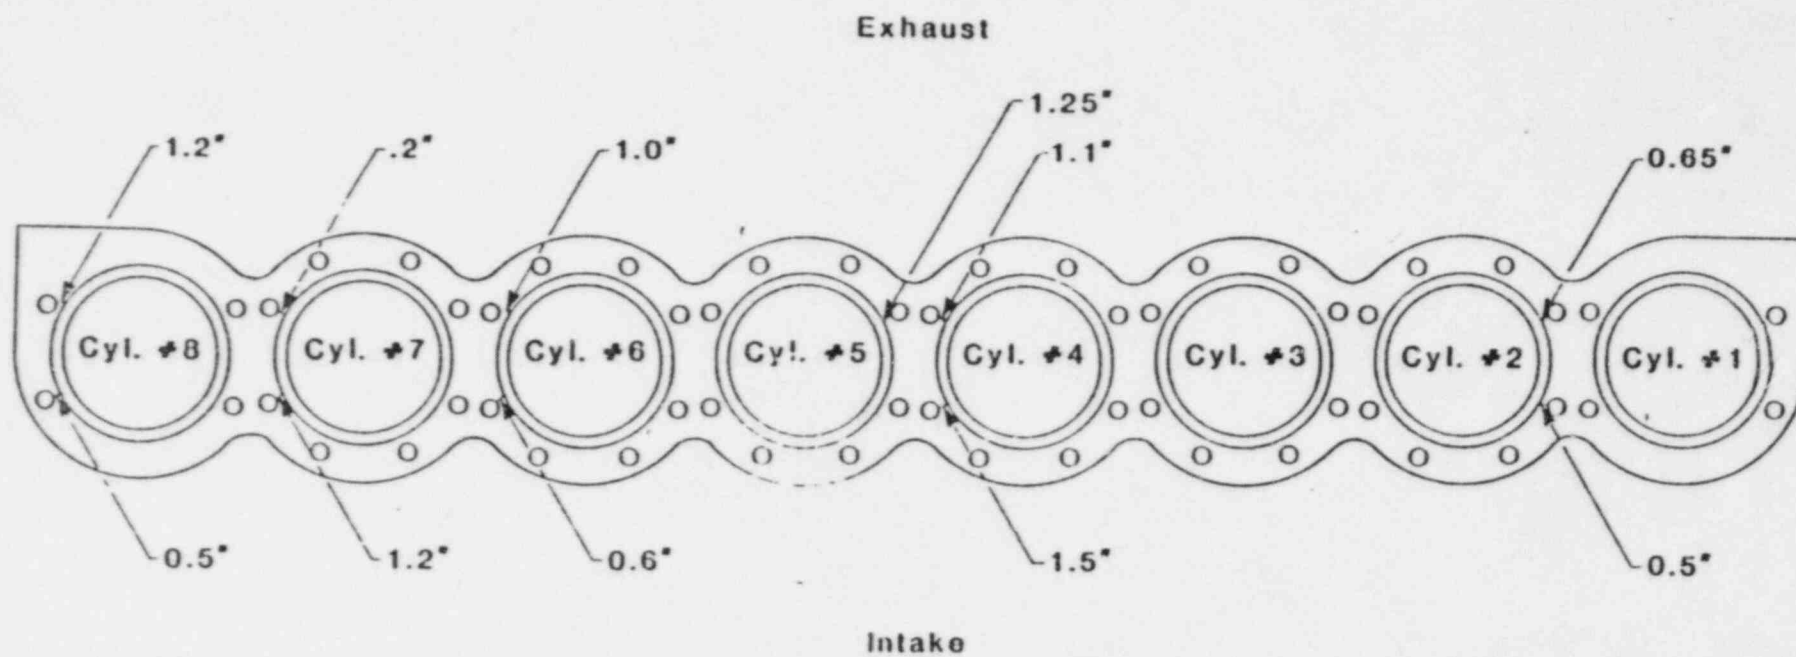
Figure 1-2. SNPS DG101 crack map.

As part of the engine requalification program after the crankshaft replacement, each engine was operated for 100 hours at or above full load and was then disassembled and inspected. During these inspections, radial/vertical cracks were discovered in the blocks of all three engines. Crack maps for DG101, DG102, and DG103 are presented in Figures 1-2, 1-3, and 1-4, respectively.

Dimensions indicate crack depth

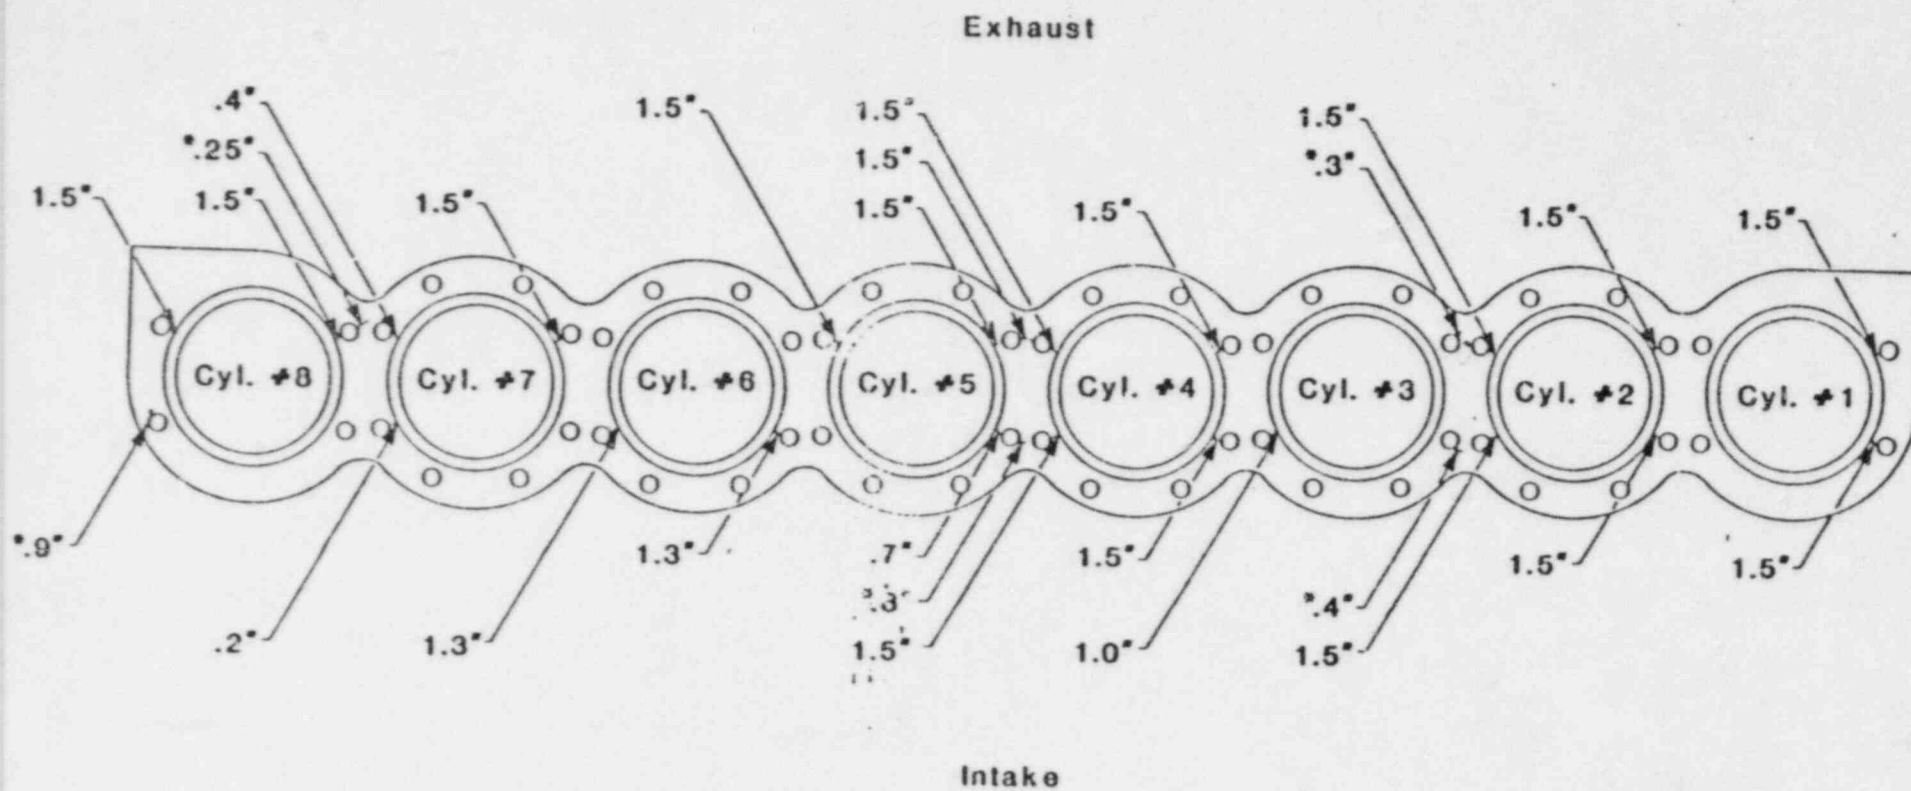
Figure 1-4. SNPS DG103 crack map as of 3/11/84.

Dimensions indicate crack depth

\*Top surface indication. Depth not measured

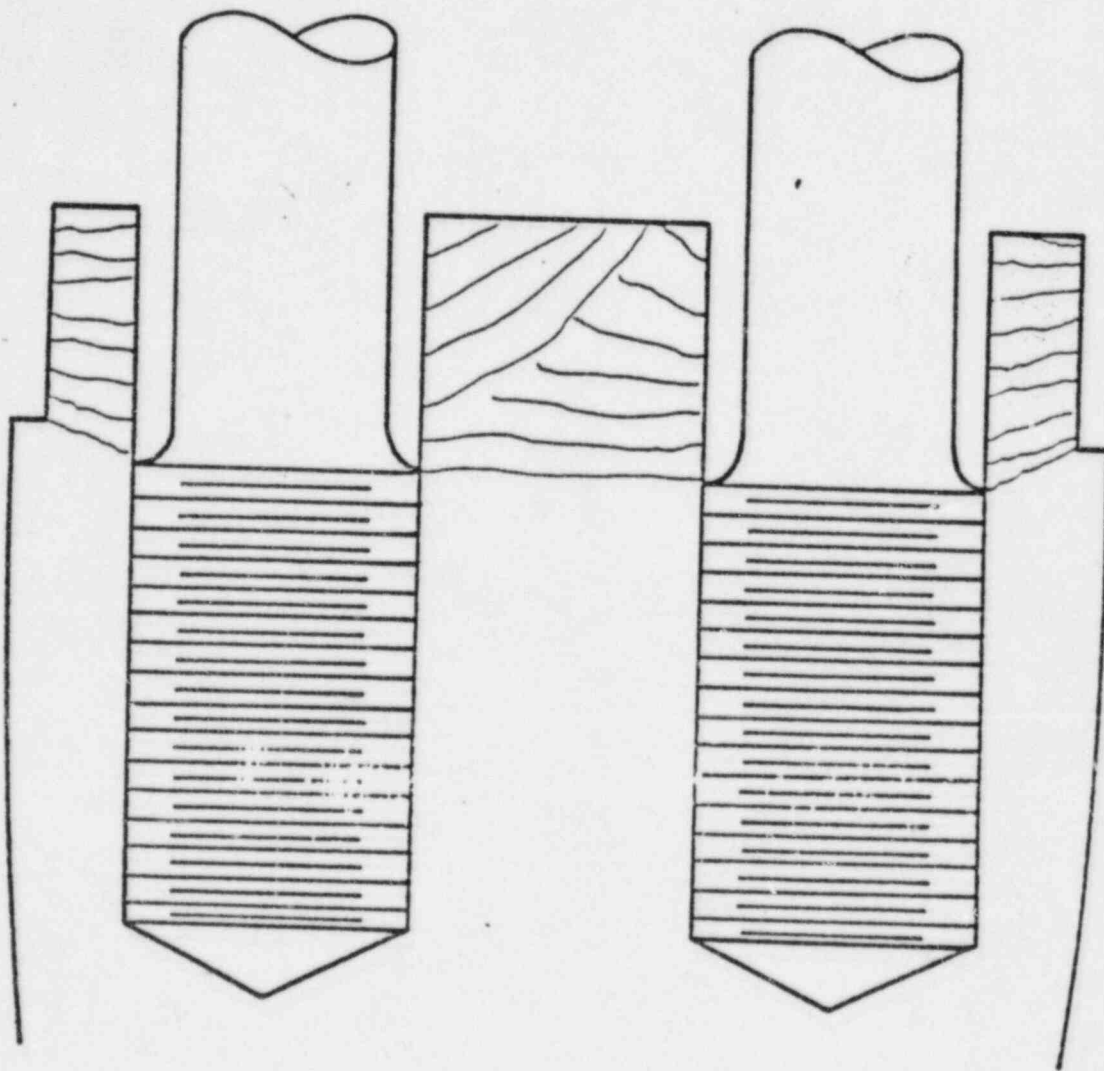
Figure 1-6. Longitudinal section between adjacent cylinders for  
SNPS DG103.

No circumferential cracks were found in any of the engines. However, each block had radial/vertical cracks between the cylinder bore and the stud hole. Sixty-seven percent of the ligament cracks were between 1 and 1 1/2 inches deep. A typical example of a cross-section of a radial/vertical crack through a ligament is shown in Figure 1-5. As depicted in the figure, none of the cracks extended below the corner formed by the counterbore and the counterbore landing. This demonstrates the apparent arrest of radial/vertical cracks that occur in the ligament region. In addition, when first inspected, the engine block from DG103 had a crack that extended between two adjacent studs on the exhaust side of Cylinder Nos. 4 and 5 as shown in Figure 1-6.

Inspection of the block top revealed cracks between stud holes with depth of 1 1/2 inches similar to those shown in Figure 1-6 at three locations. At four other locations, between-stud cracks developed along the top surface which did not extend to measureable depths down the sides of the stud hole. At one location a crack that previously extended 0.8 inch radially from one stud hole towards the adjacent stud hole grew to a maximum depth of 3.9 inches. In addition, the original crack between Cylinder Nos. 4 and 5 had ex-

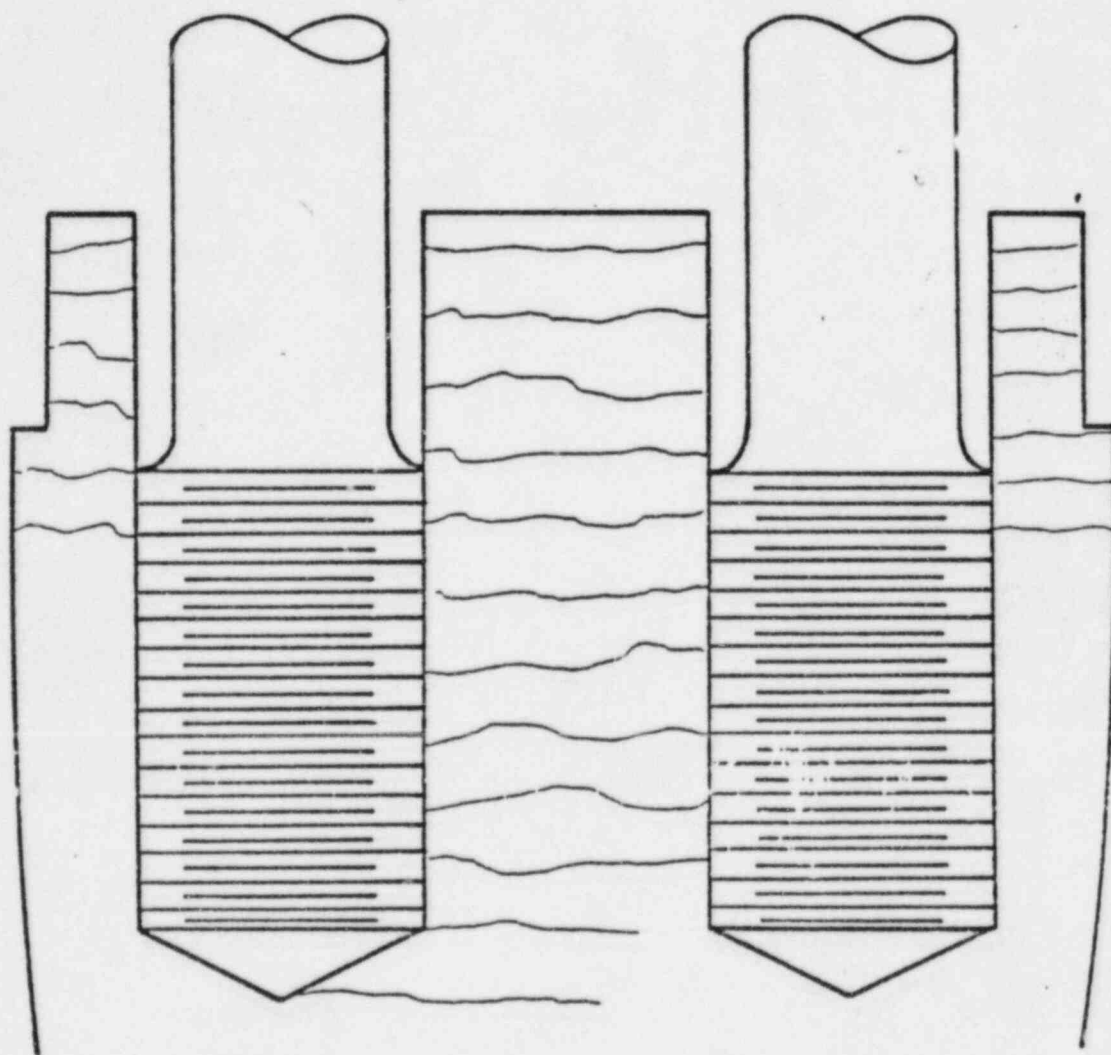
Figure 1-7. Longitudinal section between Cylinders 4 and 5 on exhaust side of SNPS DG103.

tended to a depth of at least 5 1/2 inches. As shown in Figure 1-7, the ligament cracks had also grown approximately 1 inch. Figure 1-8 is a crack map for DG103 as reinspected.

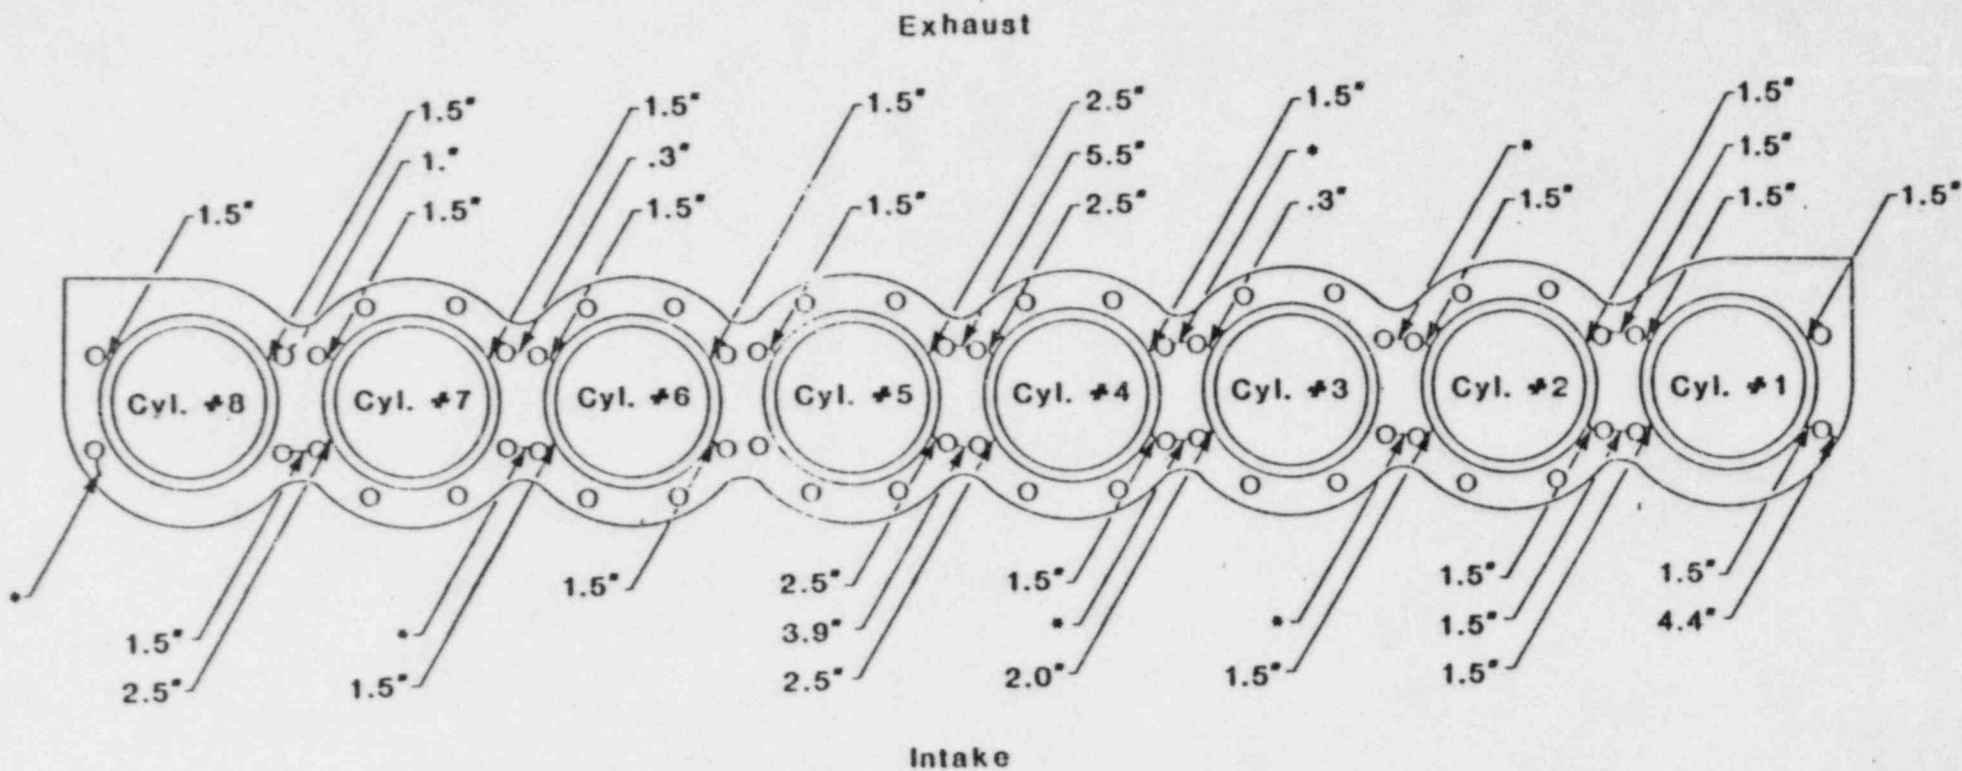
Figure 1-8. SWS DG103 crack map as of 4/23/84.

Dimensions indicate crack depth

\*Top surface indication. No depth to crack measurable down stud hole

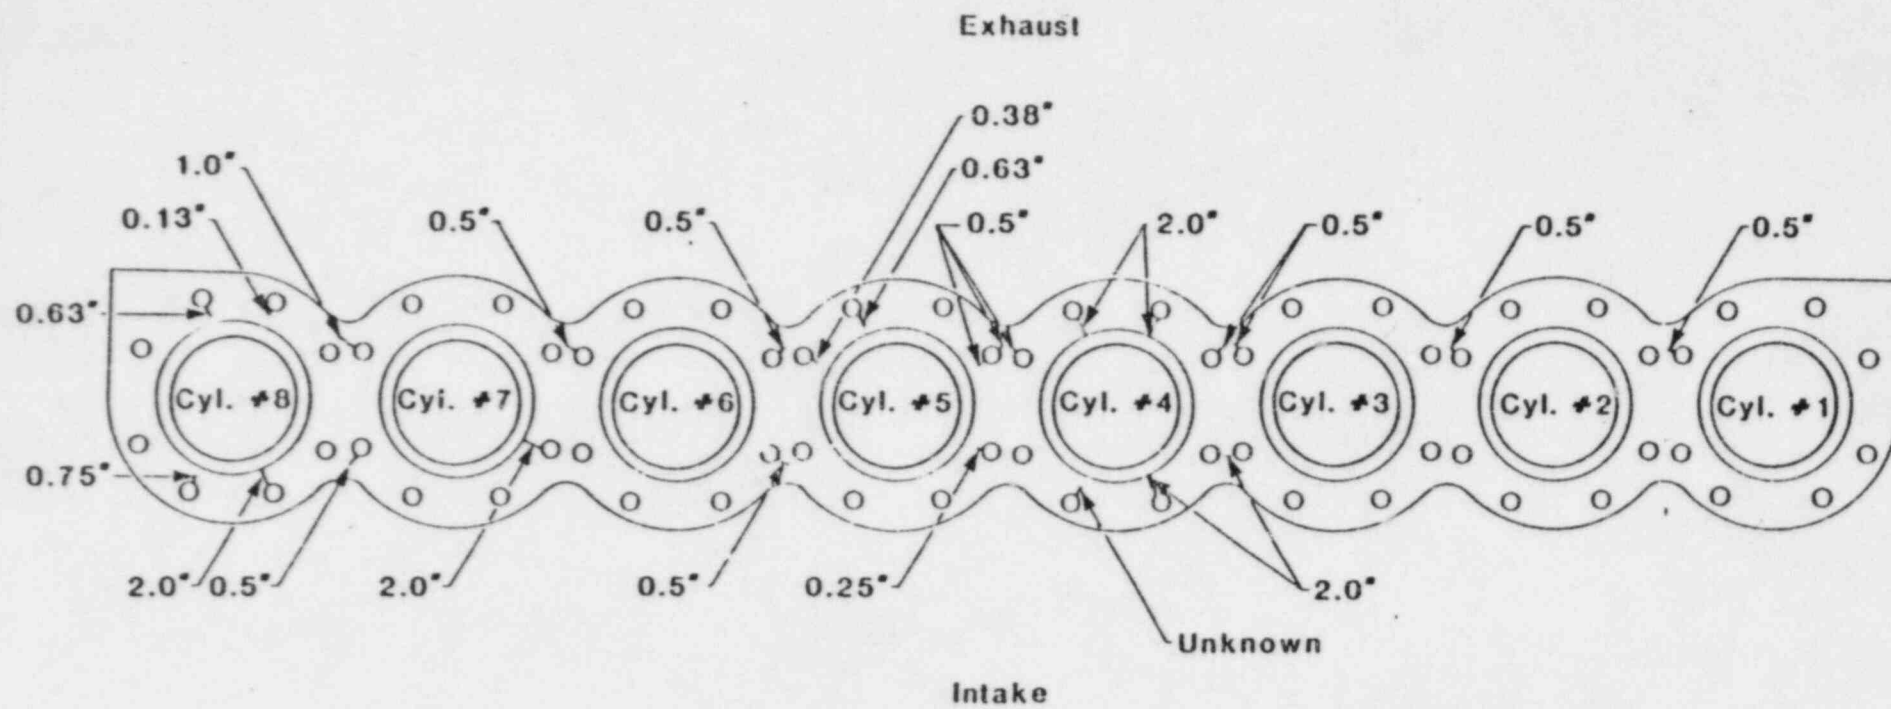
A block from a dual-fuel V-16 engine (the St. Cloud block at TDI in Oakland) shows extensive radial and circumferential cracks. Several radial cracks appear between stud holes without ligament cracks. The cracks are shown in Figures 1-9 and 1-10, but depths are not available. The detailed operating history of this block is unknown, but it had over 16,000 hours in municipal power service with fuels of varying heat content. Detonation of the gaseous fuel mixture is believed to have occurred in service, causing increases in cylinder pressure on the order of a factor of two.

Dimensions indicate crack depths

Figure 1-9. Engine crack map. Plan view of St. Cloud block top.

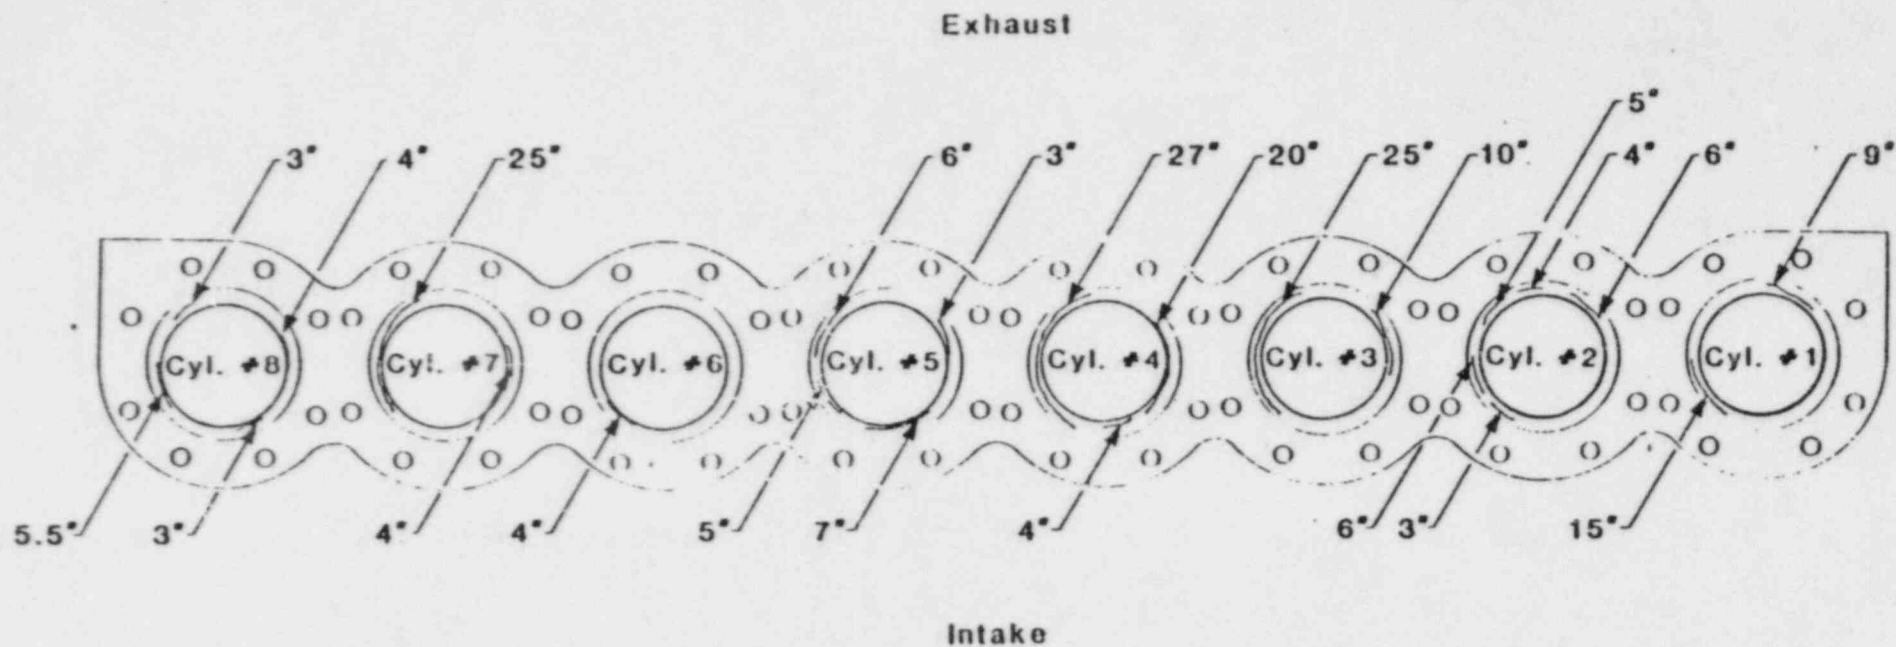
Dimensions indicate crack lengths

Figure 1-10. Engine crack map. Plan view of St. Cloud block top. Circumferential cracks in liner landing.

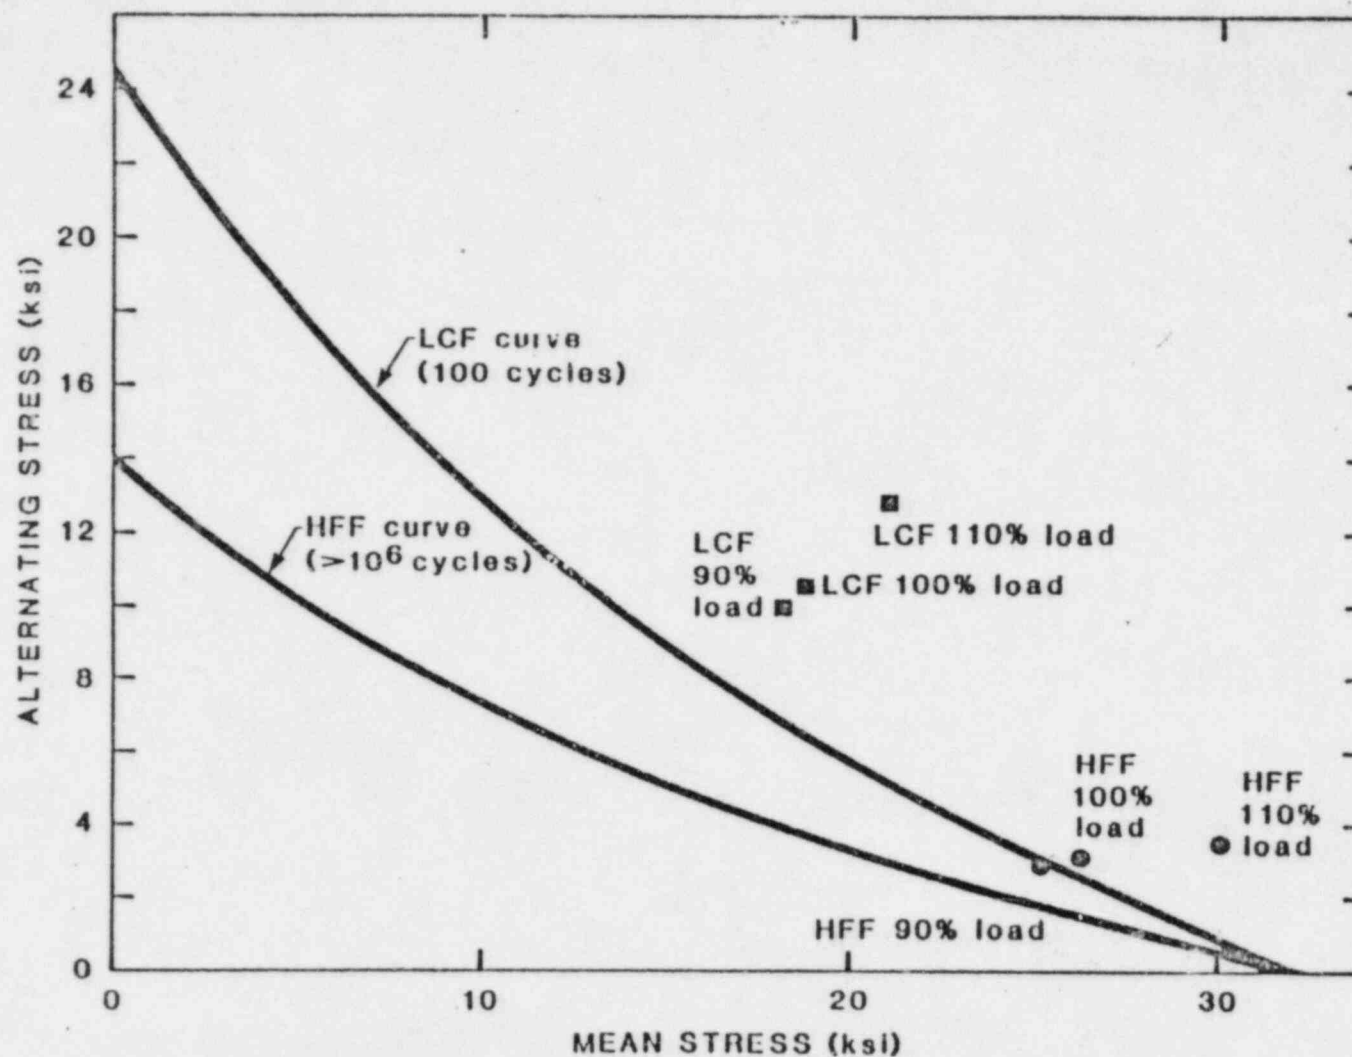
Figure 3-13. Goodman (Smith) diagram for ligament cracking.

The results are shown in modified Goodman (Smith) diagrams: Figure 3-13 for ligament cracking and Figure 3-14 for stud-to-stud cracking given cracked ligaments. The curves are derived from the minimum ultimate tensile strength in thick sections, the minimum specified endurance limit ( $>10^6$  cycles), and the stress for failure in 100 cycles (from the lowest curve in Figure 1-16). In both cracking locations, the stress state is outside the Goodman (Smith) curve for either HFF or LCF and for any load level of 90% or higher. The implication is that initiation of ligament cracks in minimum strength material

is predicted, and given a ligament crack, initiation of stud-to-stud cracks is also predicted. Initiation could occur in less than 100 load excursions from 0 to 90% power or above and/or steady running for more than  $10^6$  cycles (about 100 hours) at 90% power or above if the minimum material properties are assumed. At 110% load, overload failure could occur in both locations with minimum strength material since the peak total stress is 33 ksi compared to 32 ksi minimum thick-section ultimate strength. The fact that few blocks that have run at 110% load have cracks at both locations is indicative of higher-than-minimum material properties and/or conservatism in the analysis.

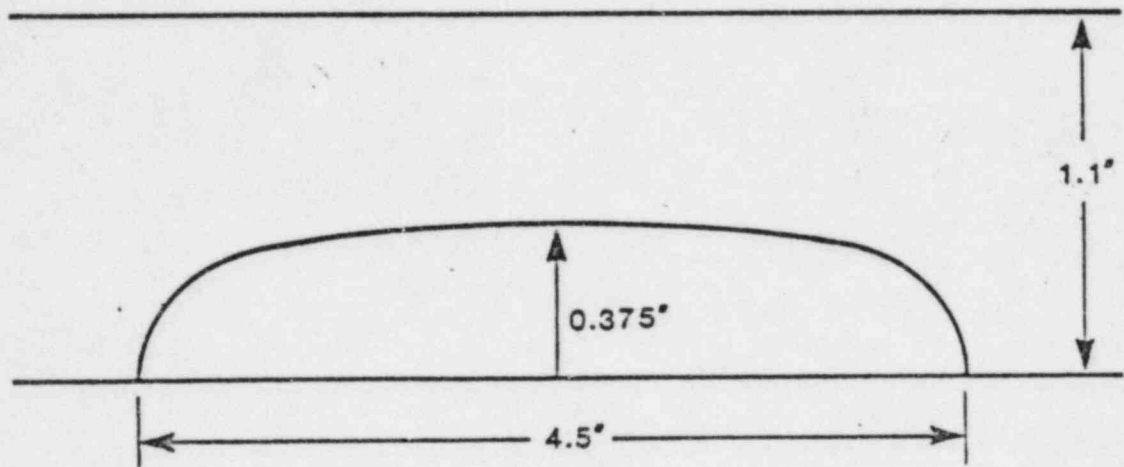
Figure 4-2. Cam gallery crack shape.

An additional type of cracking identified at SNPS is associated with the camshaft bearing supports. This cracking is unique to the inline engines and is attributed by FaAA to the casting process. At Comanche Peak, cracks unique to one engine block have been found. These have also been attributed by FaAA to the casting process.
