LICENSEE EVENT REPORT (LER)

FACILITY NAME (1) Fort St. Vrain, Unit No. 1 DOCKET NUMBER (2) 050002671 OF 17

TITLE (4) High Reactor Pressure Scram & Ensuing Control Rod Automatic Insertion Failures

SUBJECT: Licensee Event
Report 84-008,
Supplemental Report

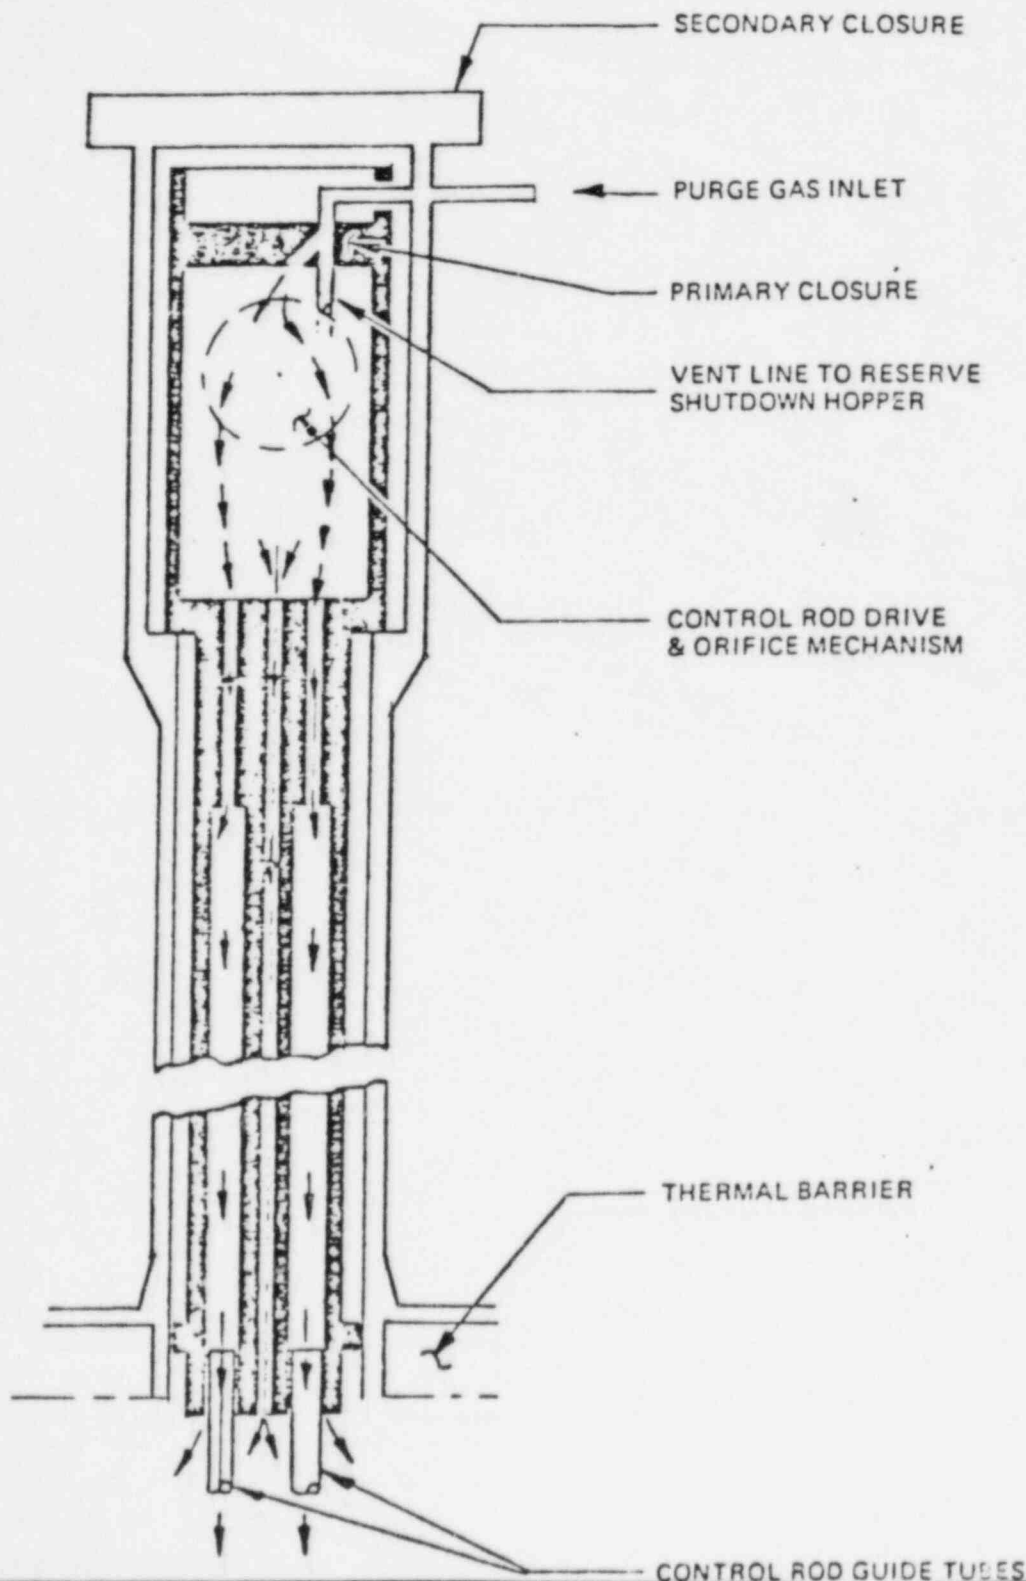
FIGURE 3

The control rod drive mechanism operates in a helium environment within the PCRV at reactor pressure (Figure 2). Ambient temperature is nominally maintained at approximately 150 degrees Fahrenheit by the refueling penetration cooling system and a thermal barrier between the drive and the reactor core. Shielding, interposed between the drive and the reactor core, limits the radiation level at the control rod drive to approximately 1 rad per hour. A helium purge flow of about 5.5 pounds per hour floods the drive assembly and reduces the ingress of contaminated reactor helium coolant (Figure 3).

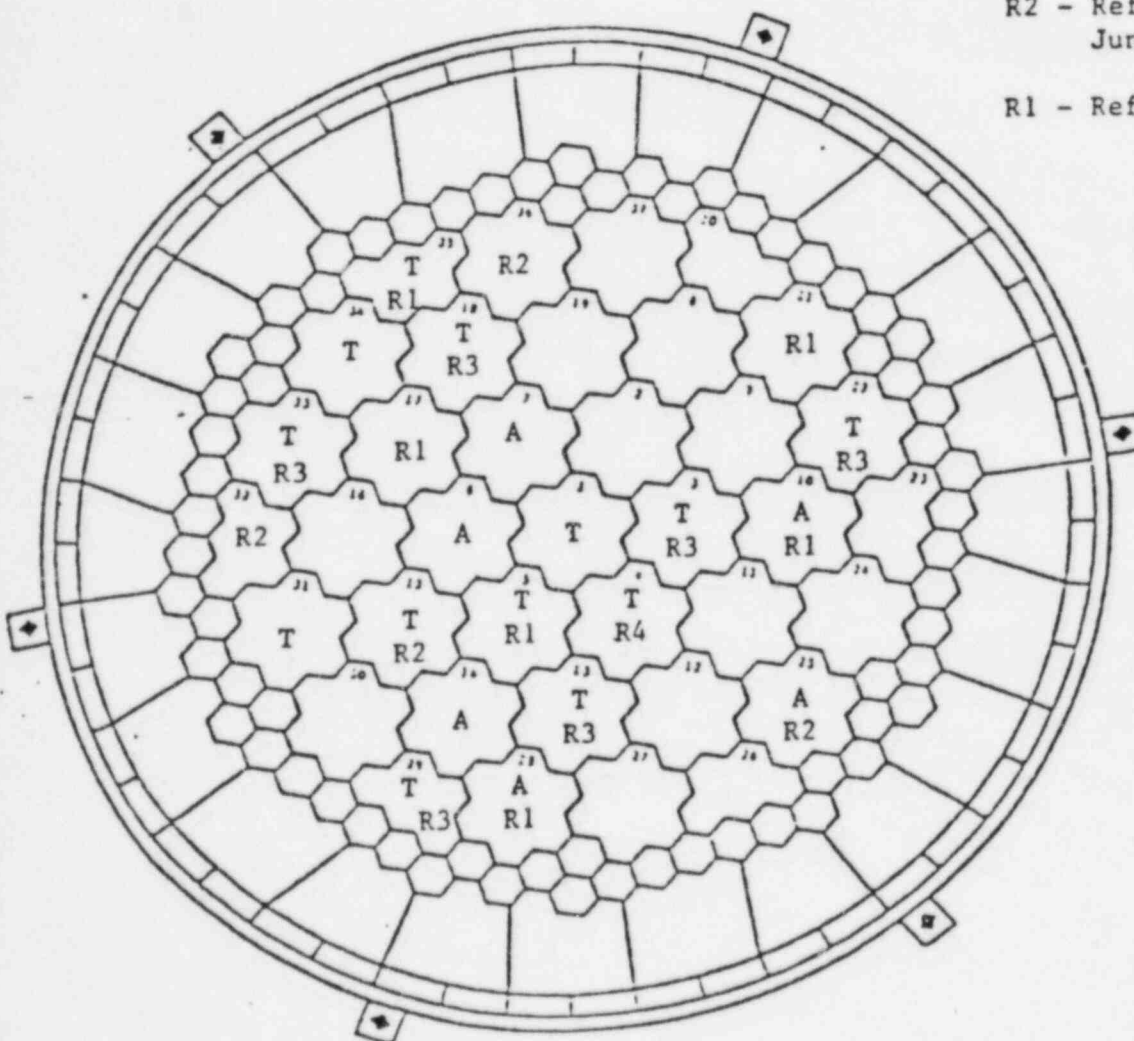
FIGURE 4

Three control rod pairs demonstrated scram failures on January 14, and 15, 1985, during the extensive testing program initiated to investigate the original failures. Control Rod Drive and Orifice Assemblies (CRDOAs) 36, 17, and 15, in Regions 28, 31, and 32 respectively, demonstrated scram failures from partially inserted positions. These rod pairs had all demonstrated successful scrams prior to the experienced failures (References 1 and 2).

CORE MAP

A - Affected Regions

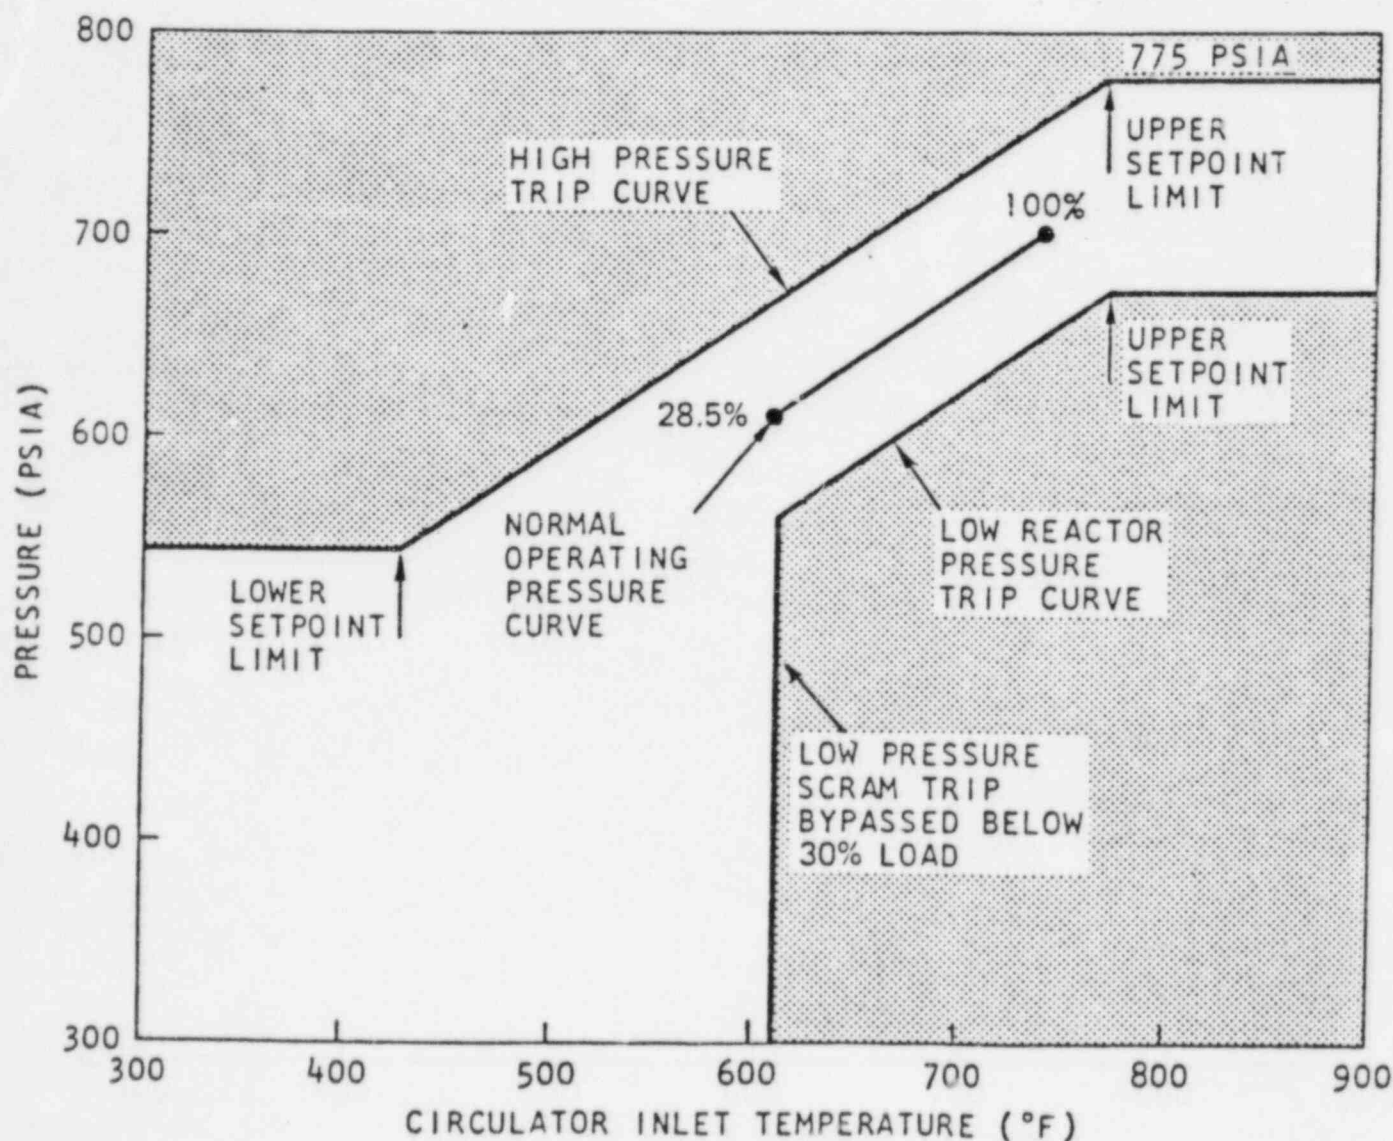
FIGURE 5

The icing up of the helium purification system was not abnormal under the observed high moisture conditions. Prior to the trip, the high pressure setpoint was decreasing as programmed with circulator inlet temperature (indicating a power reduction). When the depressurization flow path was blocked, the trip point was exceeded as temperature continued to decrease without a corresponding decrease in pressure (Figure 5).

Programmed Reactor Pressure High-Low Trip Points

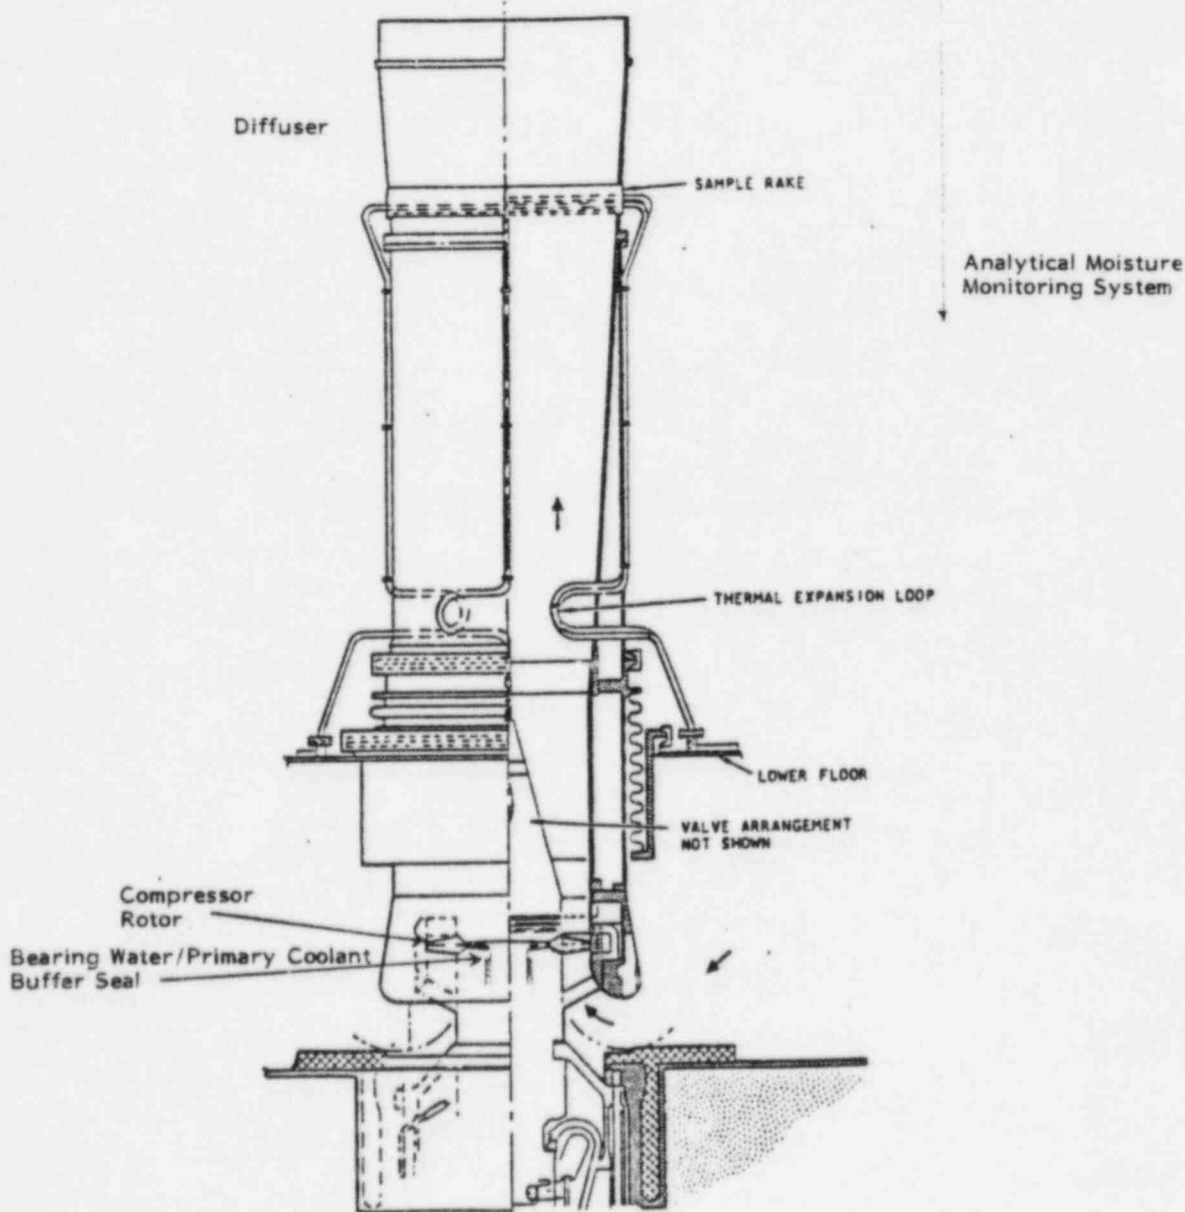
FIGURE 6

The PPS moisture monitor intake sample lines are arranged in a rake configuration located inside of the helium circulator diffuser shroud (Figures 6, 7, and 8). A helium circulator bearing water upset injects water directly into this outlet flow path, thus causing intermittent high moisture indications. The short sample flow path and high driving head allow spurious water entrainment to be cleared. A homogeneous high moisture mixture would not allow the reset circuitry to clear the trip.

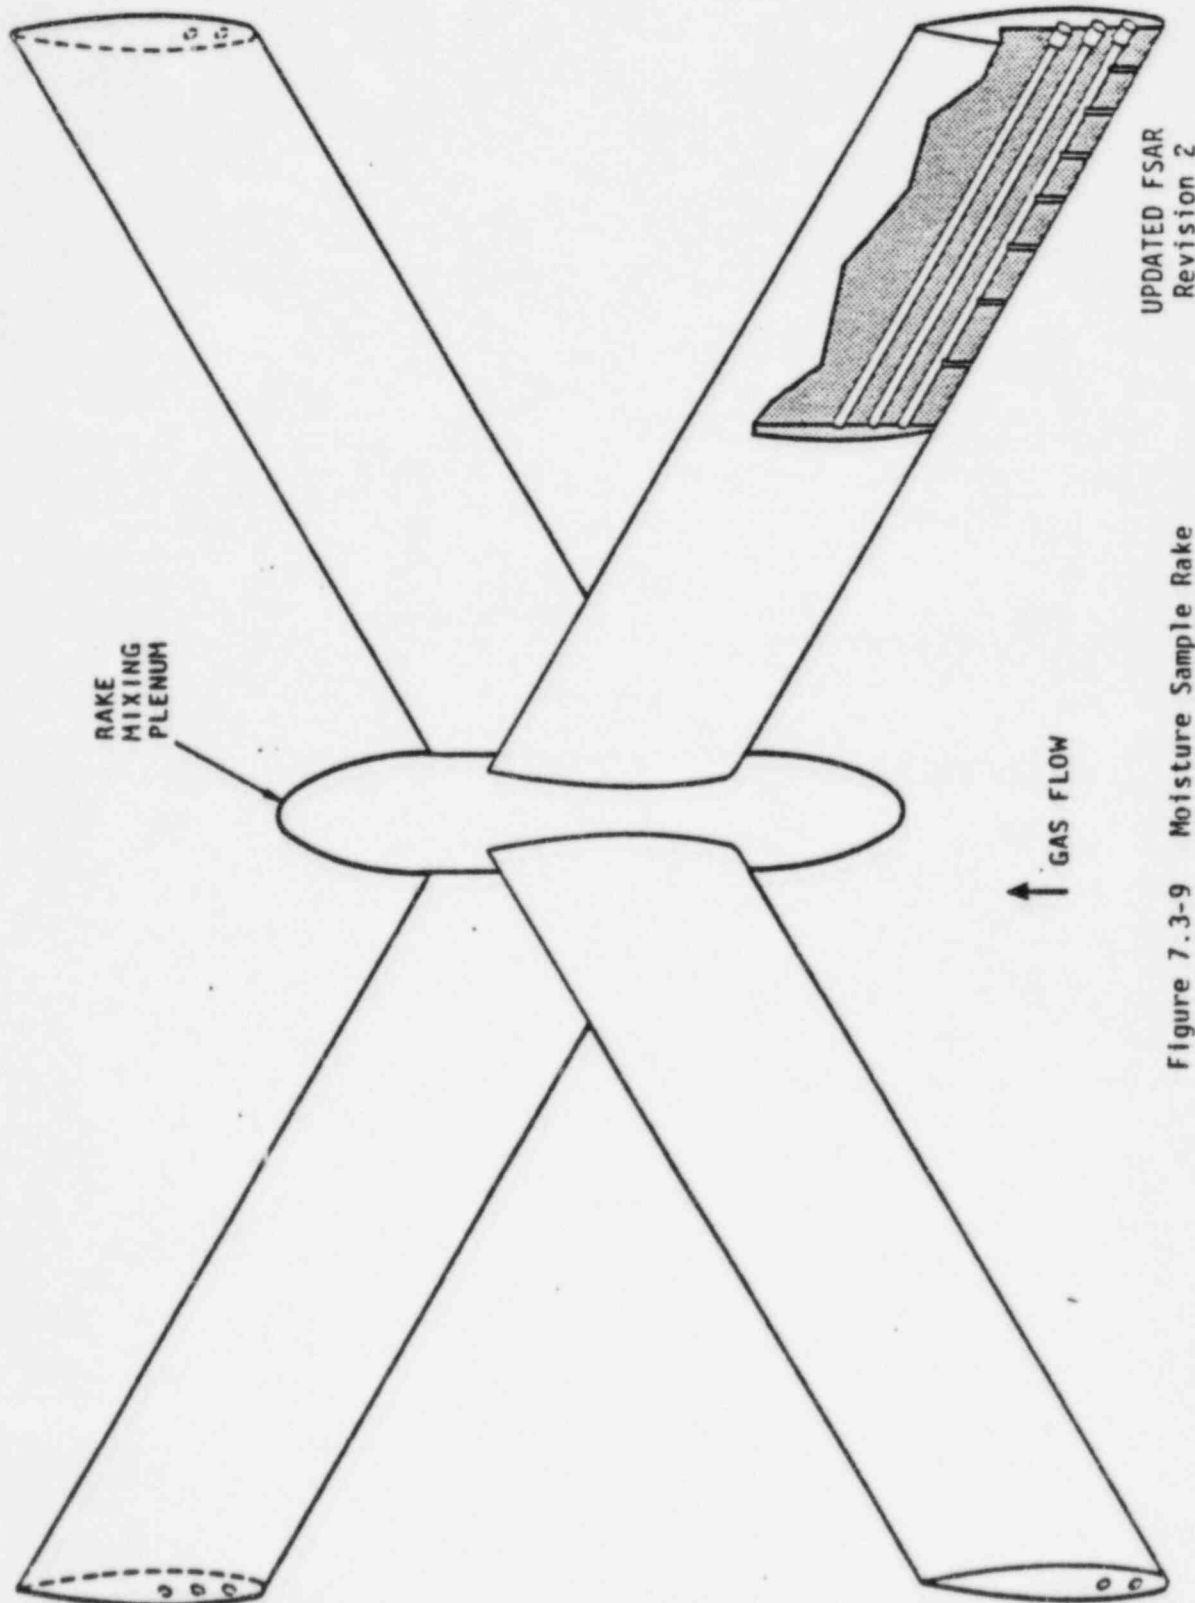
FIGURE 7

Figure 7.3-9 Moisture Sample Rake

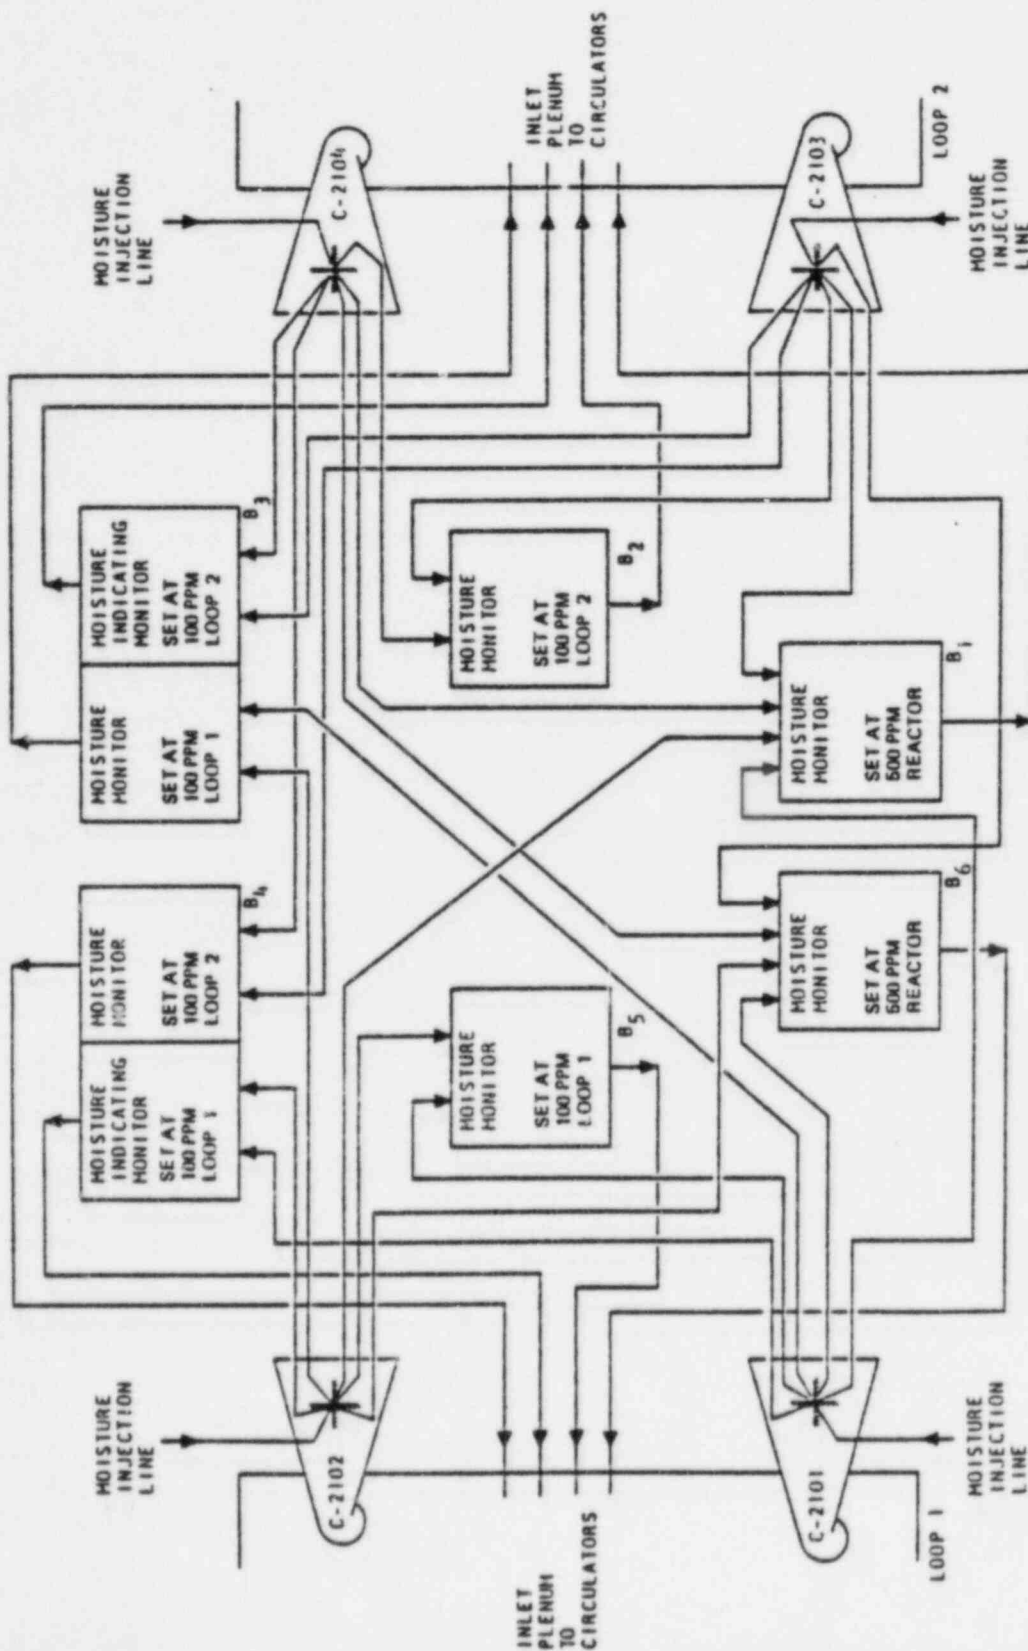
FIGURE 8

Figure 7.3-2 Moisture Sampling System
