LICENSEE EVENT REPORT (LER)

FACILITY NAME (1)										DOCKET NUMBER (2)										PAGE 3															
BYRON, UNIT 1										0 5 0 0 0 4 5 4 1										OF 0 3															
TITLE (4)																																			
POWER RANGE EXCORE NEUTRON DETECTOR FAILURE																																			
EVENT DATE (5)						LER NUMBER (6)						REPORT DATE (7)						OTHER FACILITIES INVOLVED (8)																	
MONTH		DAY		YEAR		YEAR		SEQUENTIAL NUMBER		REVISION NUMBER		MONTH		DAY		YEAR		FACILITY NAME				DOCKET NUMBER(S)													
																		Byron, Unit 1				0 5 0 0 0 4 5 4													
0 2		1 8		8 5		8 5		0 2 2		0 0		0 3		1 9		8 5						0 5 0 0 0 1 1													
OPERATING MODE (9)		THIS REPORT IS SUBMITTED PURSUANT TO THE REQUIREMENTS OF 10 CFR §: (Check one or more of the following) (11)																																	
2		20.408(a)										20.408(a)										X		60.73(a)(2)(iv)										73.71(b)	
POWER LEVEL (10)		20.408(a)(1)(i)										60.36(a)(1)												60.73(a)(2)(vi)										73.71(a)

On February 18, 1985 at 08:25, a Unit One Reactor Trip occurred due to a High Positive Rate on the Nuclear Instrumentation System, Power Range Channels. At this time the Unit was ope

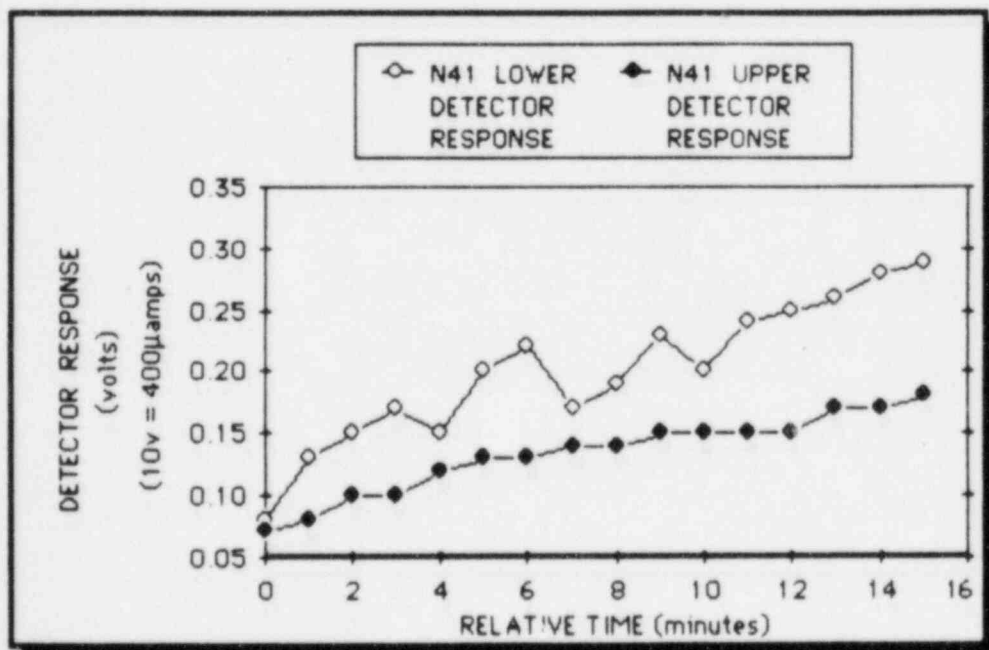
Investigation of the N41 problem started with obtaining data from the plant PRIME computer. This data included signals from the Upper and Lower detectors on channel N41, N42, and N43 (N44 being Out-Of-Service at the time). The attached figure illustrates the spiking seen on the Lower detector of channel N41 and the contrasting steady signal received from the Upper detector. Channels N42 and N43 exhibited similar steady responses for both the Upper and Lower detectors. Note that the data points collected by the PRIME are at one minute intervals. Even at this sampling rate the spiking is evident. The spiking on the lower detector could be seen in more detail on the output of the reactivity computer when it was connected to channel N41, however that data was not available for inclusion in this report. Having had extensive noise problems in the Source Range Nuclear Instrumentation on this same Unit, the Operational Analysis Department walked down the cable runs for channel N41 with noise monitoring equipment, but could not find any excessive noise sources. It was concluded that the Lower detector on N41 was bad and should be replaced.

Response of both the Upper and Lower Detectors for Channel N41. This data is taken from the plant PRIME computer which collects at 1 minute intervals. This illustrates the spiking observed on the Lower detector while the Upper detector remains steady. The steady response was the same for channels N42 and N43 (N44 was Out-Of-Service at the time).

The detector assembly (both upper and lower detectors are one unit) for N41 was removed and replaced with a spare. Subsequent observations and plant operations have yielded no further problems with this detector. This has been the only occurrence of a failed Nuclear Instrumentation Excore Neutron Detector that this station has experienced.
