# INDIANA & MICHIGAN ELECTRIC COMPANY

AEP:NRC:0898

Donald C. Cook Nuclear Plant Unit Nos. 1 and 2  
Docket Nos. 50-315 and 50-316  
License Nos. DPR-58 and DPR-74  
REFUELING CAVITY WATER SEAL  
(IE BULLETIN 84-03)

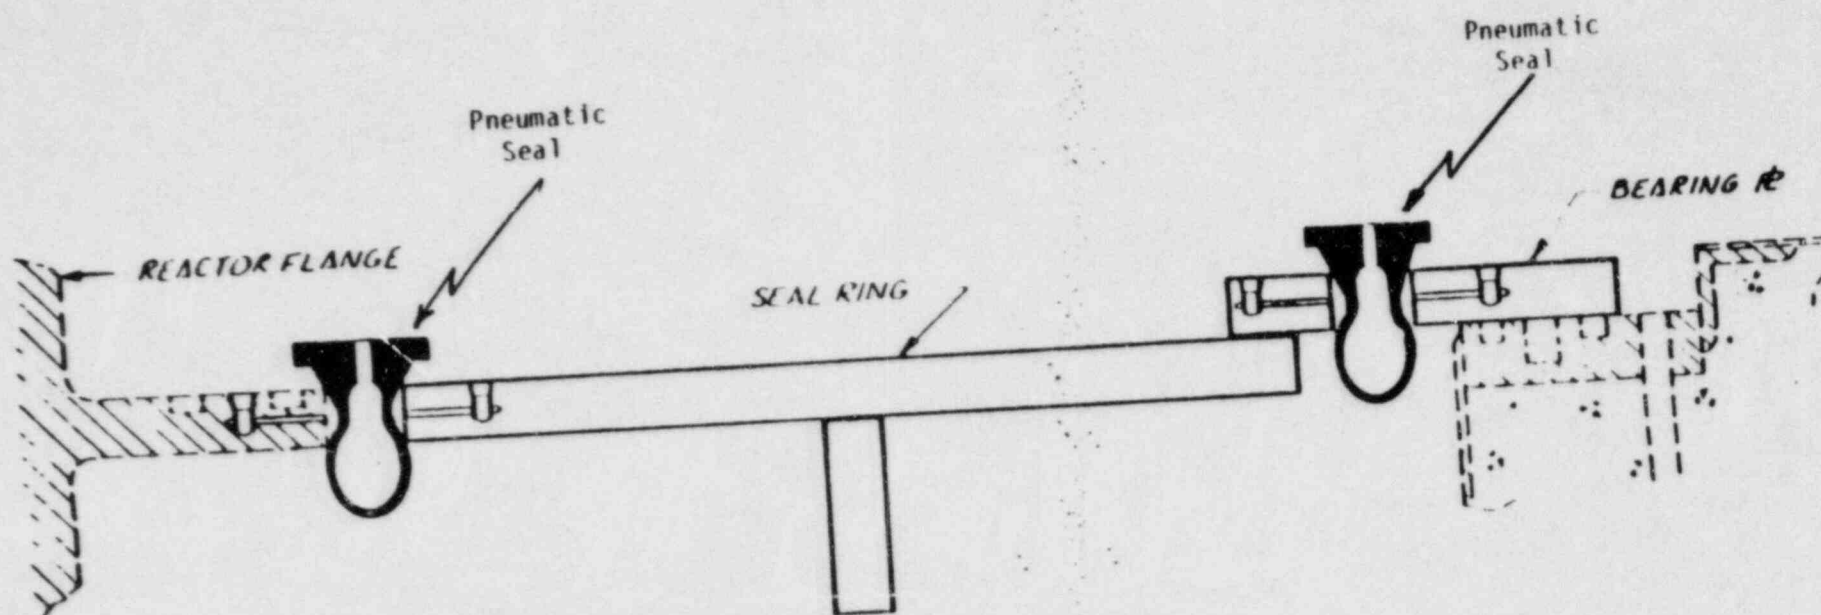
Figure 1 - Haddam Neck Refueling Cavity Water Seal

The refueling cavity seal arrangement at the Donald C. Cook Nuclear Plant is a one piece seal inserted in a nominal two inch annular opening between the reactor vessel flange and the refueling cavity wall. This arrangement is different than that depicted in Figure 1 of NRC IE Bulletin 84-03 (Attachments 1, 2, and 3).
