LICENSEE EVENT REPORT (LER)

FACILITY NAME (1) SURRY POWER STATION, UNIT 2										DOCKET NUMBER (2) 0 5 0 0 0 2 8 1				PAGE (3) 1 OF 0 4	
TITLE (4) REACTOR TRIP (LOAD SHEDDING ACTUATED)															
EVENT DATE (5)			LER NUMBER (6)				REPORT DATE (7)			OTHER FACILITIES INVOLVED (8)					
MONTH	DAY	YEAR	YEAR	SEQUENTIAL NUMBER	REVISION NUMBER	MONTH	DAY	YEAR	FACILITY NAMES				DOCKET NUMBER(S)		
													0 5 0 0 0		
1	0	29	8	4	0 1 5	0	0	11	2	8	8	0 5 0 0 0			
OPERATING MODE (9)		THIS REPORT IS SUBMITTED PURSUANT TO THE REQUIREMENTS OF 10 CFR 5. (Check one or more of the following) (11)													
N		20.402(b)				20.406(c)				50.73(a)(2)(iv)				73.71(b)	
POWER LEVEL (10)		20.406(a)(1)(i)				50.36(c)(1)				50.73(a)(2)(v)				73.71(c)	
1 0 0		20.406(a)(1)(ii)				50.36(c)(2)				50.73(a)(2)(vii)				OTHER (Specify in Abstract below and in Text, NRC Form 365A)

FACILITY NAME (1) SURREY POWER STATION, UNIT 2	DOCKET NUMBER (2) 0 5 0 0 0 2 8 1	LER NUMBER (6)			PAGE (3)		
		YEAR	SEQUENTIAL NUMBER	REVISION NUMBER			
		8 4	0 1 5	0 0	0 2	OF	0 4

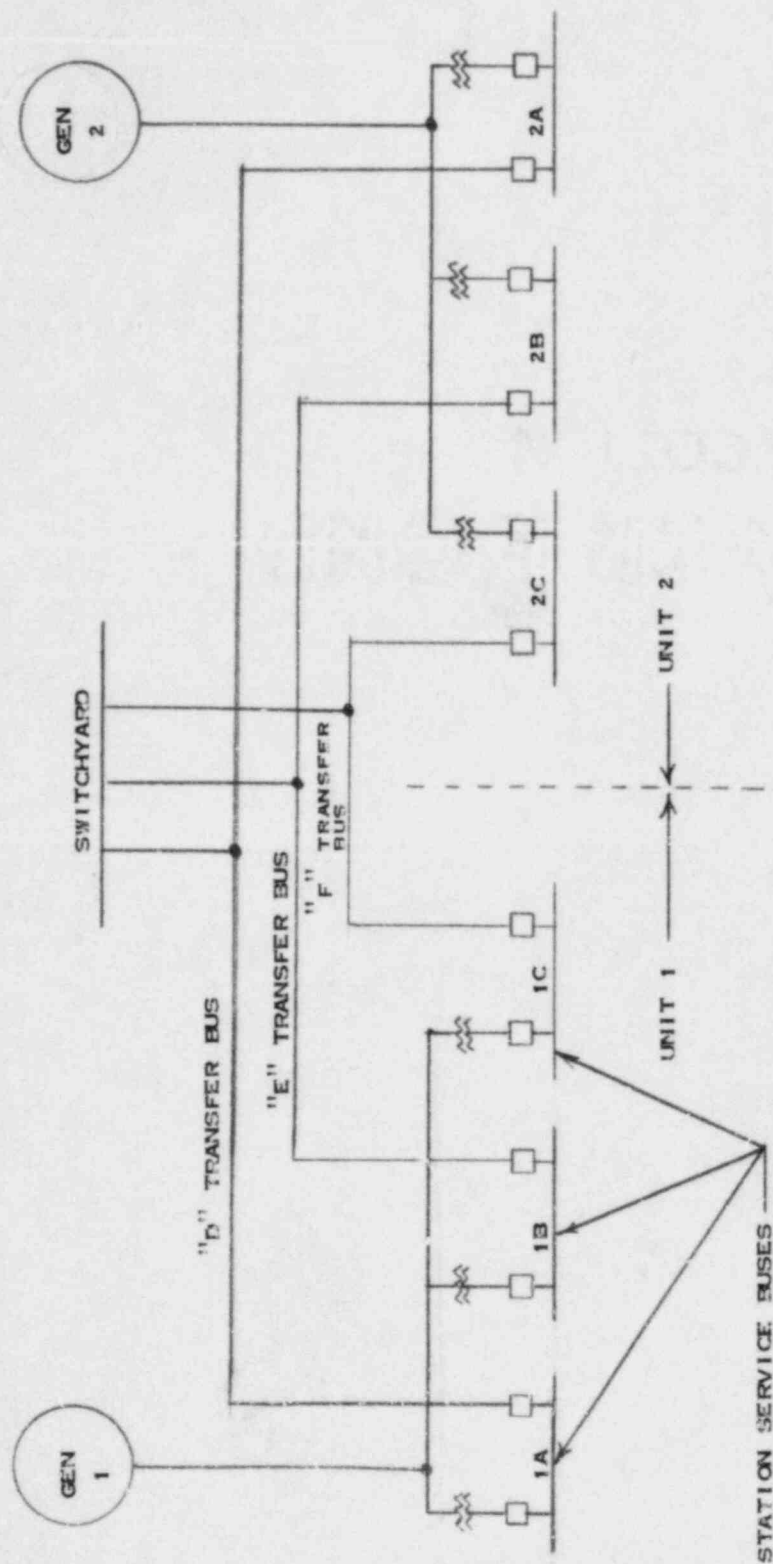
FIGURE 1

On October 29, 1984, unit 1 was in refueling shutdown and unit 2 was at full power. The "D" transfer bus (See figure 1) was deenergized for unit 1 breaker testing being conducted by Control Operations. The load shed selector switch was in enable with testing in progress. As a result of this testing, load shedding was initiated. The unit 2 "A" main feedpump (2-EW-P-1A) tripped as a result of load shedding leading to a low steam generator level and a reactor trip.

When the auto transfer from station service to reserve station service occurred, "A" reactor coolant pump (RCP) lost power because the "D" transfer bus was deenergized for testing.

The load shed switch should have been in bypass since unit 1 was shutdown and all of its large electrical loads were deenergized. If it had been in bypass, the unit would not have tripped.

The "D" transfer and "A" station service electrical buses were reenergized to return the station electrical distribution to normal. The load shed switch was also placed in the bypass position.
