South Texas Project
Units 1 & 2
Dockets Nos. STN 50-498, STN 50-499
First Interim Report Concerning
Trapeze Type Support Assemblies

South Texas Project
Units 1 & 2
First Interim Report Concerning
Trapeze Type Support Assemblies

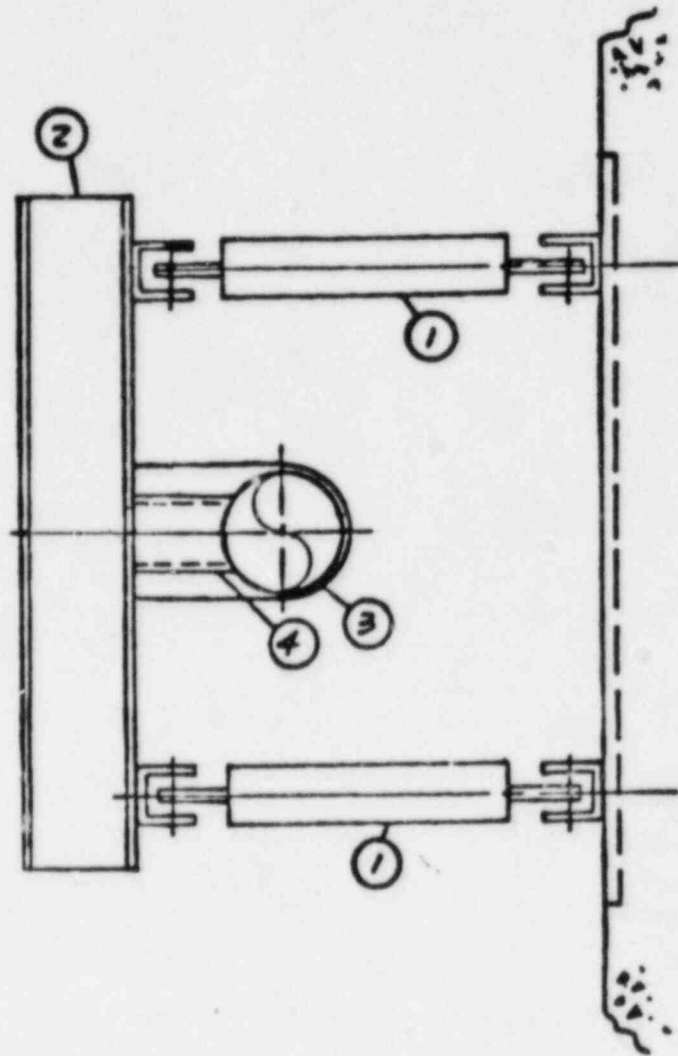
Figure 1

A deficiency has been identified in the design of trapeze type support assemblies with mechanical snubbers used to support a feedwater line in the Reactor Containment Building (RCB). The design was such that if left uncorrected, the trapeze assemblies could become misaligned such that an overstress condition could develop in the pipe during dynamic events. In addition, these assemblies used U-Straps around the pipe for which there was no analysis showing that these straps were qualified for lateral loads.

three trapeze type supports used in a feedwater line would have a tendency to slide or rotate around the pipe.

The support concept in question is identified in Figure 1. This support is commonly used in the industry in those locations where the pipe is located too close to a wall to allow for adequate room for snubber placement. In those situations, a beam is placed outboard of the pipe from the wall and the snubbers connected to the beam. Typically the support is held in place by friction between the beam and pipe that is developed by the tensioning of a U-Bolt that goes around the pipe. The deficiency concerned supports that used a welded strap to attach the support to the pipe, such that a gap existed between the strap and pipe. This clearance between the strap and pipe would allow the assembly to slide down the pipe in the case of a vertical pipe or to rotate around the pipe in the case of a horizontal pipe. The stress analysis is performed assuming that snubbers are correctly oriented and acting as designed. If, due to misalignment, these supports fail to act during the dynamic event for which they are designed, then the piping system can be overstressed. In the case of the feedwater line, the trapeze assemblies are designed for waterhammer as well as seismic loads. An additional item of concern was that there was no documentation to show that the U-Straps used in the trapeze assemblies were qualified for side loads.

1. The affected pipe support assemblies in the feedwater line will be redesigned to preclude misalignment and will be properly qualified for lateral loads.
2. Other piping systems will be reviewed to identify deficient assemblies. Deficient assemblies identified will be redesigned to preclude misalignment and qualified for lateral loads.
3. Pipe support design personnel have been made aware of the deficiency and training sessions have taken place to prevent recurrence of such problems.

1. Pipe support designs currently issued for construction will be reviewed to identify the number of supports that are subject to the deficient conditions identified herein. The identified supports will be placed on construction hold to preclude installation. A corrective action program for these supports will be developed and described in the next report.
2. Pipe support personnel have been given additional training in the design of pipe support trapeze assemblies.
3. The three trapeze assemblies in the feedwater line will be corrected and revised drawings issued by December 31, 1984.
