TDI EMERGENCY DIESEL GENERATOR 103 10<sup>7</sup> CYCLE CONFIRMATORY

TEST/INSPECTION REPORT

SHOREHAM NUCLEAR POWER STATION - UNIT 1

Long Island Lighting Company

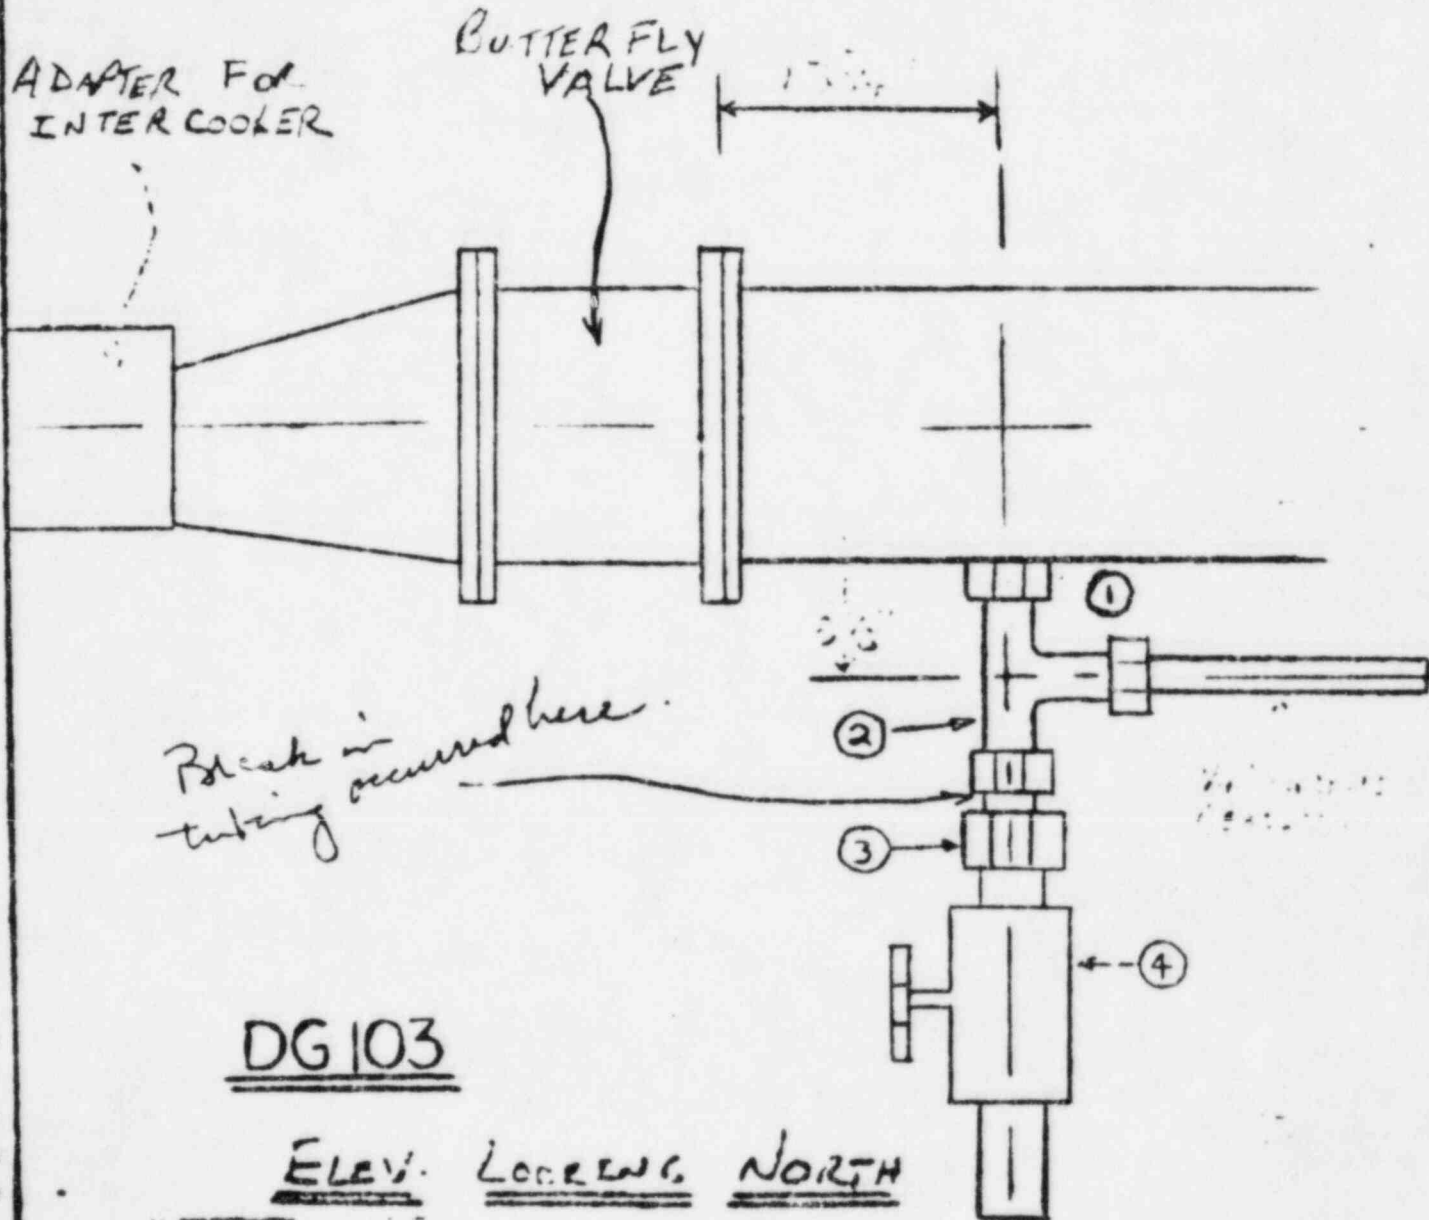
Break in  
tubing  
occurred here.

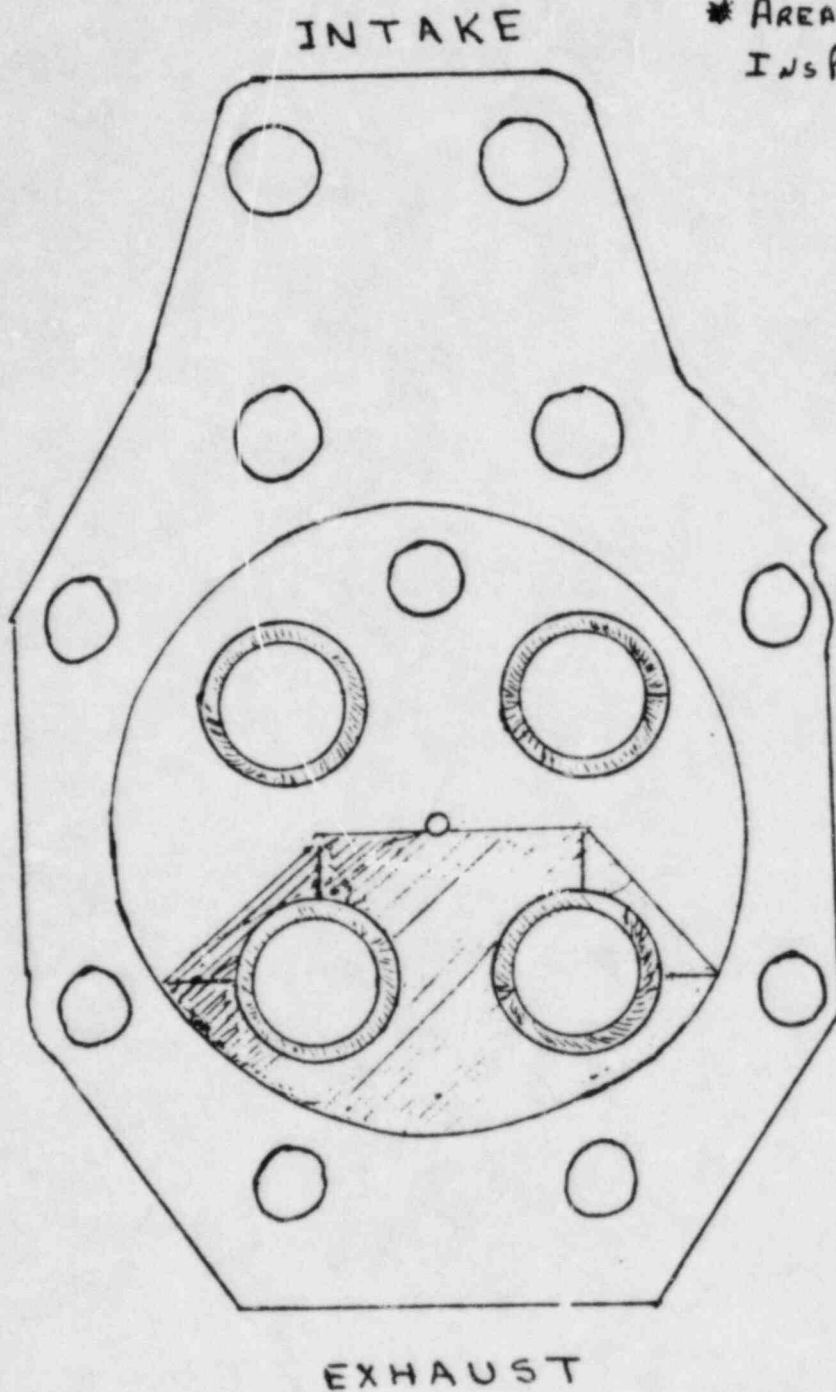
CYL. HEAD H-60  
10 min. Dwell - Penetrant  
7 min Dwell - Developer  
NO Relevant Indications NOTED  
*Victor H. K. 11/1/84*  
\* AREAS OF LIQUID PENETRANT  
INSPECTIONS ARE SHADED

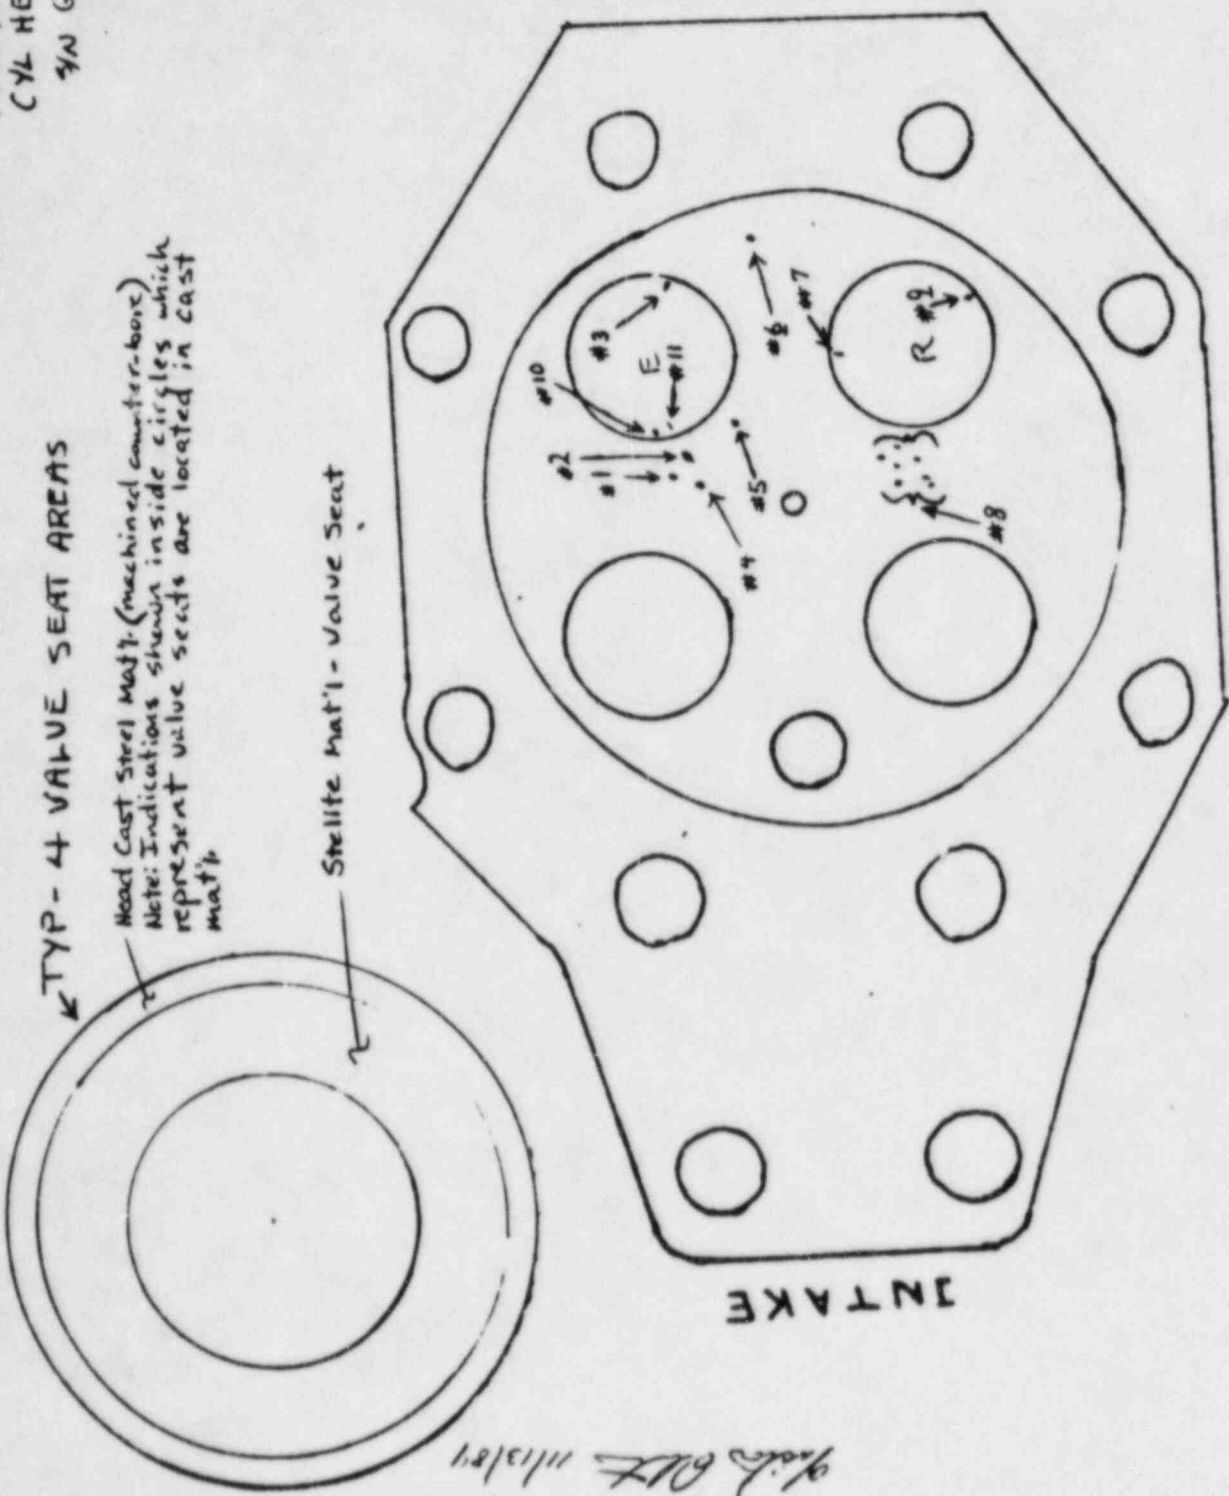
Head Cast Steel Mat'l. (machined counter-bore)  
Note: Indications shown inside circles which represent valve seats are located in cast mat'l.

- #1 -  $\frac{1}{16}$ " Rounded
- #2 -  $\frac{3}{16}$ " Rounded
- #3 -  $\frac{1}{32}$ " Linear
- #4 -  $\frac{1}{16}$ " Rounded
- #5 -  $\frac{1}{16}$ " Rounded
- #6 -  $\frac{1}{16}$ " Rounded
- #7 -  $\frac{1}{16}$ " Linear
- #8 -  $\frac{1}{16}$ " Rounded - 7 ind

tations, separated more than  $\frac{1}{16}$ "

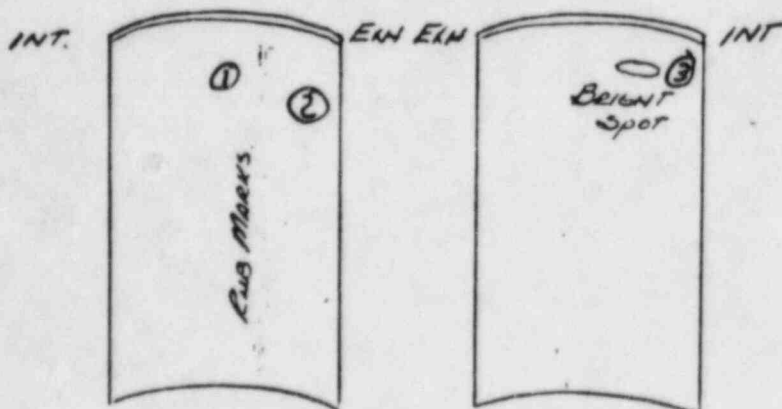
**1**  
**RMS READINGS**  
**APPROX. 15" FROM LINER TOP**  
① VERTICAL 4 RMS  
① HORIZONTAL 8 RMS  
② VERTICAL 3 RMS  
② HORIZONTAL 5 RMS

**2**  
**RMS READINGS**  
③ VERTICAL 8 RMS  
③ HORIZONTAL 3 RMS

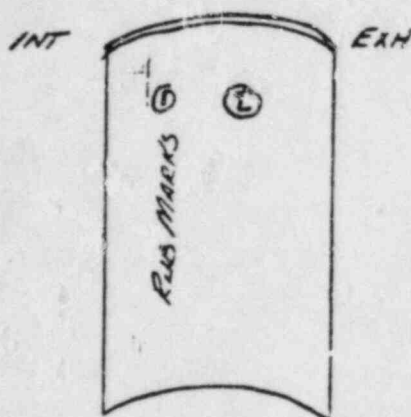
**RMS READINGS**  
Approx. 15" from liner top

① VERTICAL	11 RMS
① HORIZONTAL	5 RMS
② VERTICAL	2 RMS
② HORIZONTAL	2 RMS

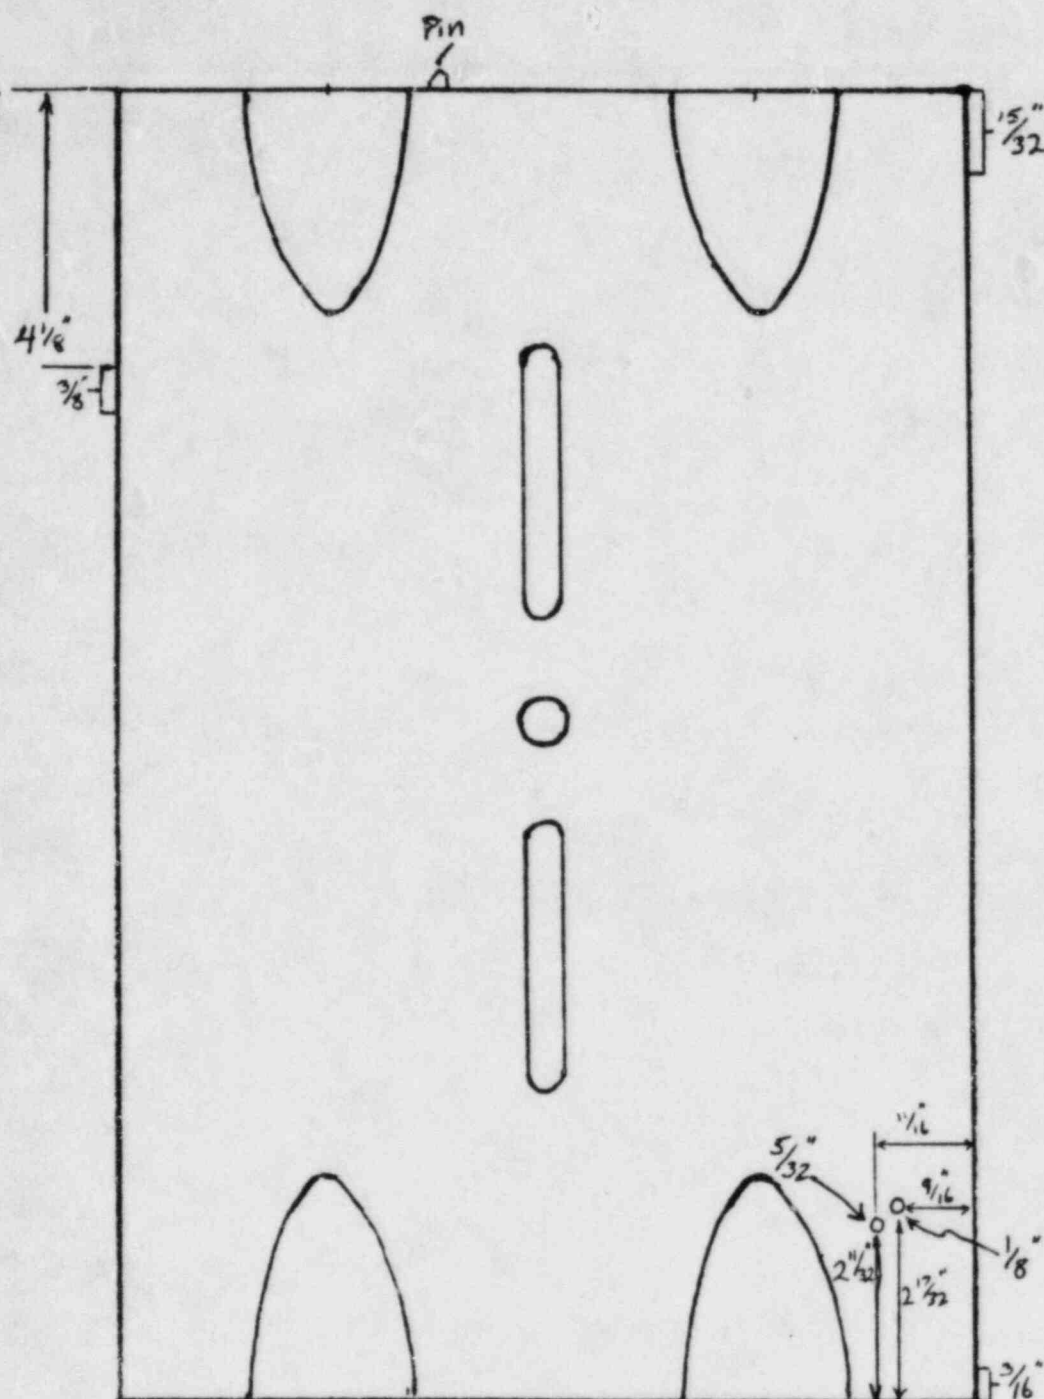
Page 2 of 3

Note : ① Numerous rounded indications  
     $\angle 0.05"$  except as noted

② Linears on edges are  $1/8"$   
    From aluminum surface

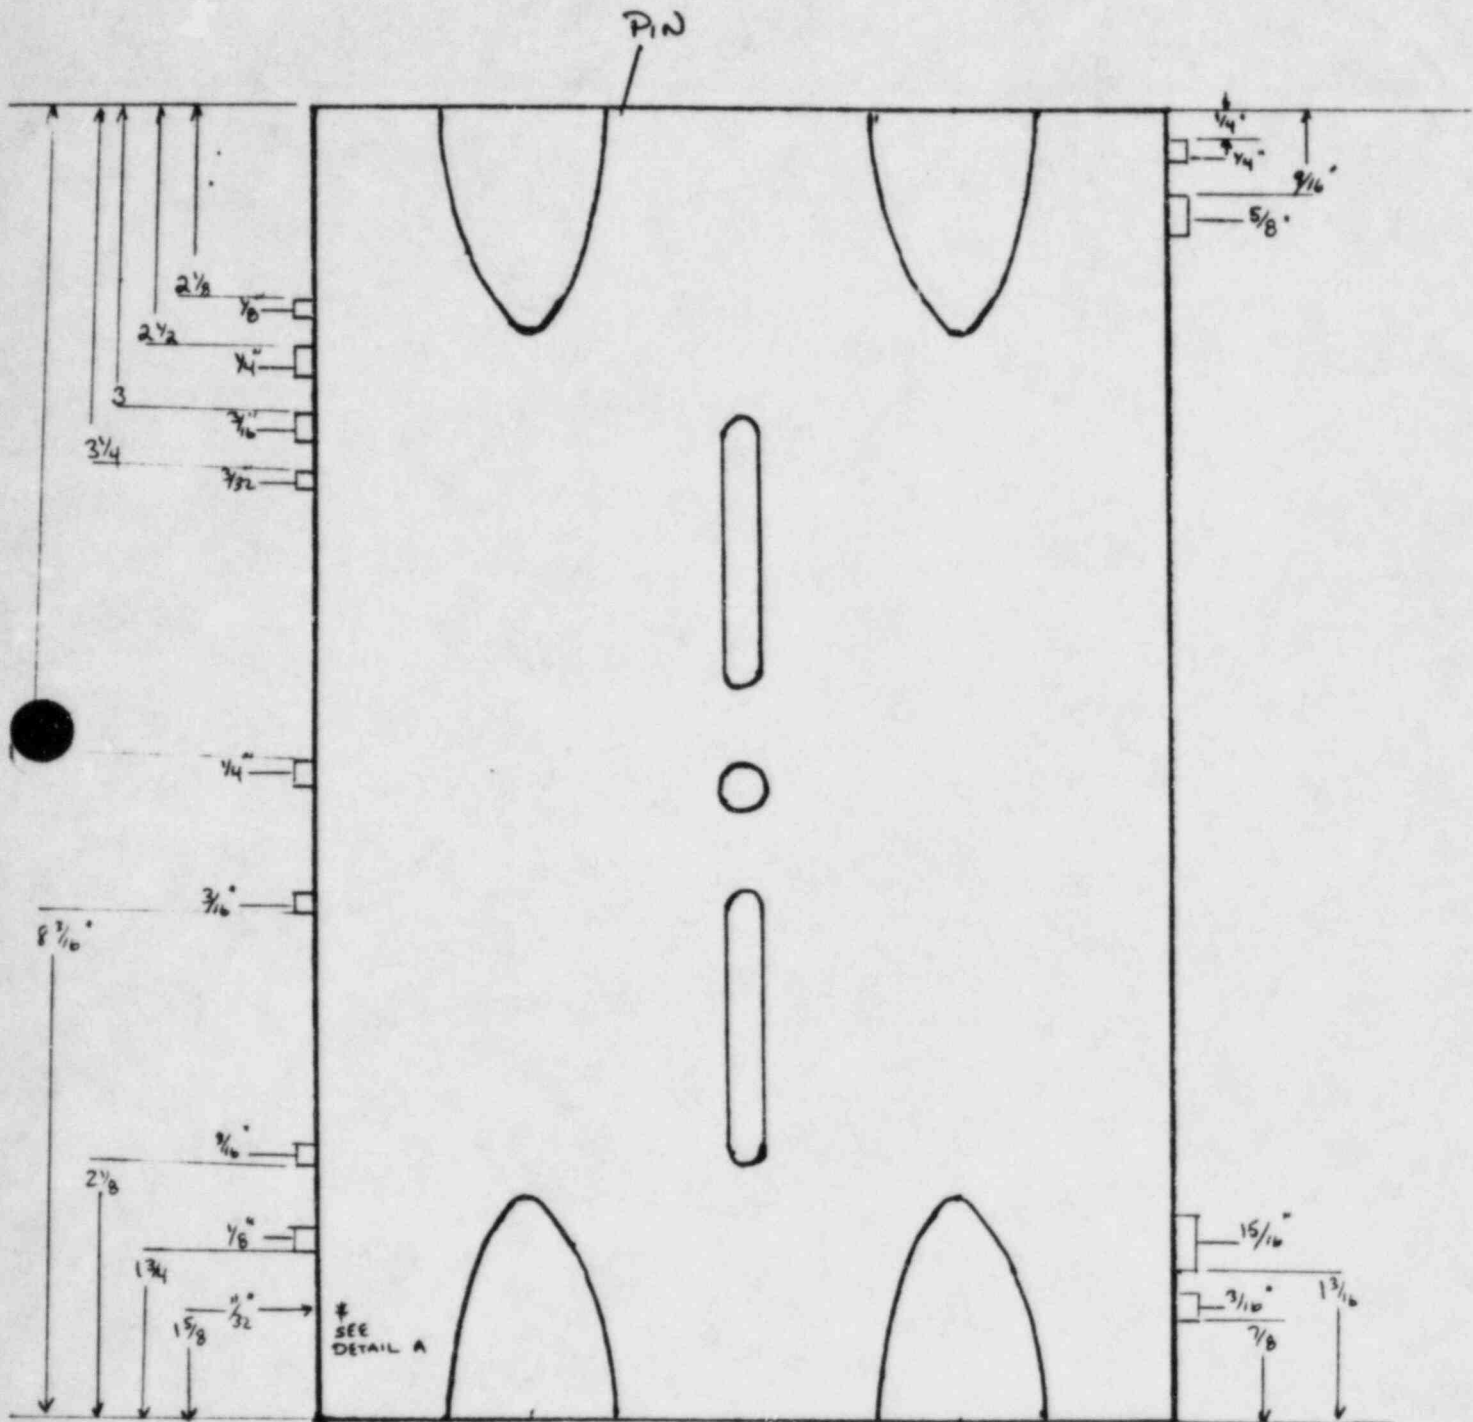
NOTE: ① NUMEROUS POROSITY INDICATIONS  
L.05"

② LINEARS ON EDGES ARE 1/8" FROM  
ALUMINUM SURFACE, EXCEPT  
AS SHOWN ON DETAIL A

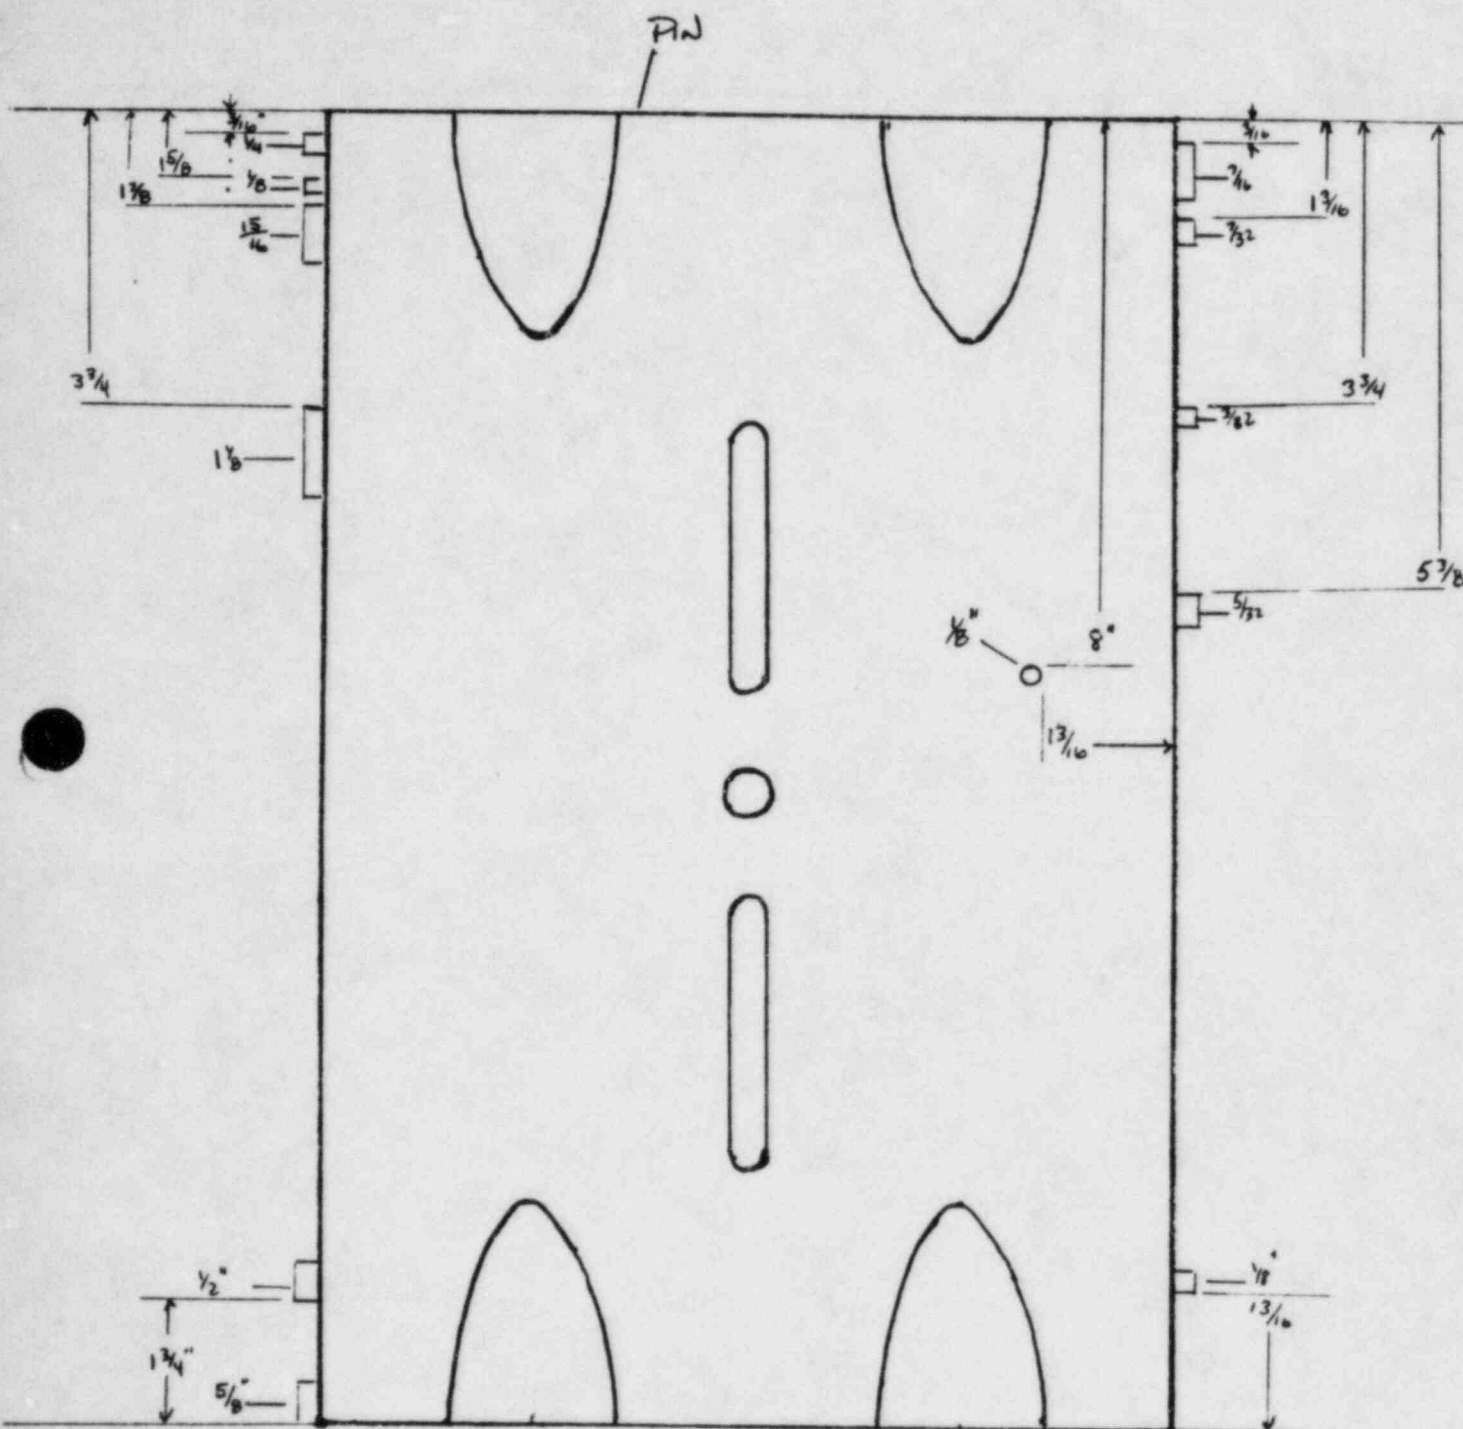
PAGE 3 OF 6

NOTE: ① NUMEROUS POROSITY INDICATIONS  
L .05" EXCEPT AS NOTED

② LINEARS ON EDGES ARE 1/8" FROM  
ALUMINUM SURFACE.

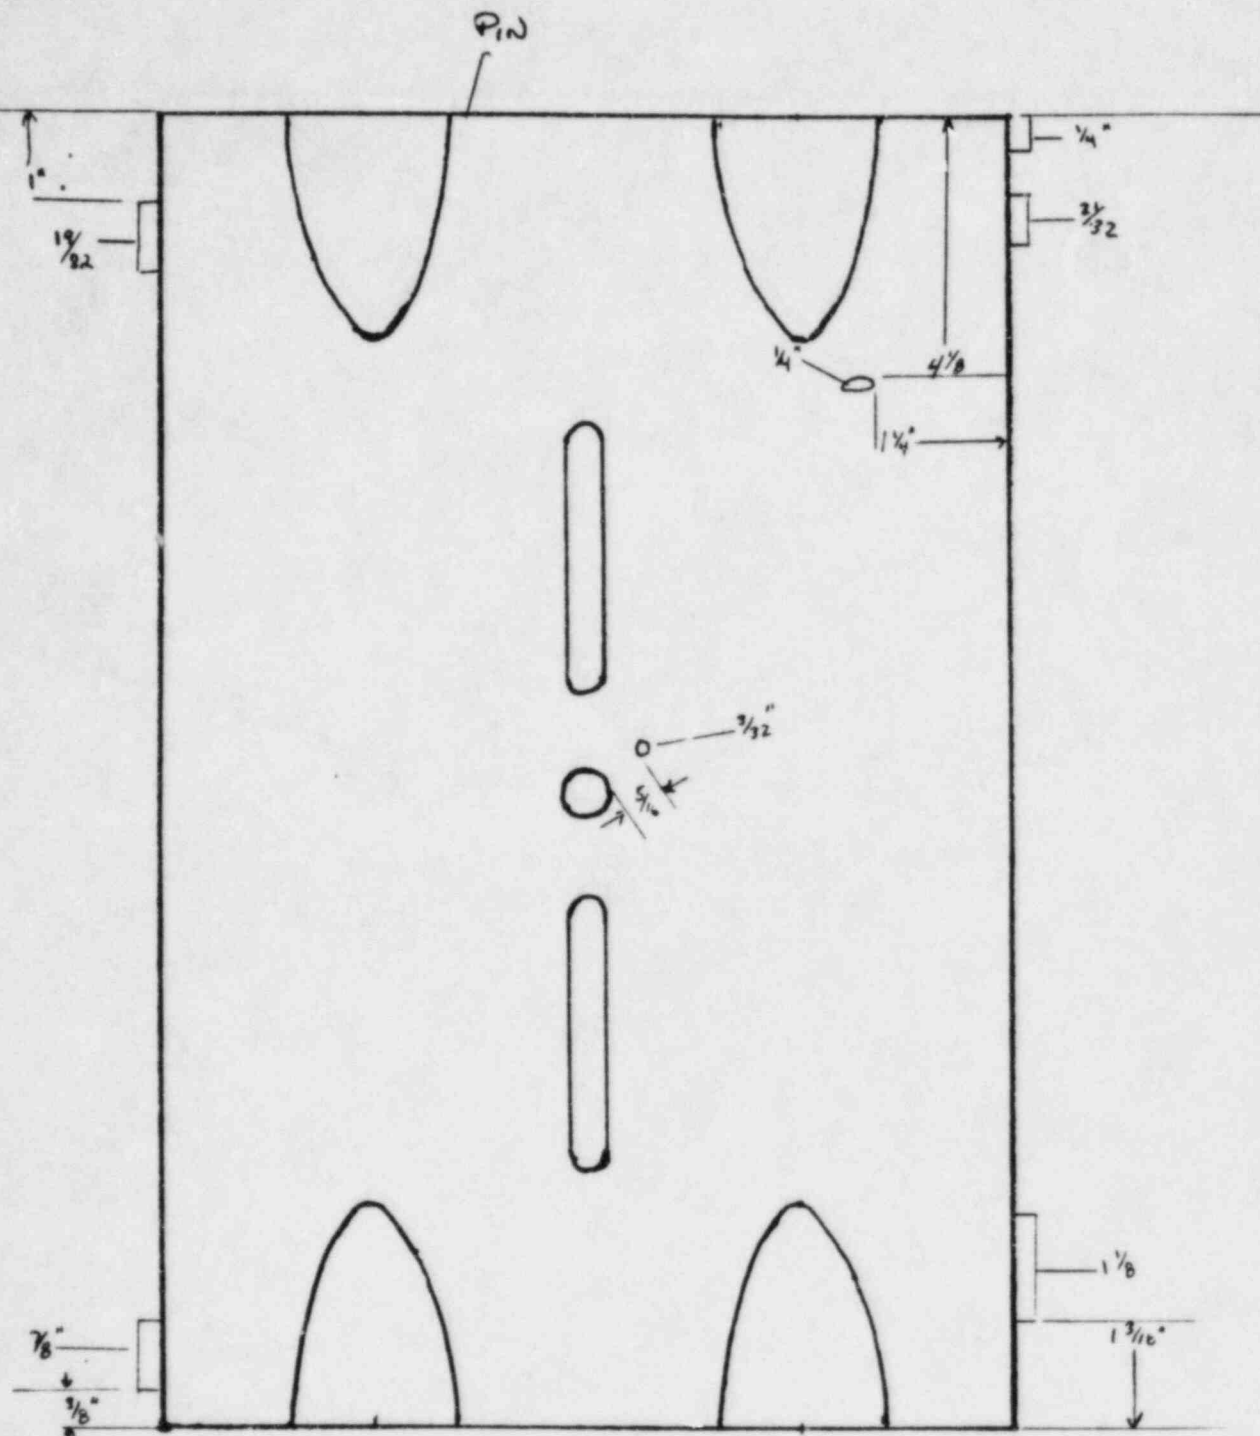
NOTE: ① NUMEROUS POROSITY INDICATIONS  
LESS THAN .05" EXCEPT AS NOTED

② LINEARS ON EDGES ARE  $\frac{1}{8}$ " FROM  
ALUMINUM SURFACE.

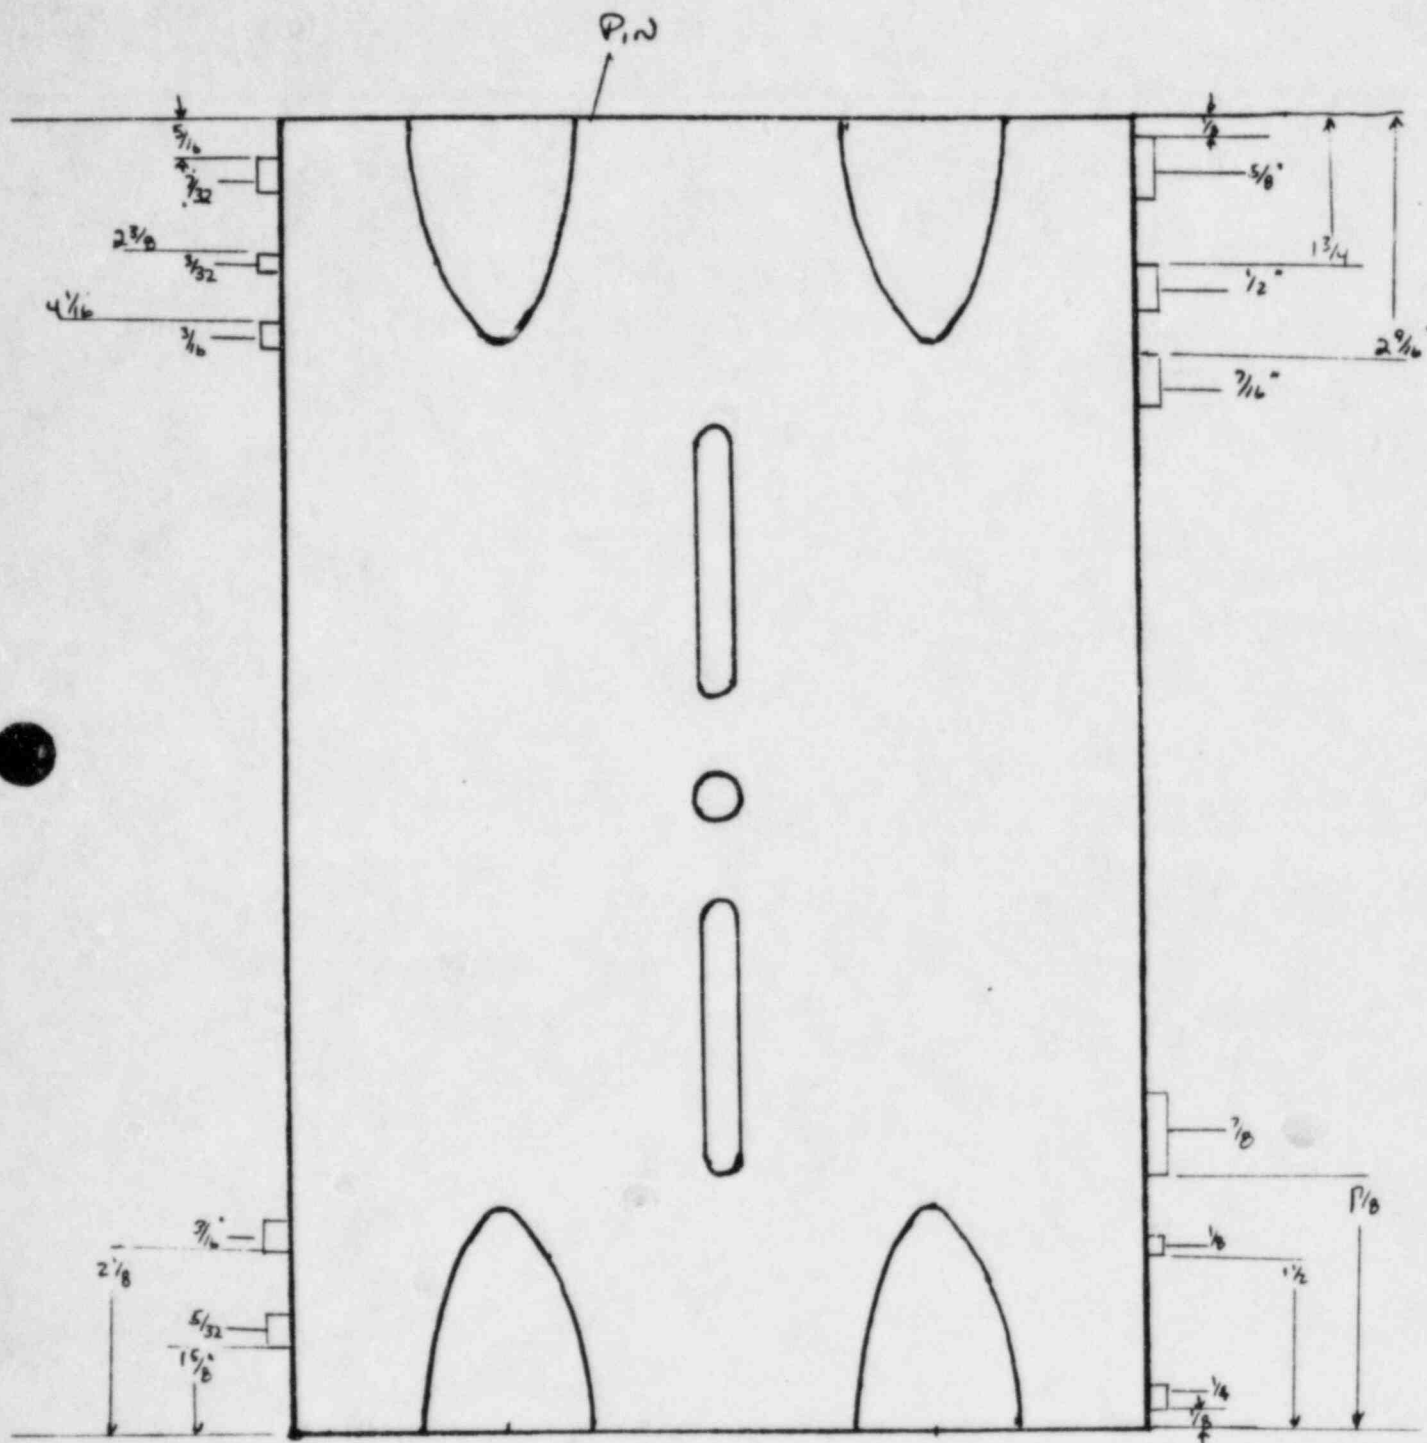
PAGE 5 OF 6

NOTE: ① NUMEROUS POROSITY INDICATIONS  
L .05"

② LINEARS ON EDGES ARE 1/8" FROM  
ALUMINUM SURFACE.

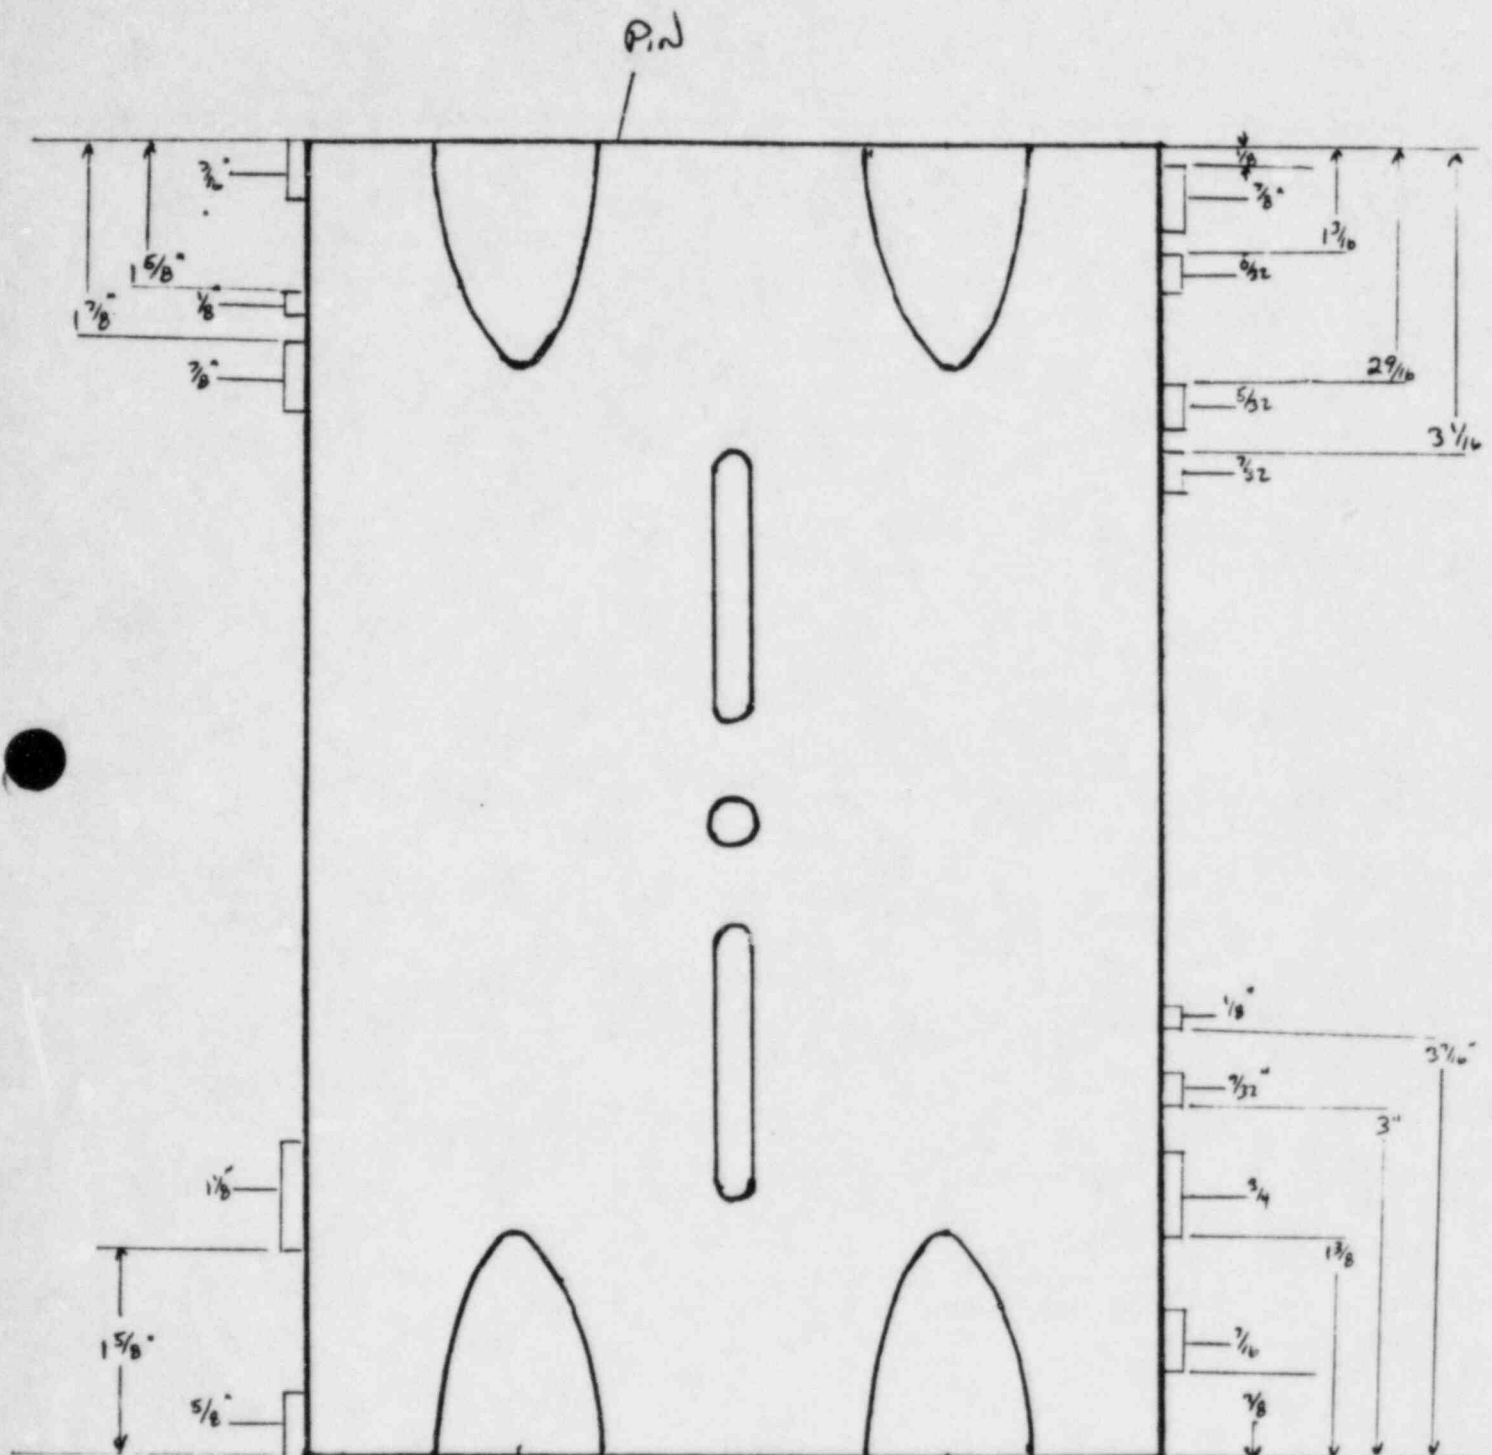
PAGE 6 OF 6

NOTE: ① NUMEROUS POROSITY INDICATIONS  
L.O.F.

② LINEARS ON EDGES ARE 1/8" FROM  
ALUMINUM SURFACE.

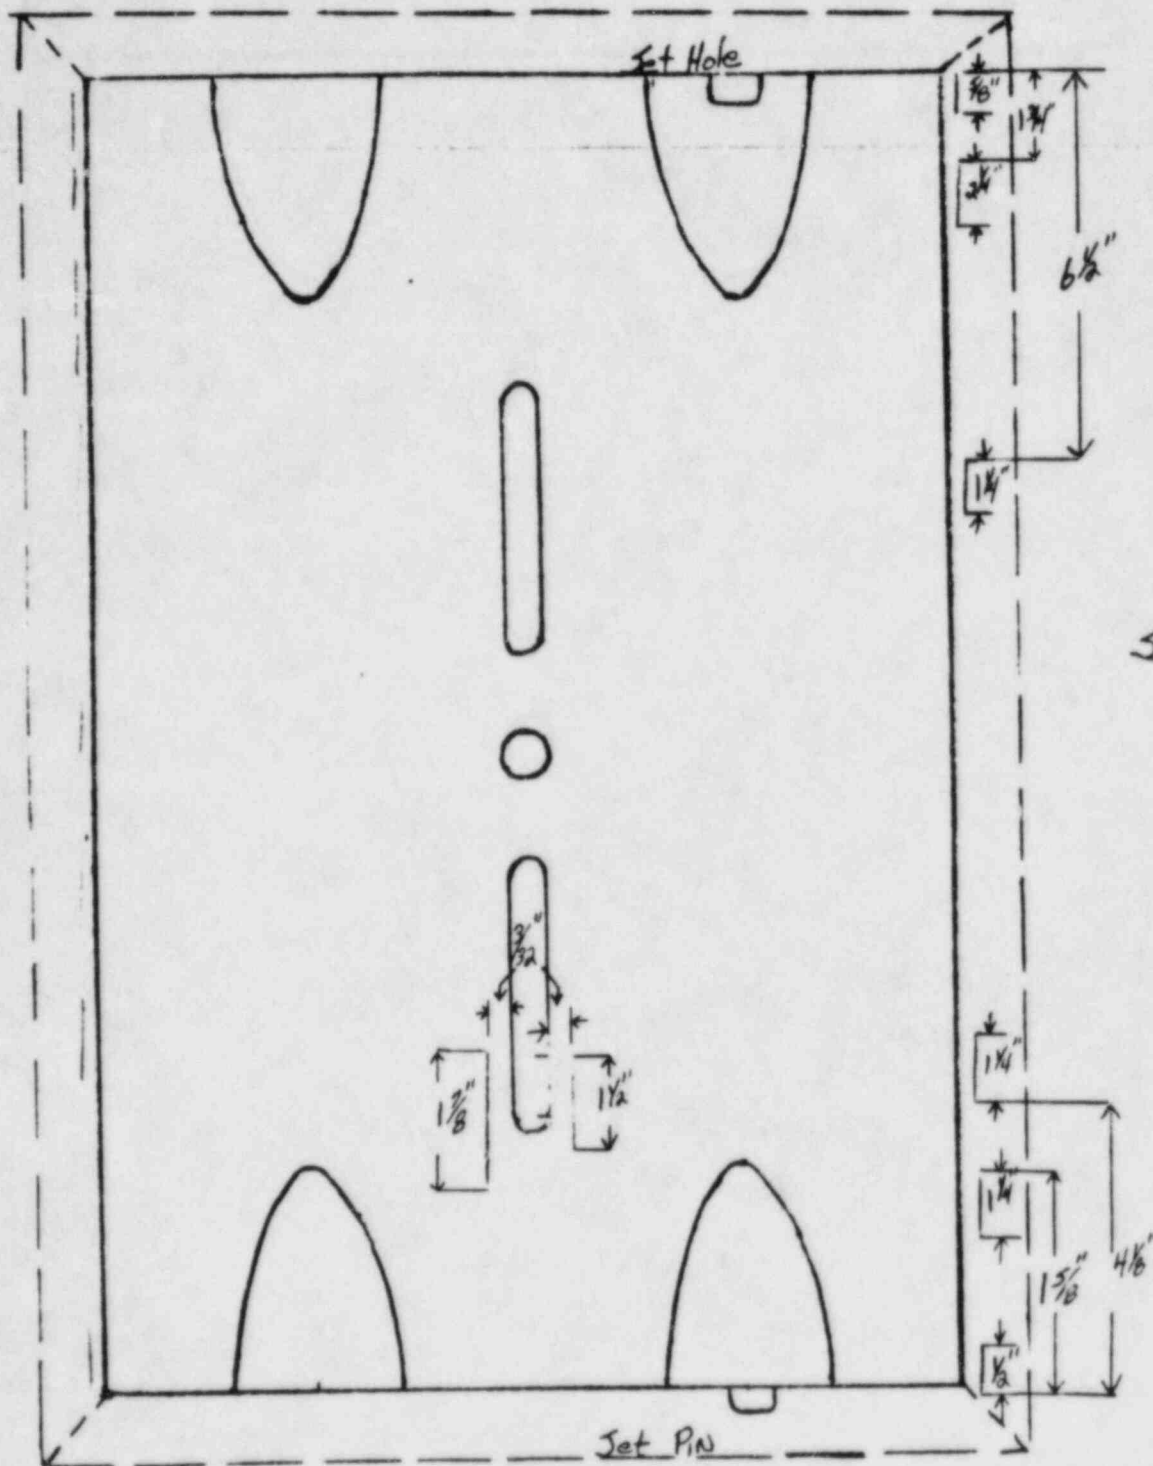
Page 2 of 10

\* All Linear Indications on Sides A + B are  $\frac{1}{16}$ " From O.D. Aluminum Side

\* Linear Indications on Side A are Intermittent From Set Hole to Set Pin Edges

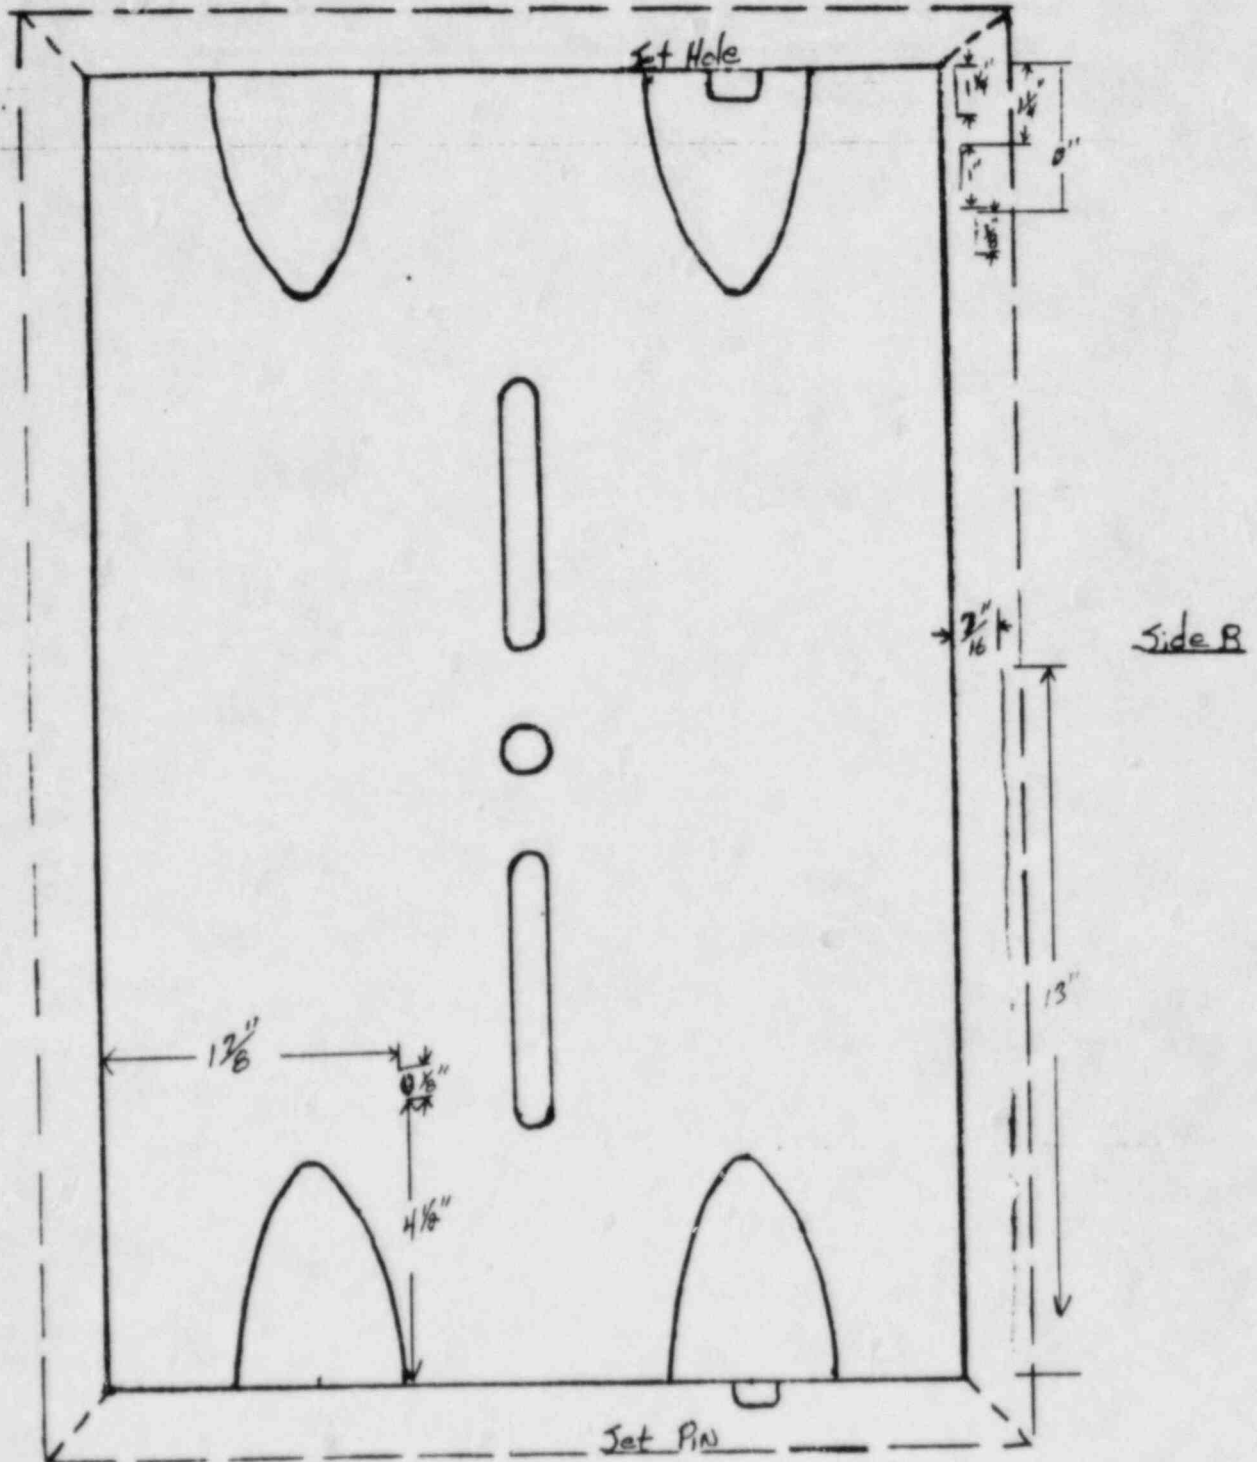
Upper Bearing #4  
Mercurian side

\* Linear Indications  $\frac{1}{16}$ " From A.D. Aluminium Side unless other wise noted, on side B.

\* Light frosty located on entire surface no larger than  $\frac{3}{32}$ "

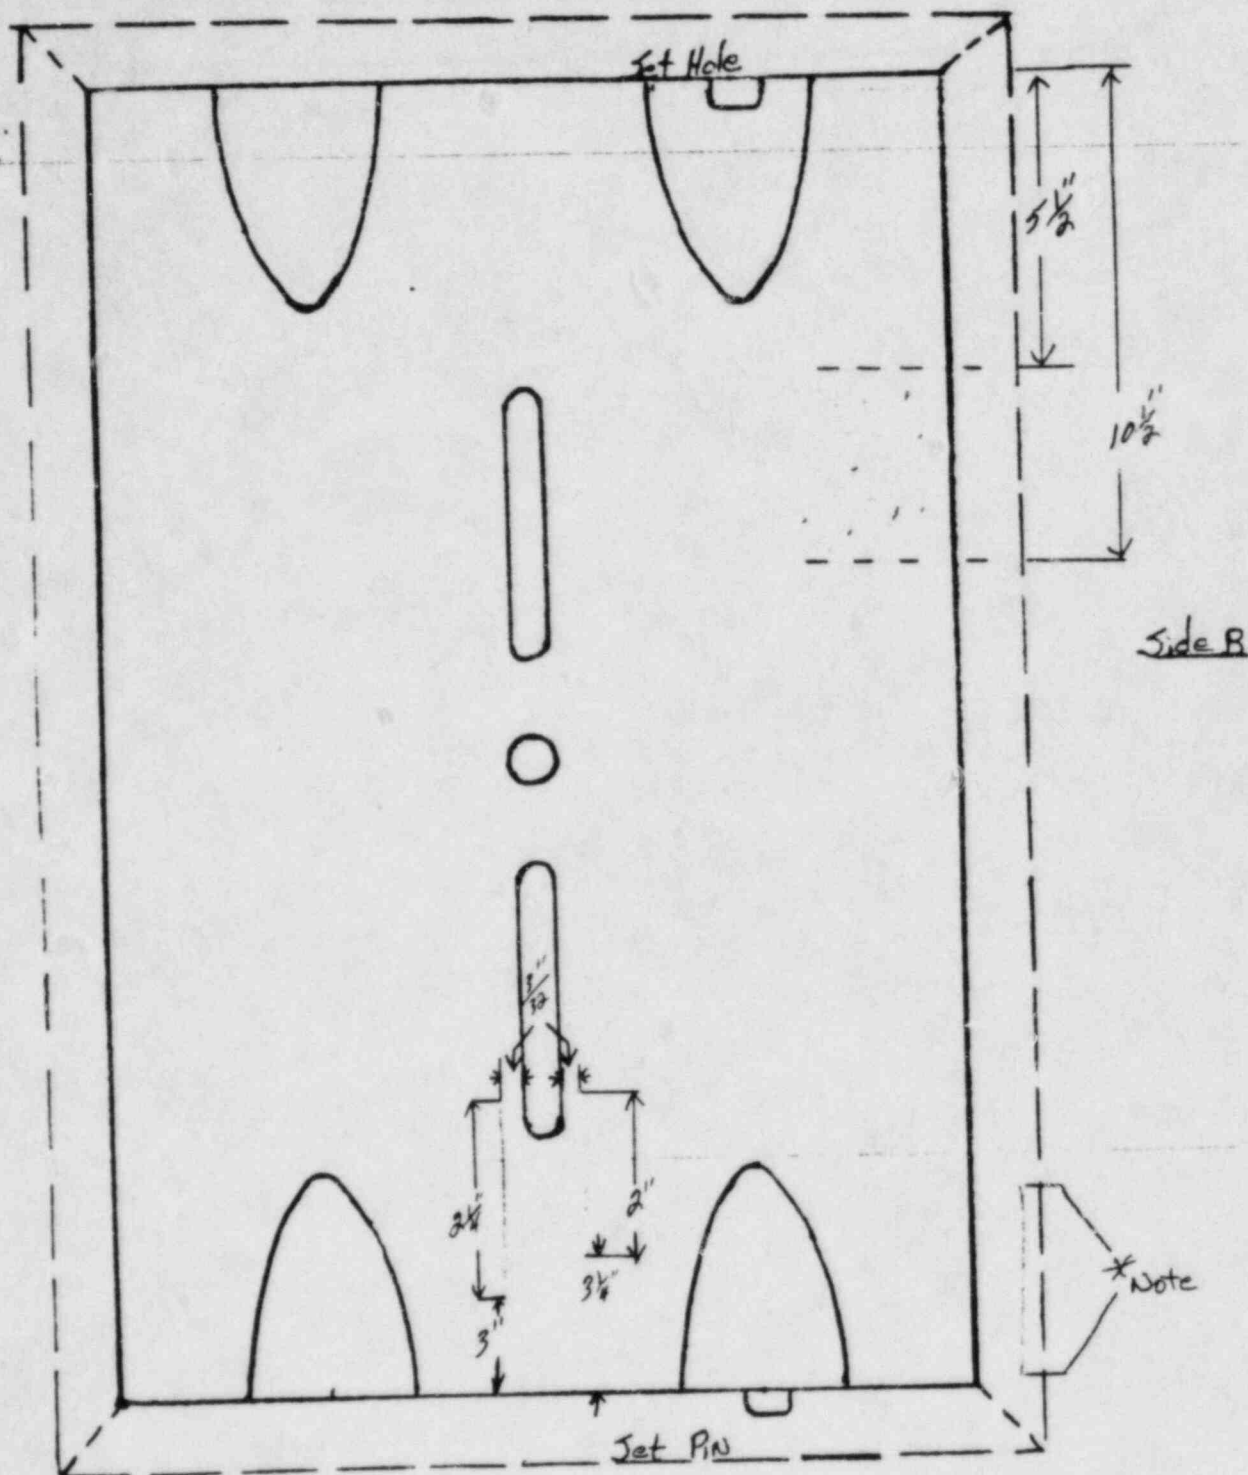
\* Linear Indication is Full Radius. stays between a  $\frac{1}{32}"$  to  $\frac{1}{16}"$  from the I.D. surface.
