TDI EMERGENCY DIESEL GENERATOR 103 10<sup>7</sup> CYCLE CONFIRMATORY

TEST/INSPECTION REPORT

SHOREHAM NUCLEAR POWER STATION - UNIT 1

Long Island Lighting Company

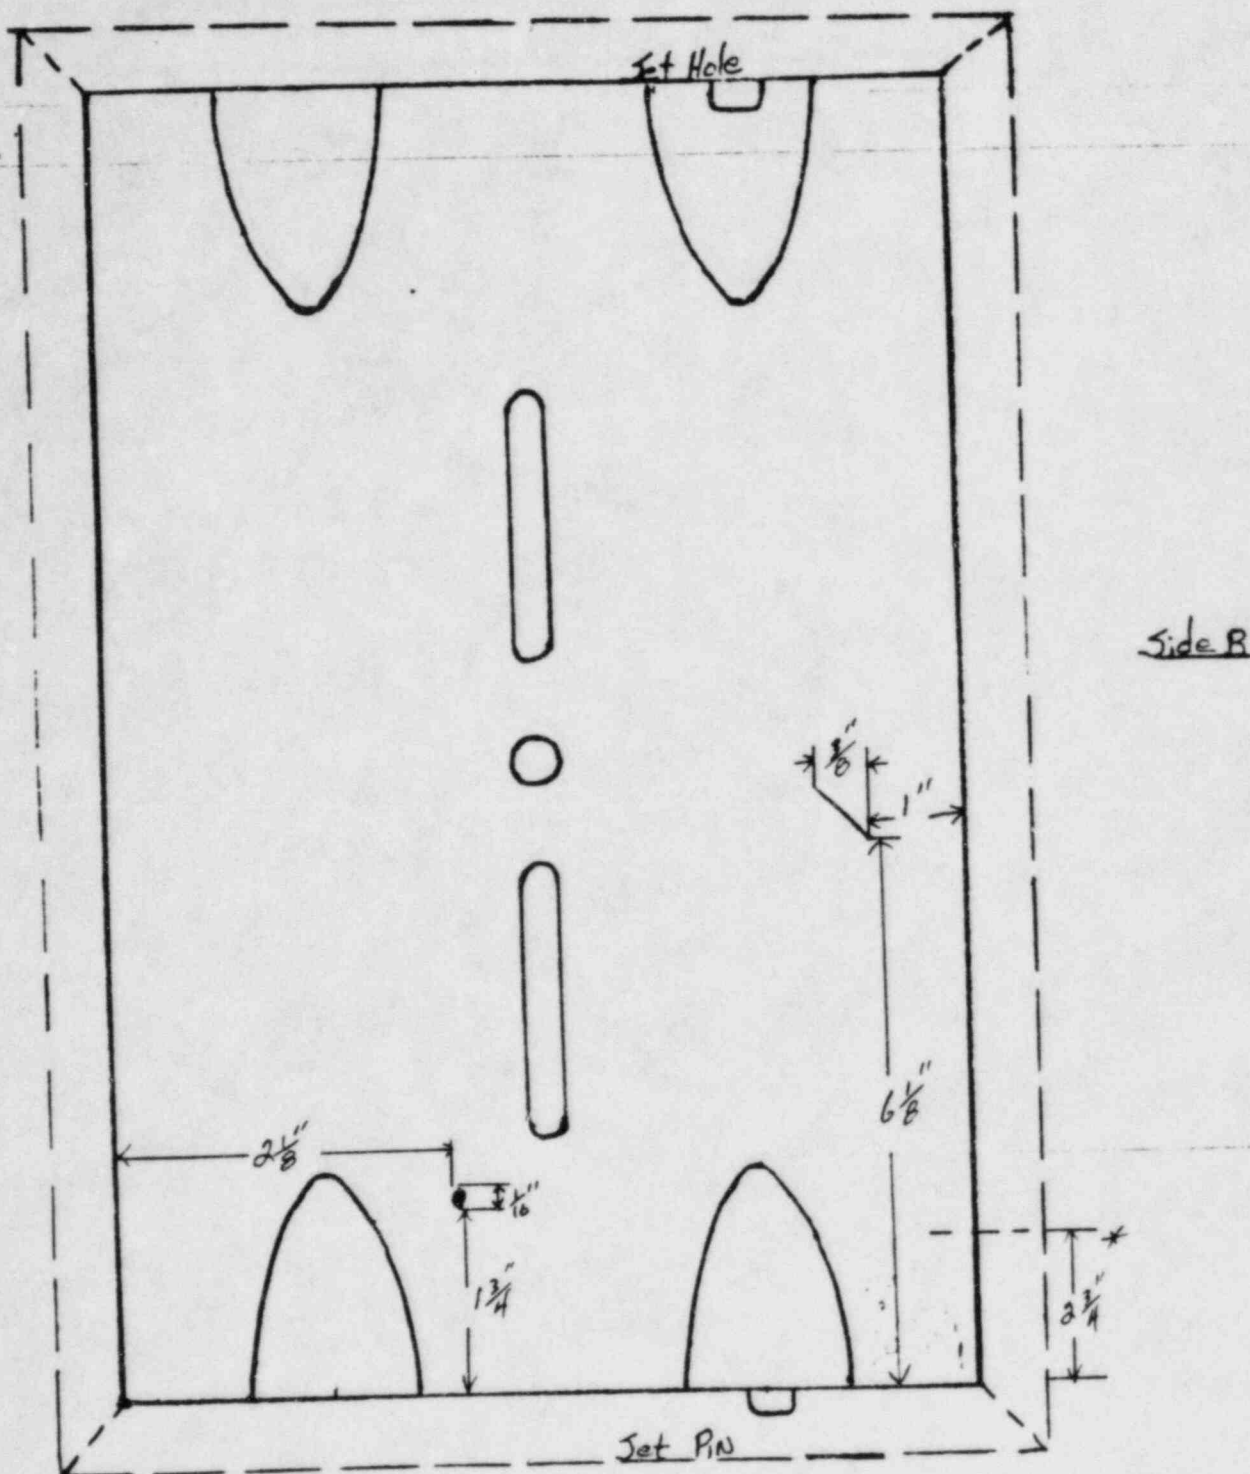
Page 7 of 10

- \* Moderate Porosity Condition within the  $3\frac{3}{4}"$  area no larger  $\frac{1}{32}"$
- \* Light Pore over surface no larger than  $\frac{1}{16}"$

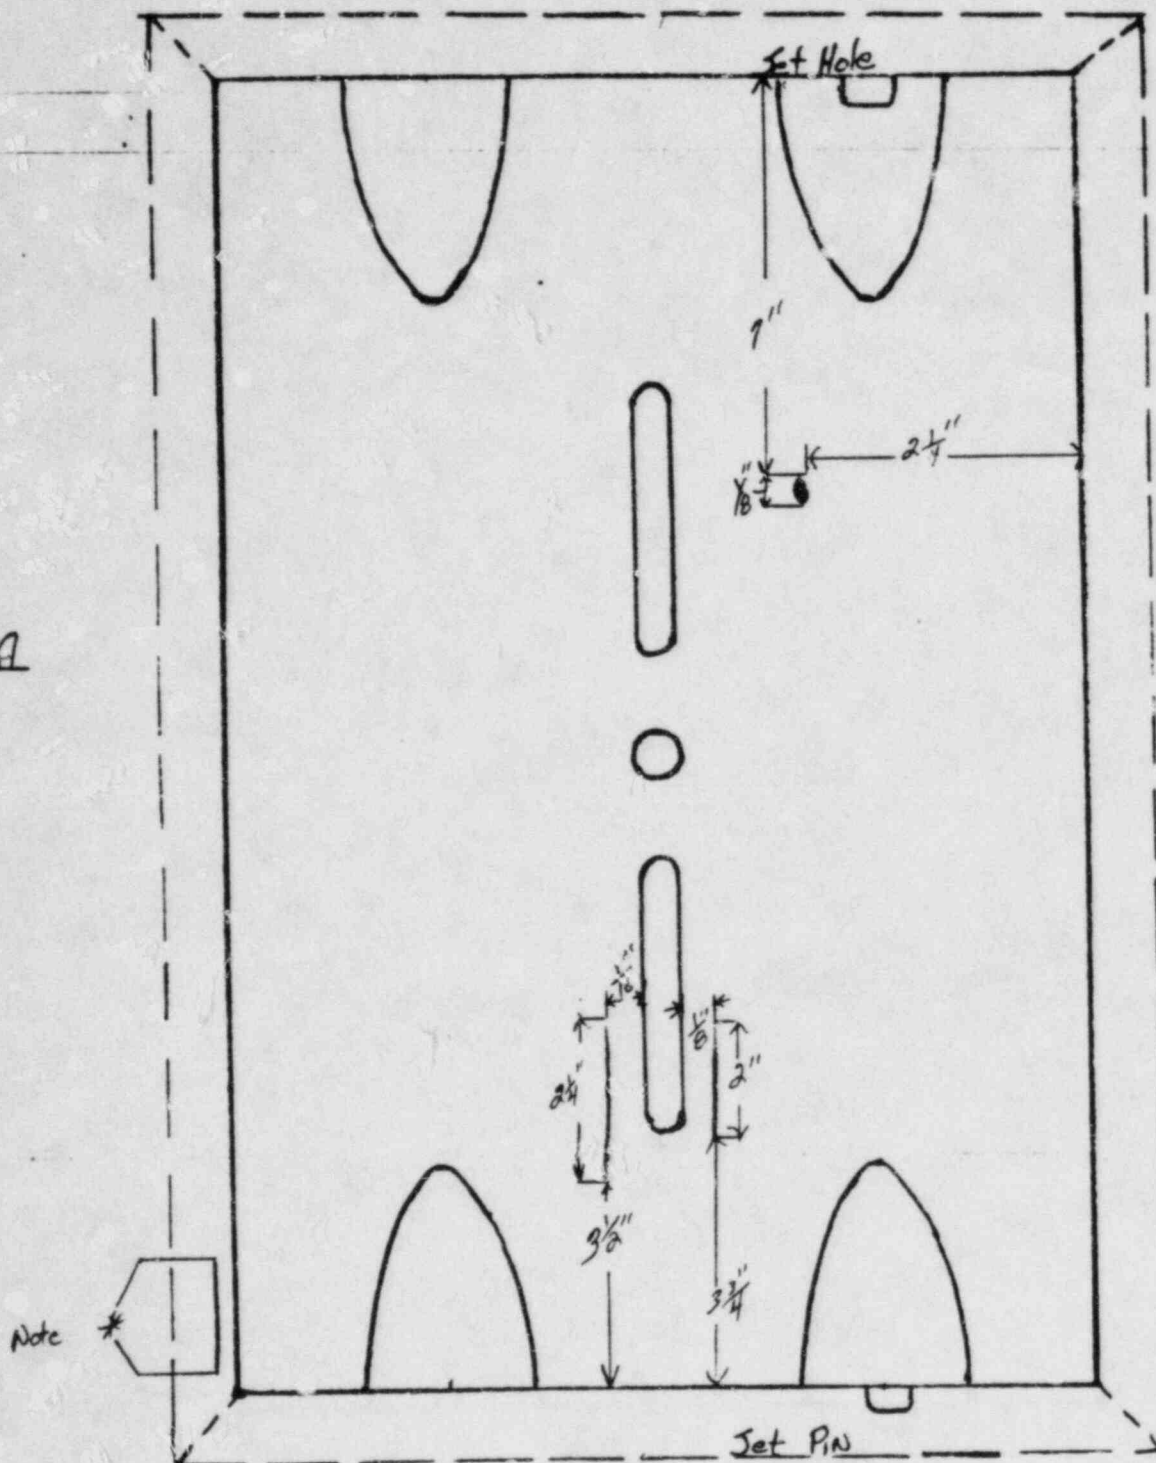
- \* Linear Indication runs entire Radius (Side A)  
1/8" from all Radii.
- \* Porosity located over entire Side A and QR Surface

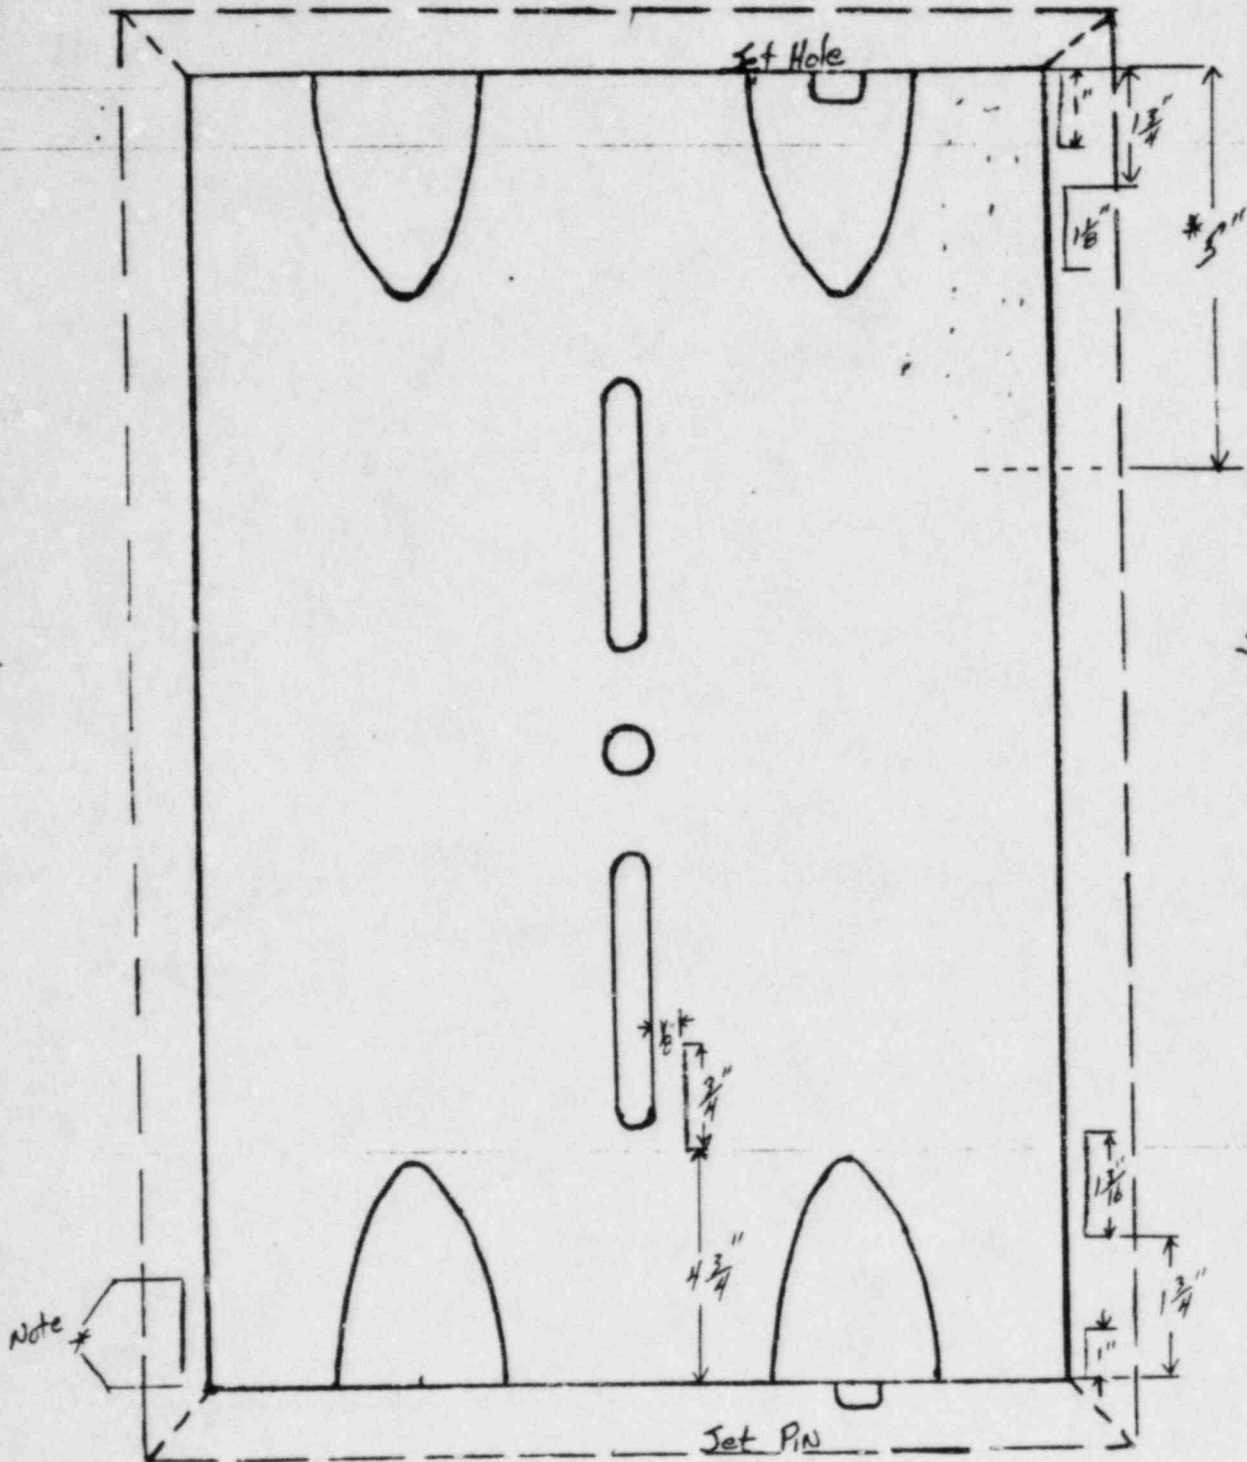
- \* Linear Indication entire Radius (Intermittent)
- \* All Linear Indications on Side A+B are  $\frac{1}{16}$ " from the D.D. (Aluminum Side)
- \* Moderate Porosity Condition Between 5" Area
- \* Light Porosity on entire D.D. surface

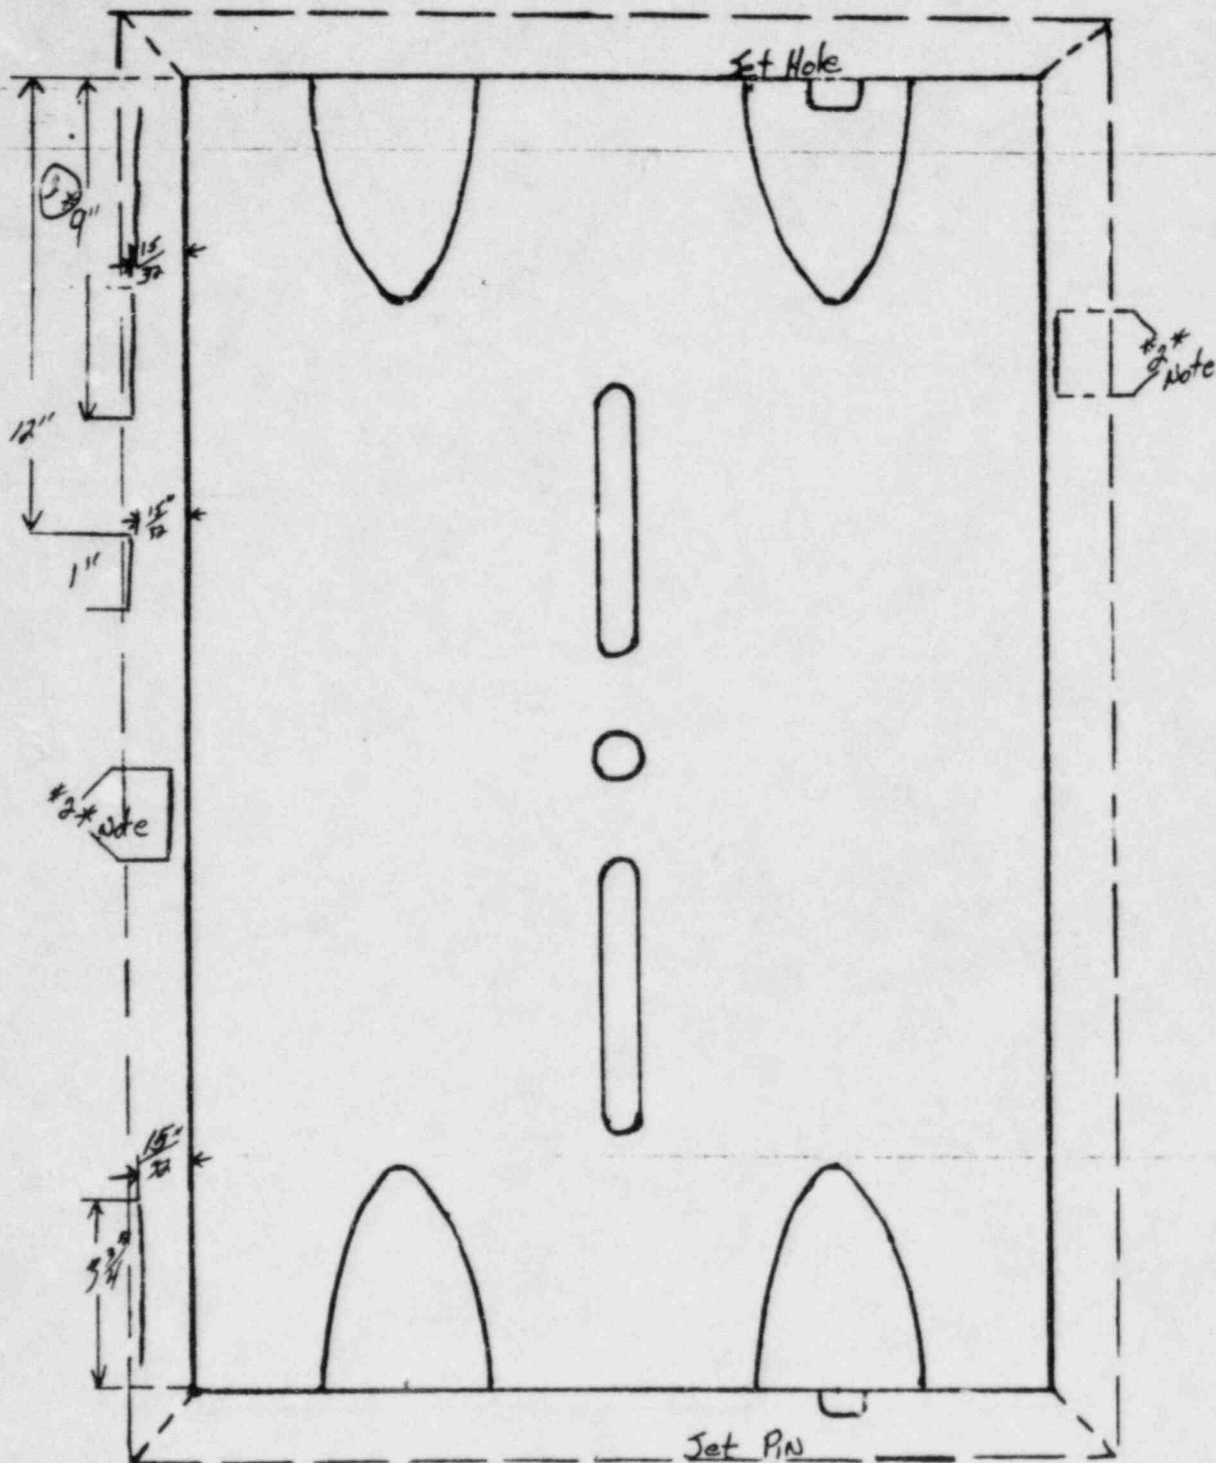
Page 16 of 10

- \* 1\* Intermittent Linear from Set Hole Edge to 9"
- \* 2\* Intermittent Linear Full radius 1/16" from QD, Aluminum Side
- \* Moderate Porosity Condition on entire QD Surface.
