March 22, 1985
ST-HL-AE-1210
File No.: G12.215

South Texas Project
Units 1 & 2
Docket Nos. STN 50-498, STN 50-499
Final Report Concerning
Trapeze Type Support Assemblies

South Texas Project
Units 1 & 2
Final Report Concerning
Trapeze Type Support Assemblies

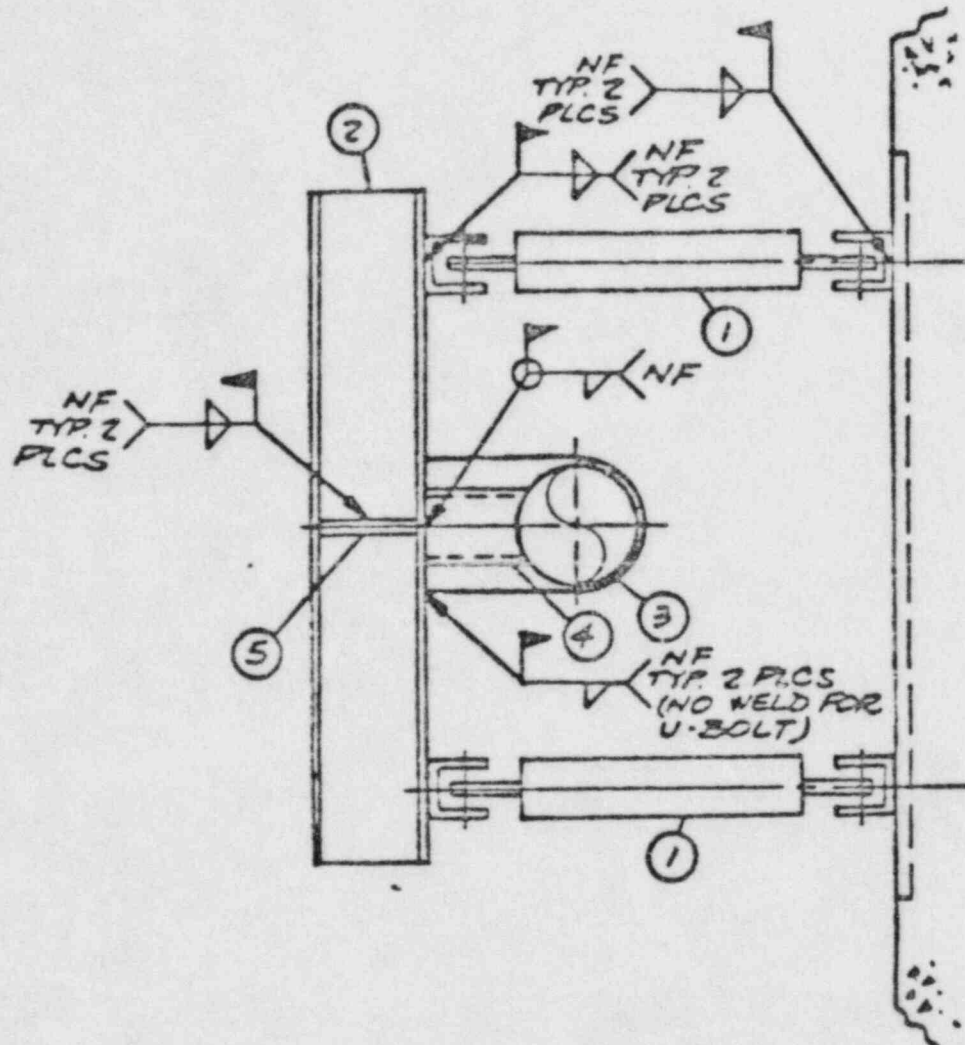
The support concept in question is identified in Figure 1. This support is commonly used in the industry in those locations where the pipe is located too close to a wall to allow for adequate room for snubber placement. In those situations, a beam is placed outboard of the pipe from the wall and the snubbers connected to the beam. Typically the support is held in place by friction between the beam and pipe that is developed by the tensioning of a U-Bolt that goes around the pipe. This deficiency concerned supports that used a welded strap to attach the support to the pipe, such that a gap existed between the strap and pipe. This clearance between the strap and pipe would allow the assembly to slide down the pipe in the case of a vertical pipe or to rotate around the pipe in the case of a horizontal pipe. The stress analysis is

performed assuming that snubbers are correctly oriented and acting as designed. If, due to misalignment, these supports fail to act during the dynamic event for which they are designed, then the piping system may be overstressed. In the case of the feedwater line, the trapeze assemblies are designed for waterhammer as well as seismic loads. An additional item of concern was that there was no documentation to show that the U-Straps used in the trapeze assemblies were qualified for side loads.

BEC will redesign the ASME Class 2 and 3 supports to replace the U-bolts or straps with welded pipe attachments. These welded attachments are standard designs which have been used both on STP and on other projects and will be qualified using standard state of the art computer programs.

BEC will avoid the use of welded pipe attachments for the supports on the ASME Class 1 lines. Other standard designs, such as pipe clamps and structural frames, will be used where possible. These designs will be corrected on or before September 13, 1985.
