| <b>GPU Nuclear</b> | | TDR NO. 666 | | REVISION NO. 0 | |
| PROJECT:<br>TMI-1 OTSG REPAIRS | | DEPARTMENT/SECTION E&D/Mech. Conn. | | | |
| DOCUMENT TITLE: Adequacy of TMI-1 OTSG Return to Service Safety Assessment<br>After 1984 Technical Specification ECT Examination | | | | | |

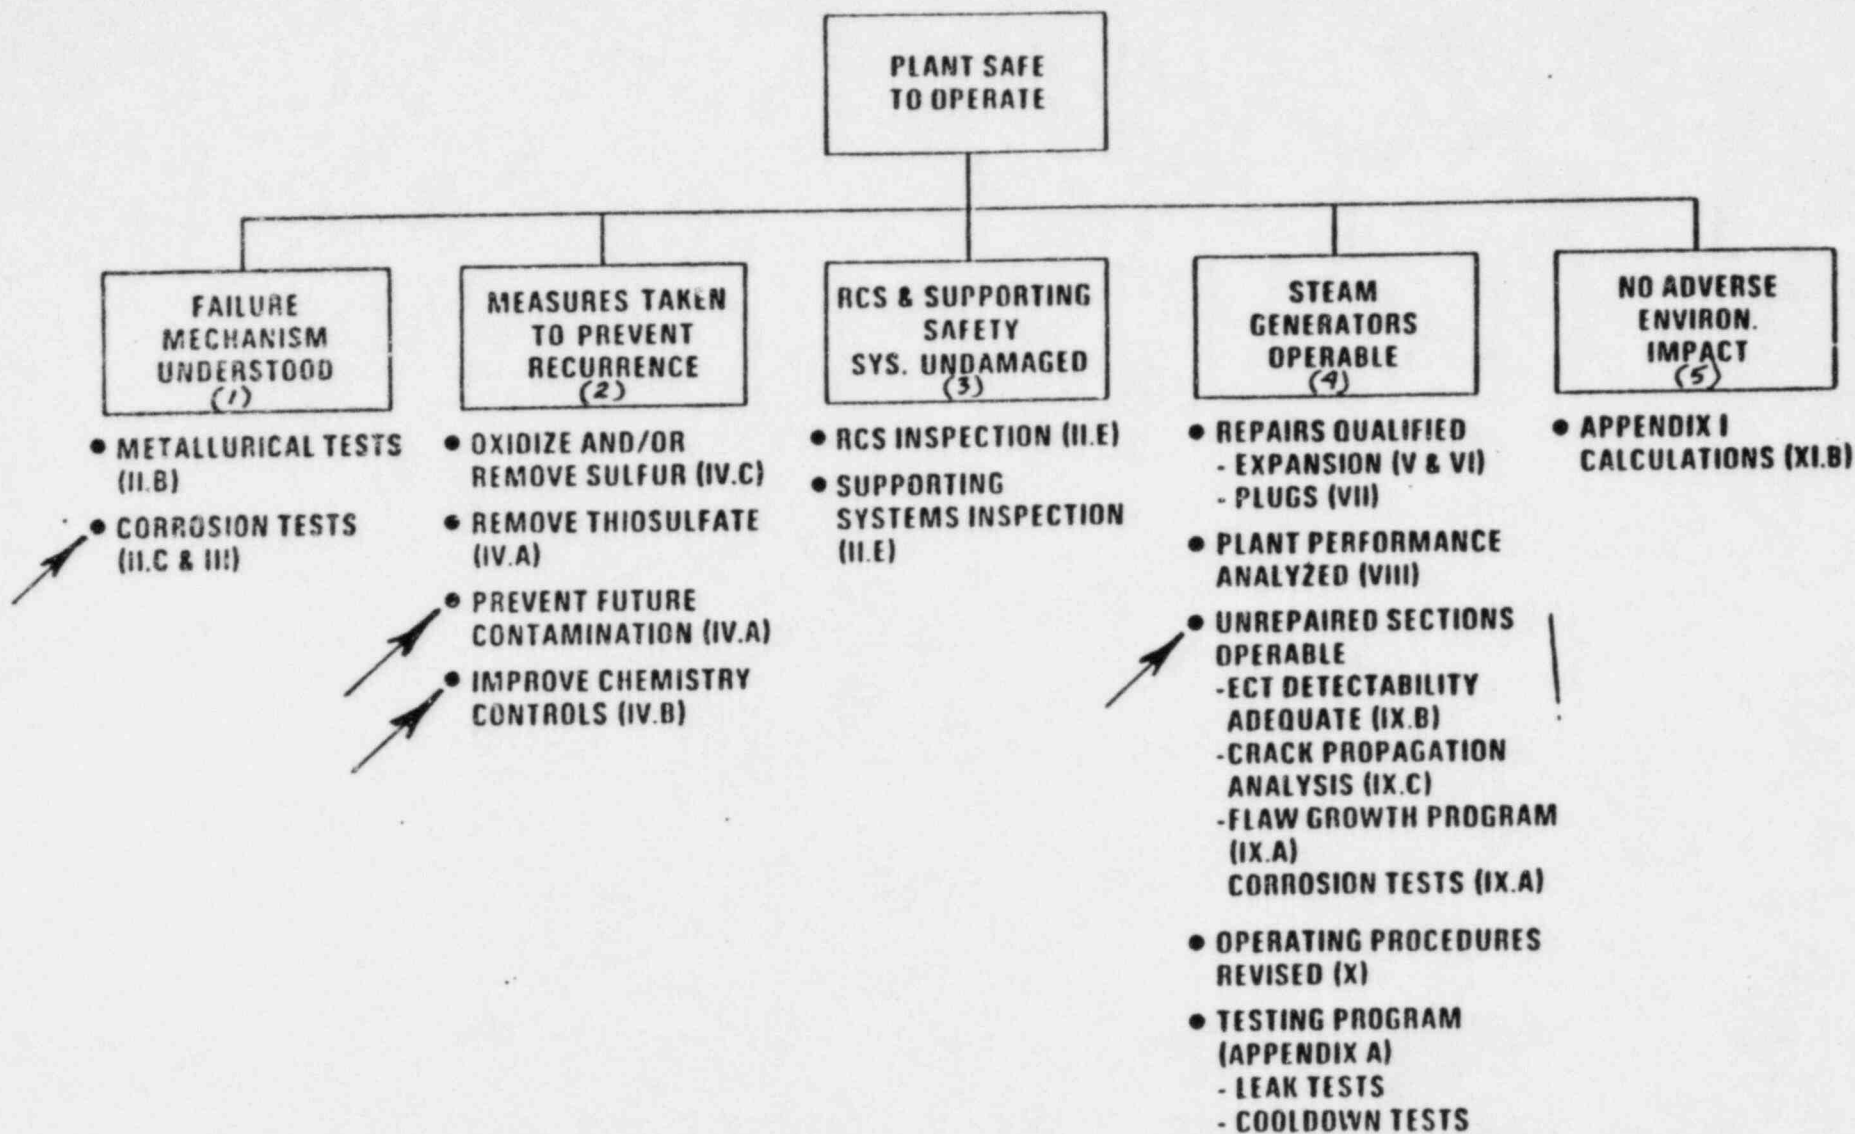
FIGURE I-7

The logic of the safety evaluation done in TR-008 is set forth in Section ID and describes the points to be demonstrated and assured by the repair program to allow OTSG return to service. This logic is graphically captured in Figure 1-7 (attached) and stated in ID (1) through (5) as follows (Ref. 1, Section ID, page 3):

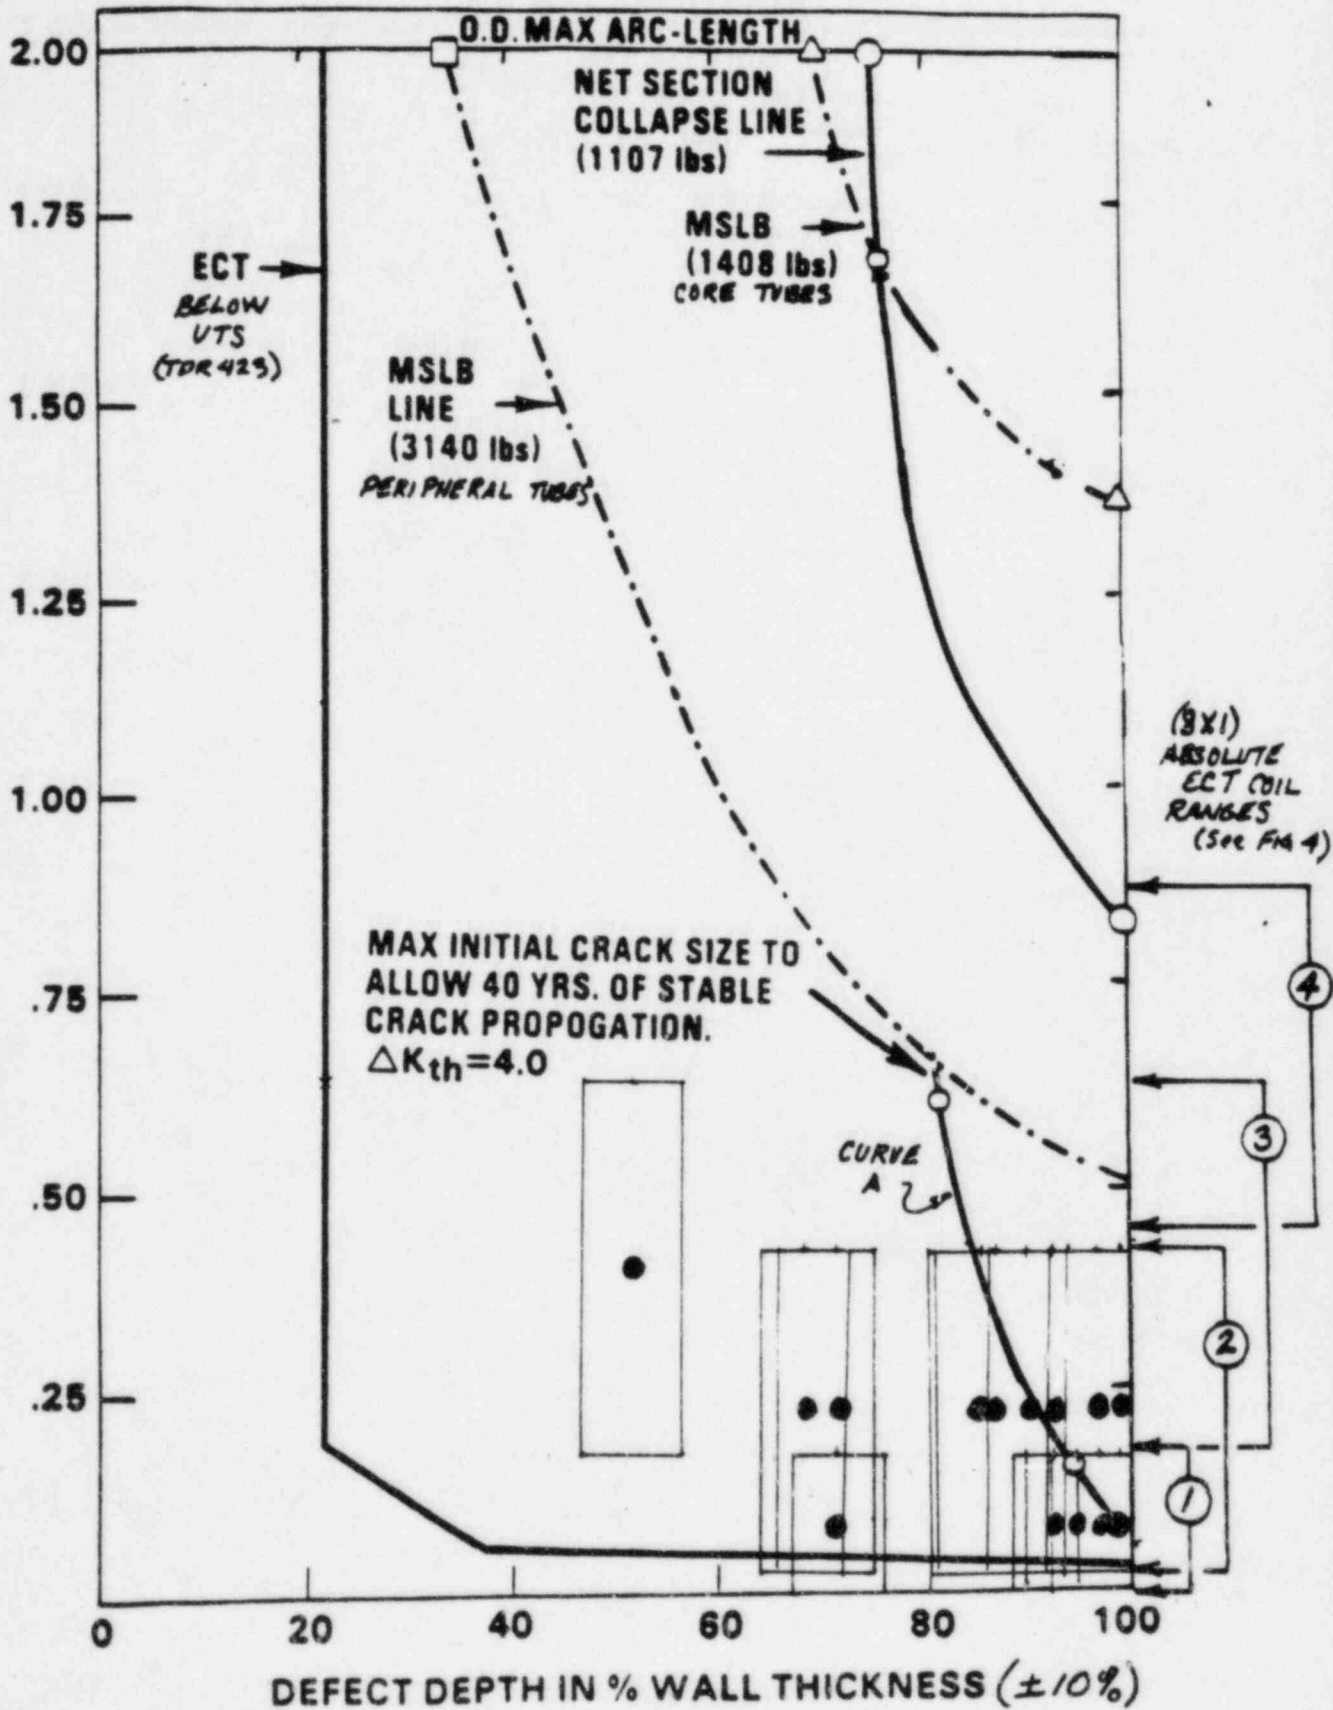
FIGURE 1a

Nonetheless, for conservatism all 1984 indications have been dispositioned as if they were defects capable of active mechanical propagation in service (cracks). When this was done it could be seen that none of the defects individually challenged the Main Steam Line Break criteria for peripheral tubes. This is depicted on Figure 1 (a thru c), where the effects of through-wall penetration uncertainty and absolute ECT probe coil overlaps are used to show each defect as a probability area

rather than a point. The indications plotted in Figure 1 (a thru c) include all the worst combinations of through-wall penetration and circumferential extent for single defects (See Table 1). These tubes have all been removed from service in 1985. Three tubes exhibited defects of large circumferential extent but lesser penetration: 3 coil signals coupled with 20-50% through-wall penetration, with one showing 76% through-wall but located within the upper tubesheet. These extreme cases are also plotted and they nonetheless did not approach the MSLB line for peripheral tubes. It should be noted that, minority extremes aside, the great majority of all 1984 ECT indications fall below or in the immediate vicinity of the limits of ECT detectability (See Figure 2).

It can be seen from Figure 1a-c that the maximum possible size characterization of several indications both extend above the ECT detectability curve and include areas above curve A. Areas above curve A represent crack sizes which will propagate through-wall in service. Nonetheless, assuming the worst confluence of events (1- the indication is truly at the maximum extent of its characterization range, and 2- the defect is a crack and not an IGA pit) there is still no unanticipated hazard. Degradation in this range will be by through-wall penetration before tube rupture (Leak Before Break) and OTSG leak detection systems and procedures will enable operators to deal with the leaking tubes safely.

MAJOR INDICATIONS BELOW THE UTS LOWER FACE ( $\pm 1''$ )

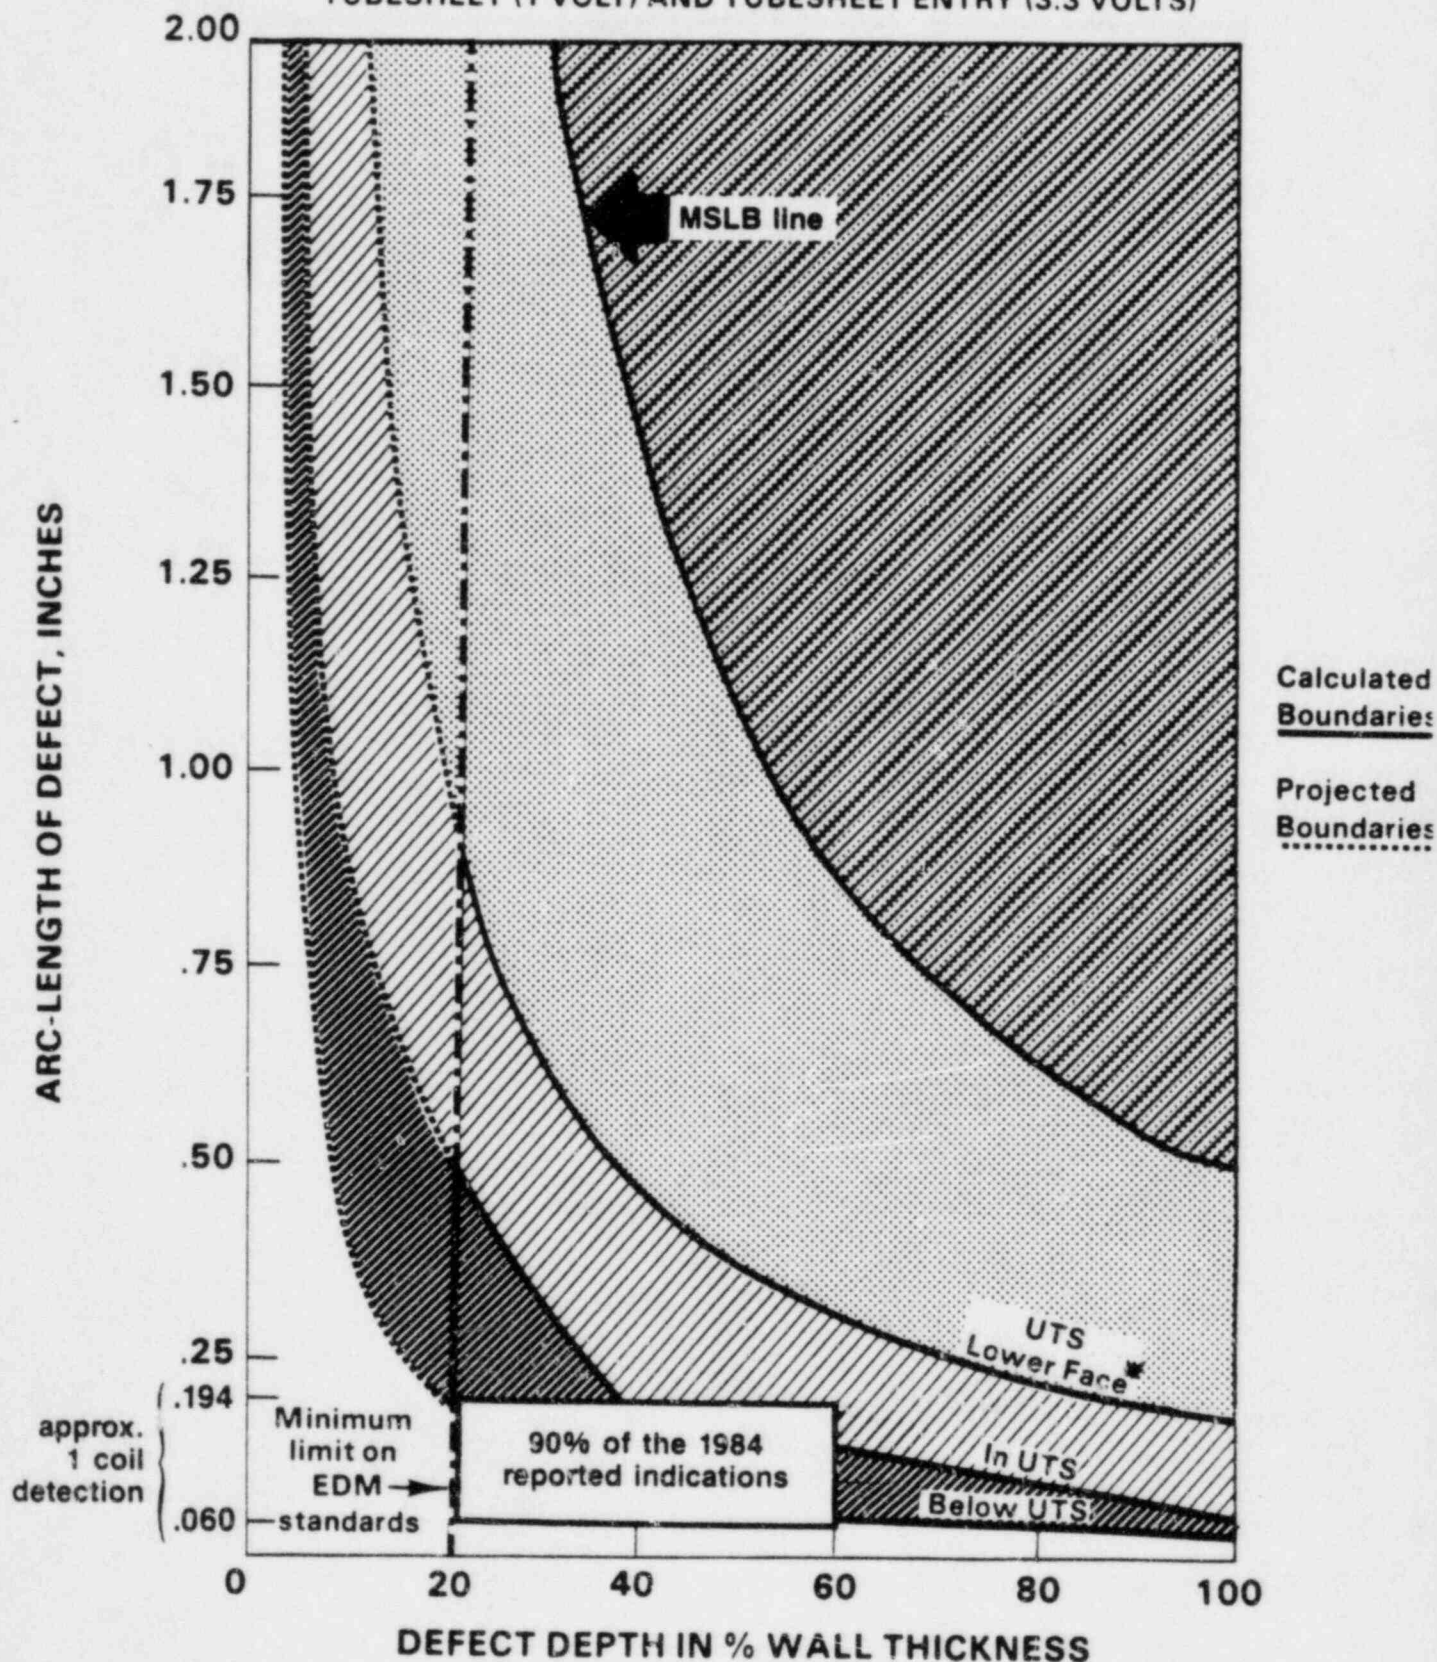
**FIGURE 2**  
(WAS FIGURE 6 OF TDR 652)

ESTABLISHED MINIMUM SENSITIVITY FOR THE HIGH GAIN .540 S.D. EXAMINATIONS  
BELOW UPPER TUBESHEET (300 MV) WITHIN UPPER  
TUBESHEET (1 VOLT) AND TUBESHEET ENTRY (3.3 VOLTS)

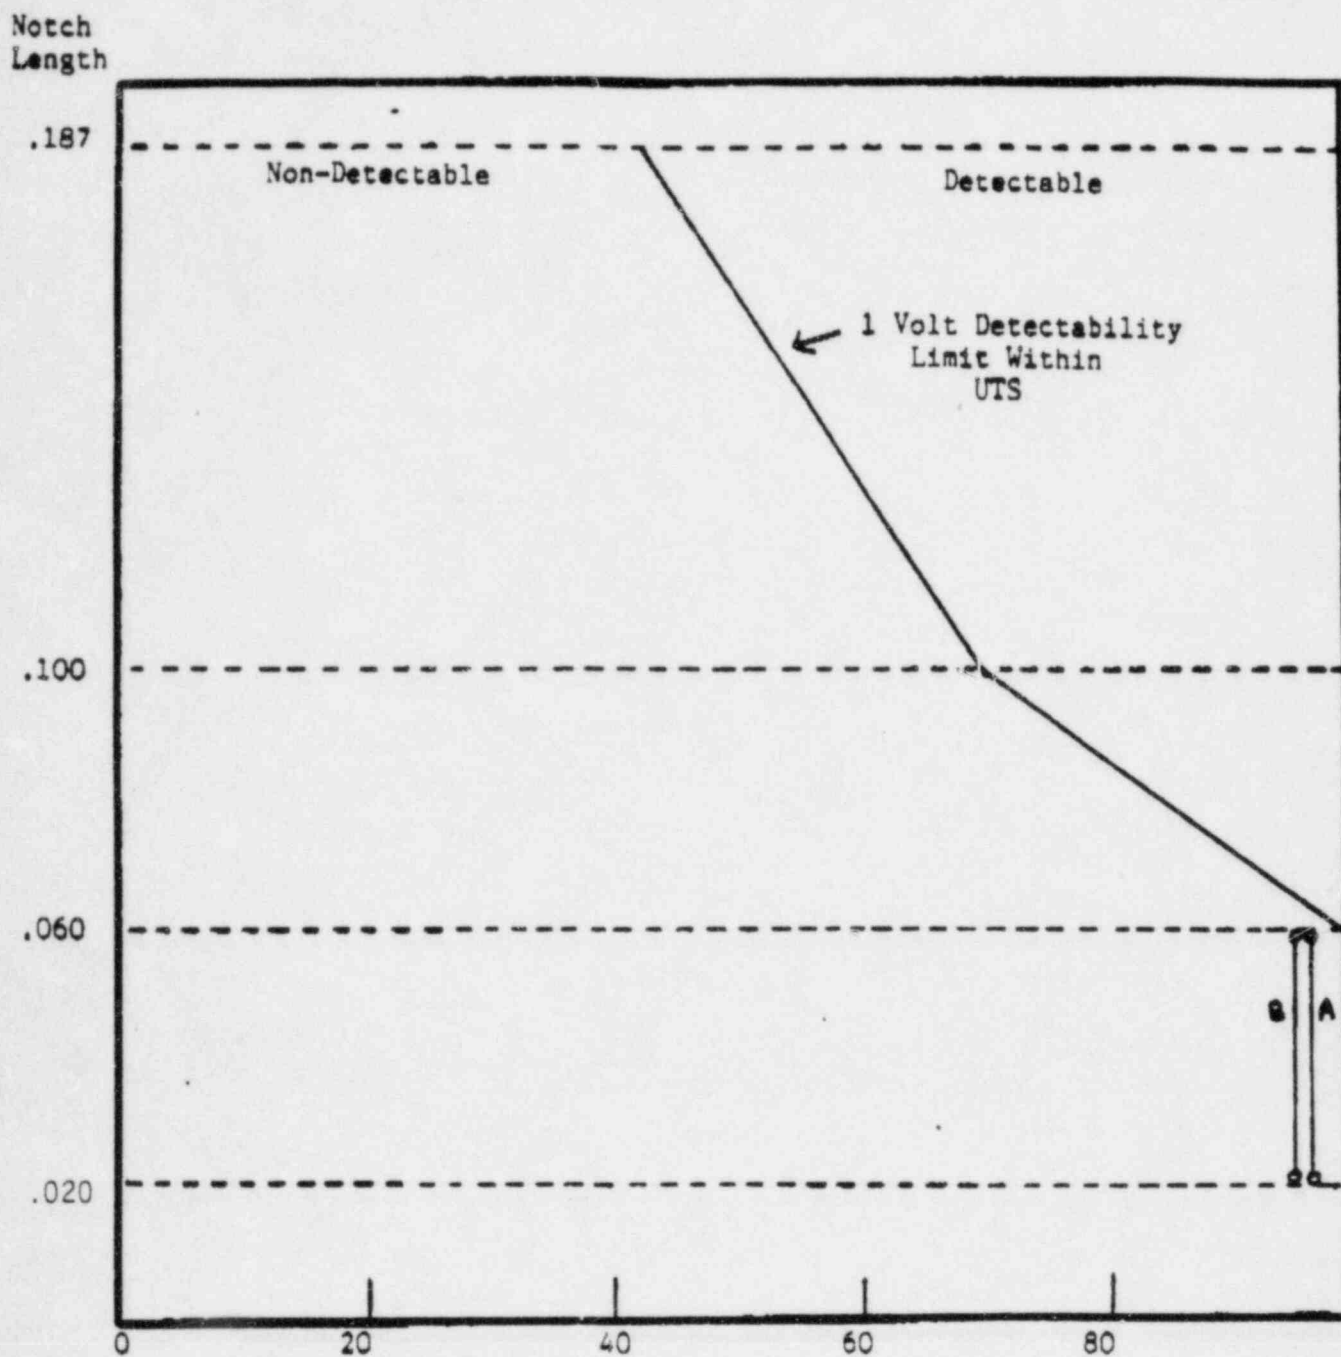
Figure 3a - Within - Tubesheet  
 Fiberscope Indications  
 Compared to Detectability Limit

Subsequent to the release of TR-008 the observations obtained from the outcome of the Long Term Corrosion Tests and failure analysis are now seen to support the presence of local IGA which may not be visible to the standard .540 differential probe but have the potential to be exercised into visibility by mechanical loadings (Ref. 2, pg. 22). This presence is further suggested by the distribution of new indications (in tubes of higher mechanical loading) and the results of fiberscope observations in OTSG tubes in which rounded dark areas consistent with IGA in appearance were seen at locations where ECT reported indications (See Figures 3a and 3b).

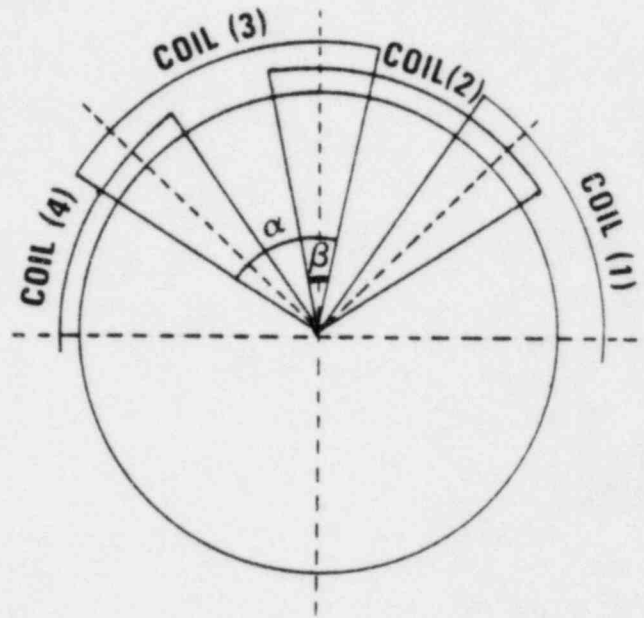
FIGURE 4  
(WAS Figure B-1)

Many of these defects were nonetheless used as justification for removal of a tube from service. This arose from considering these pits as behaving like cracks and therefore capable of propagative interaction. Additionally, circumferential extent was characterized solely by the maximum number of ECT probe coils signalling; no credit was taken for the overlap of coils (See Figure 1a thru c) whereby a defect only slightly larger than one-half of one-coil sensitivity would register as a two-coil defect. These are inherent conservatisms which should not be used to mask the actual appreciation of the comparatively benign nature of these defects.
