W3F1-96-0026

LICENSEE EVENT REPORT (LER)

WATERFORD STEAM ELECTRIC STATION UNIT 3

LOGARITHMIC POWER CHANNELS INDICATING 5 PERCENT OF SCALE BELOW ACTUAL POWER

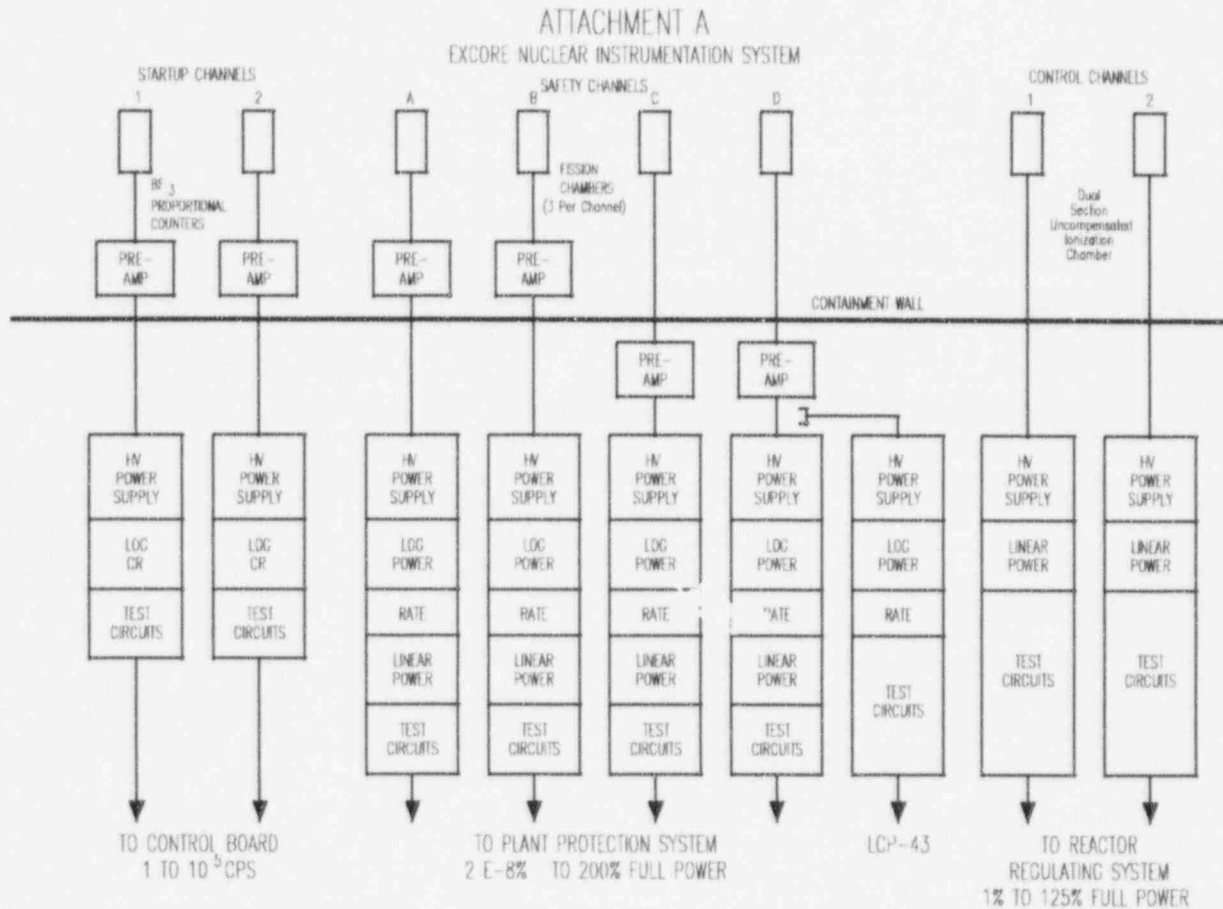
(Refer to Attachment A) The actual trip bistable for the Plant Protection System log power trip is set inside the PPS at 0.257 percent power (or 7.109 vDC). Adding a Periodic Test Error Value of 0.038 vDC to this gives the Technical Specification Allowable Value of 0.281 percent power (or 7.147 vDC). The resulting low reading discovered would make the indicated power lower than actual by 0.5236 vDC (5.236 percent of scale) for the 'A' channel. Instead of the trip actuating at 0.257 percent actual power, the trip would have occurred at 0.858 percent (or 7.6326 vDC for channel 'A'). Channels 'B', 'C', and 'D' were similarly affected and would have tripped at: channel 'B', 7.6318 vDC; channel 'C', 7.3542 vDC; and channel 'D', 7.355 vDC. Each of these values exceeds the Technical Specification 3.3.1 allowable value of 7.147 vDC.

(Refer to Attachment A) Each safety channel uses three vertically stacked fission chambers mounted in symmetrically located wells (thimbles) surrounding the reactor vessel.

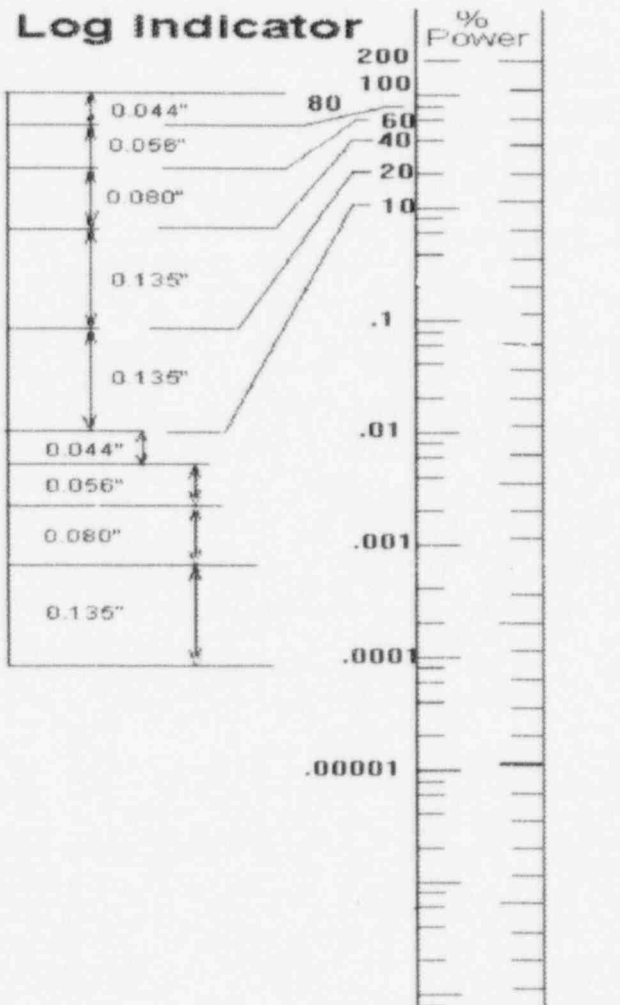
ATTACHMENT C

(Refer to Attachment C) Engineering Calculation EC-I95-019 contains the loop uncertainties for each of the instrument output indications. The Log power channel output is from 2E-8 percent to 200 percent power or ten decades of power. The output signals to the indicating devices were found to be low by approximately the same amount as seen by the flux ratio change from cycle 1 to the present. The 'A' Log channel was reading approximately 50 percent power with the plant at 100 percent. This deviation on a log scale meter with a 4.5 inch measurement distance, was an approximate 0.14 inch deviation of the pointer or a 3 percent of scale deviation. Calculation EC-I95-019 indicated that the uncertainty of the control indications at the time of calibration can be expected to be as much as 4.96 percent of scale. The small deviation seen on all four output instrument channels was an acceptable amount of deviation in accordance with EC-I95-019. This small amount of indicator deviation was a contributor to the problem going undetected by routine channel observations.
