Crystal River Unit 3
Docket No. 50-302

Subject: Licensee Event Report (LER) 95-013-01

Design Deficiency May Cause Makeup Tank Vortexing Resulting in Failure to Meet Appendix R Requirements

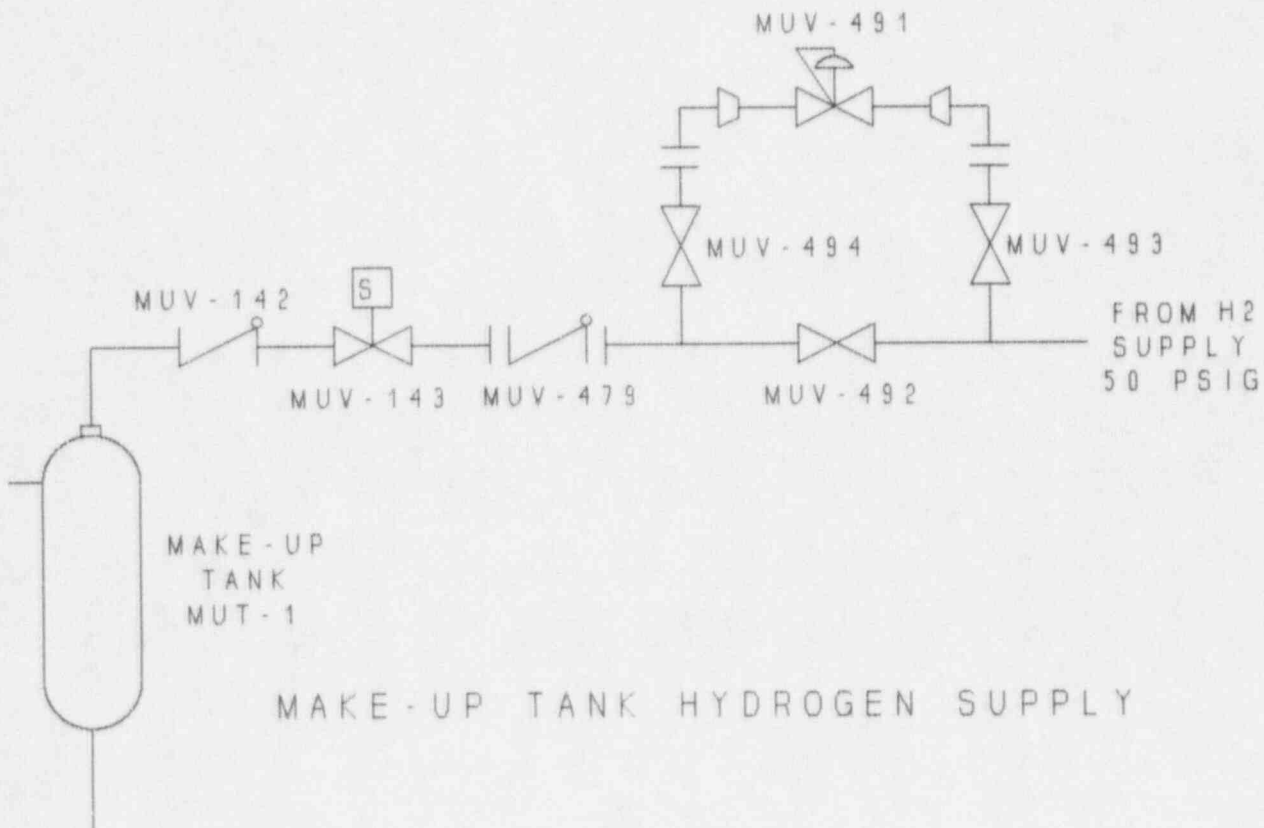
FIGURE 1

In the first scenario, a fire is postulated in fire area AB-119-6H (119 foot elevation of the auxiliary building), near Makeup Valve-143 [CB,FSV](MUV-143). A fire induced hot short occurs, causing the solenoid valve to open, providing a continuous supply of hydrogen to MUT-1. Due to normal reactor coolant system [AB](RCS) makeup flow, the level in MUT-1 decreases to a point and vortexing in MUT-1 may occur, at very low tank levels, allowing hydrogen to enter the running makeup pump [CB,P](MUP), subsequently challenging its operability. In this event, the remaining train would still be available to provide RCS makeup; therefore, Appendix R criteria would not be violated.

A 1985 Appendix R fire analysis postulated a spurious opening of the hydrogen addition control valve MUV-143 due to a fire induced hot short. MUV-143 is a 3/4 inch solenoid control valve located in the hydrogen addition line. The analysis concluded that a fire in certain areas of the plant could cause MUV-143 to spuriously open. Spurious operations based on Appendix R concerns must be addressed by one of two ways. Actions to preclude the spurious operation must be taken, or compensatory actions must be specified to mitigate the effects of the spurious operation.

The cause of this event was a design analysis error in that the original Analysis/Calculation for hydrogen pressure in MUT-1 did not take into consideration vortexing at reduced inventory in the tank.

Figure 1 - Makeup Tank Hydrogen Supply

1. Continue to leave the regulator (MUV-491) normally isolated and use the manual isolation valves to add hydrogen to the MUT as described above. It was also agreed that manually charging the MUT with hydrogen would not be considered an Operator Work Around and that long term, this method was preferred because it is fast and puts more focus on the evolution.
2. Generate a design change to lower the setpoint on MUV-491 to a value that would bring it into compliance with design assumptions, adding a level of defense when using the regulator to add hydrogen to the MUT. The design change will be issued and installed during the Refuel 10 outage scheduled for the Spring of 1996.
