# Pennsylvania Power & Light Company

SUSQUEHANNA STEAM ELECTRIC STATION  
T-ASCO SCRAM PILOT SOLENOID VALVES  
ER 100450/100508 FILE 841-4  
PLA-2361

Subject: Preliminary Evaluation of Failed Scram Pilot Solenoid Valve

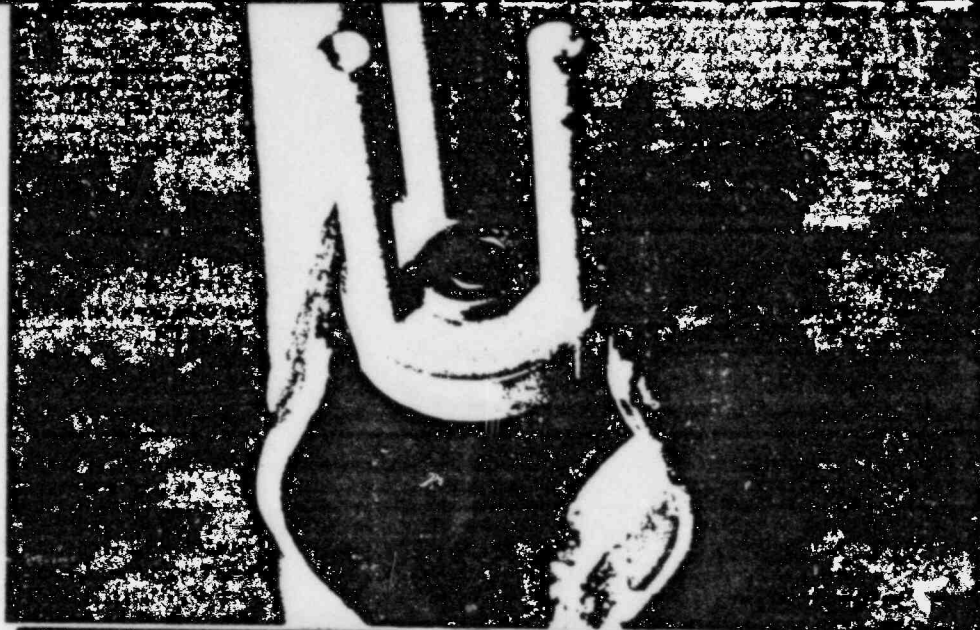
FIG. 2

FRC has included three color photographs of the solenoid valve internals marked as Figures 2, 3, and 4. All three photographs are of components from the solenoid valve that had failed in service. Figure 2 is a photograph of the disc holder subassembly with its polyurethane seat. The compressive set and the roughness outside the diameter of the compressive set should be noted. The roughness is a result of tearing of the polyurethane seat due to adhesion to the exhaust pilot orifice. Matching patterns of polyurethane were found adhered to the exhaust pilot orifice. Figure 3 is a photograph of the core disc seat with a similar compressive set evident. The black ring at the mating surface may be the result of either heat or contaminants in the air supply and further testing would be required for a determination. Figure 4 shows the stem and disc holder subassembly. Although it may not be evident in the photograph, the disc holder subassembly is being supported by the stem. The stem had firmly adhered to the polyurethane at the base of the disc holder subassembly. The photographs depict the as-found condition of these components.

The preliminary cause of the failures in service appear to be a result of the disc holder sub-assembly adhering to the exhaust pilot.
