NED-84-605

December 10, 1984

NRC DOCKET 50-321
OPERATING LICENSE DPR-57
EDWIN I. HATCH NUCLEAR PLANT UNIT 1
INSERVICE INSPECTION OF STAINLESS STEEL PIPING -
1984 REFUELING OUTAGE

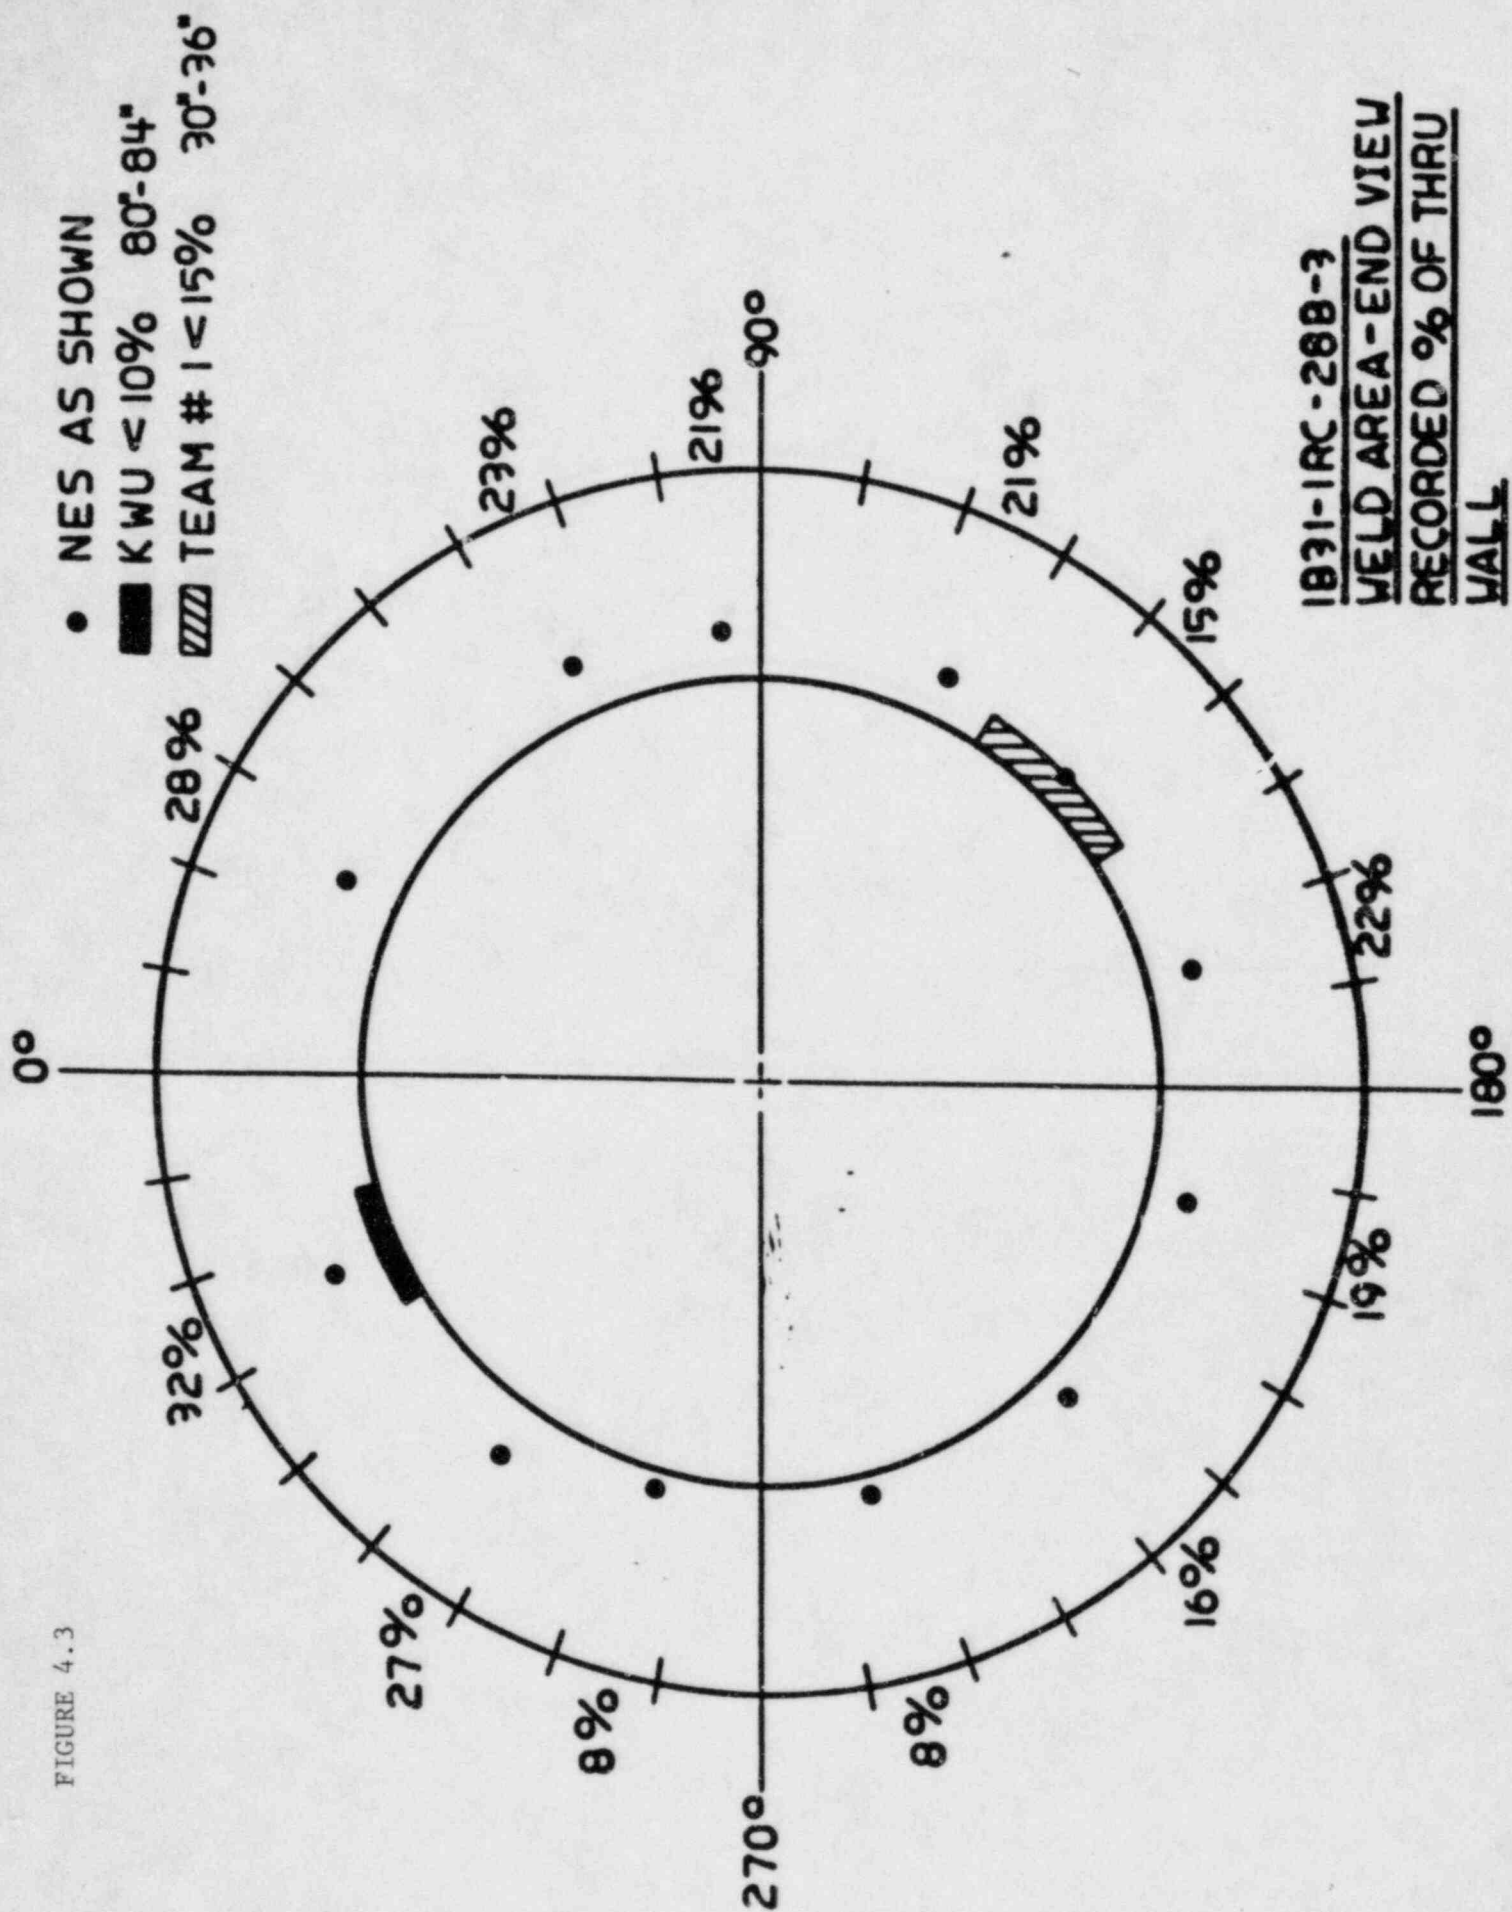
FIGURE 4.3

indications. However, final evaluation and disposition of sizing results was made by SCS and/or NES. The most conservative estimate was reported to GPC by SCS and was used in analysis for decisions concerning repairs. It should be noted that this was not a research effort but a means to show that results were conservative. Some examples of the third-party review results are shown in Figures 4.3 and 4.4.

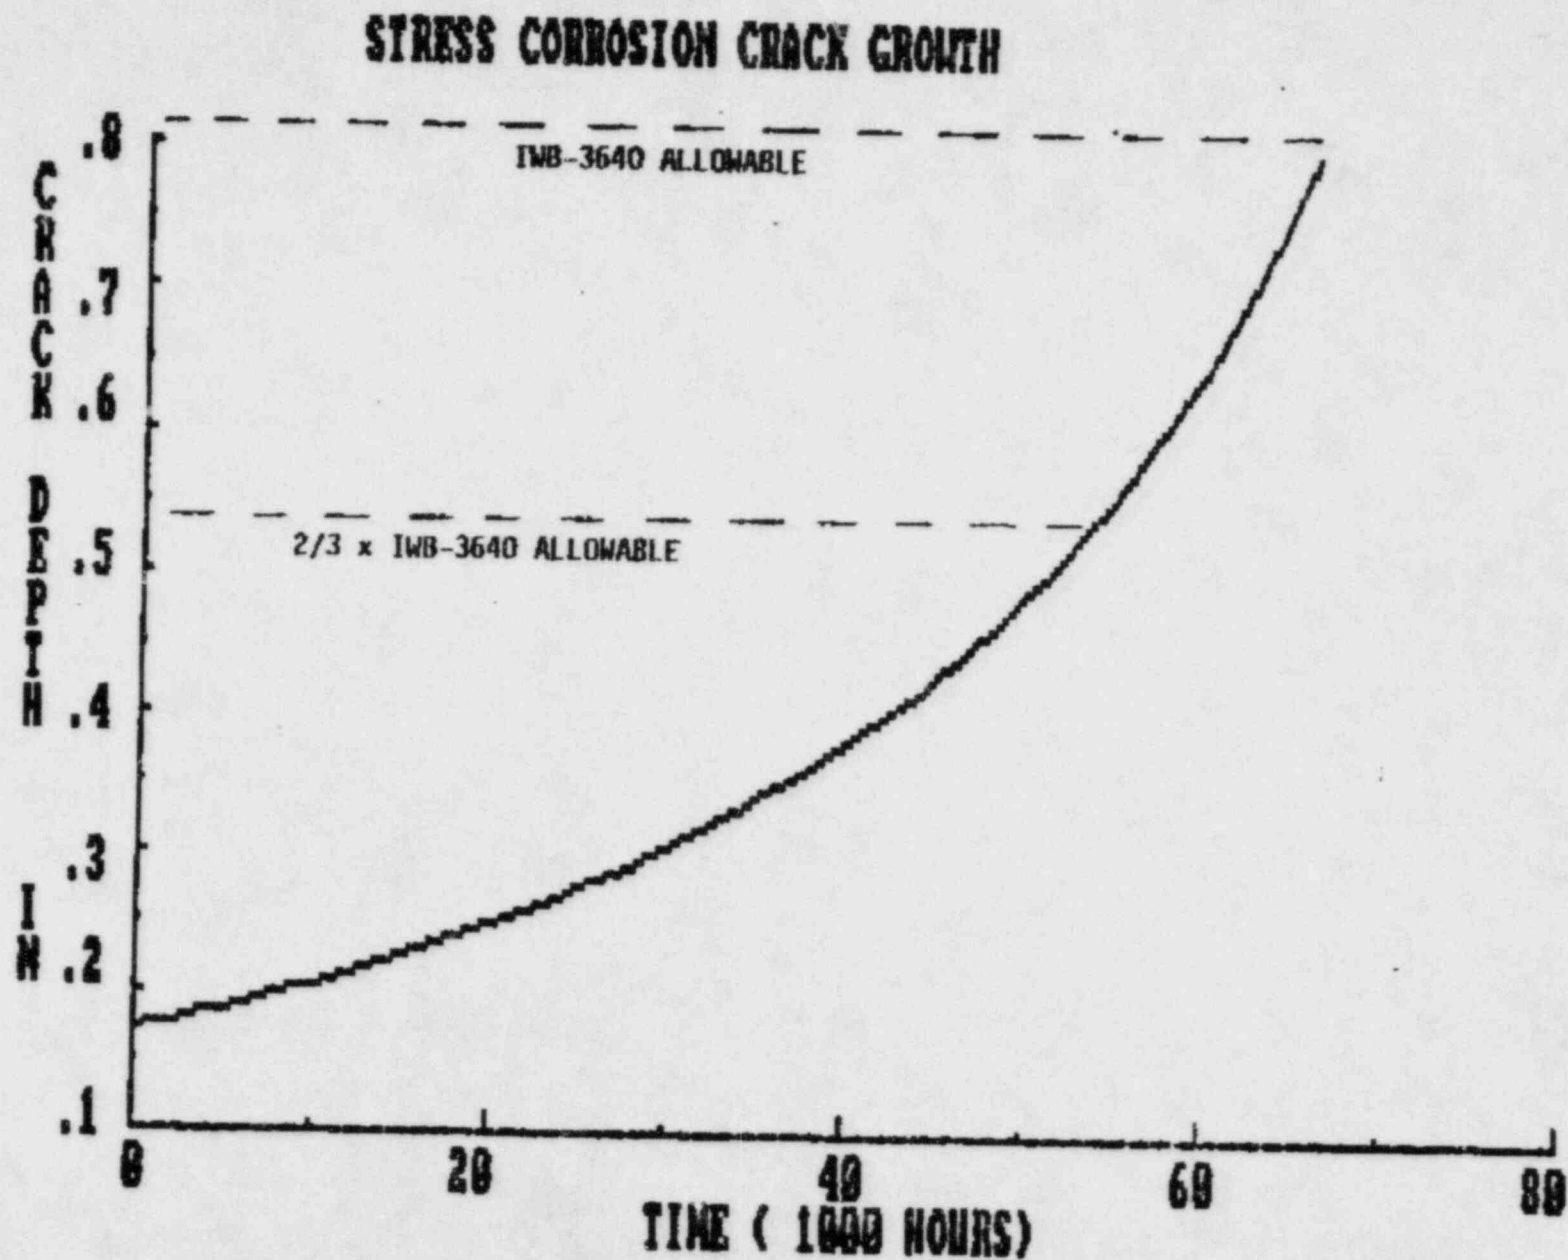
FIGURE 5.1 Projected Crack Growth Versus Allowable For Weld 2B-A6

The two axial crack-like indications were of a depth so that flaw evaluation was able to demonstrate continued successful operation for at least one additional fuel cycle with these joints unrepaired. The crack growth analysis utilized representative circumferential residual stress data and analysis for this pipe size obtained from EPRI reports (Refs. 2, 3, 4). The analysis technique and results were again compared to the NUTECH Engineers results and agreement was obtained. Crack growth curves versus allowable flaw size for the two joints are presented in Figures 5.1 and 5.2. It is seen that in both cases the indications are acceptable for a period well in excess of one fuel cycle.

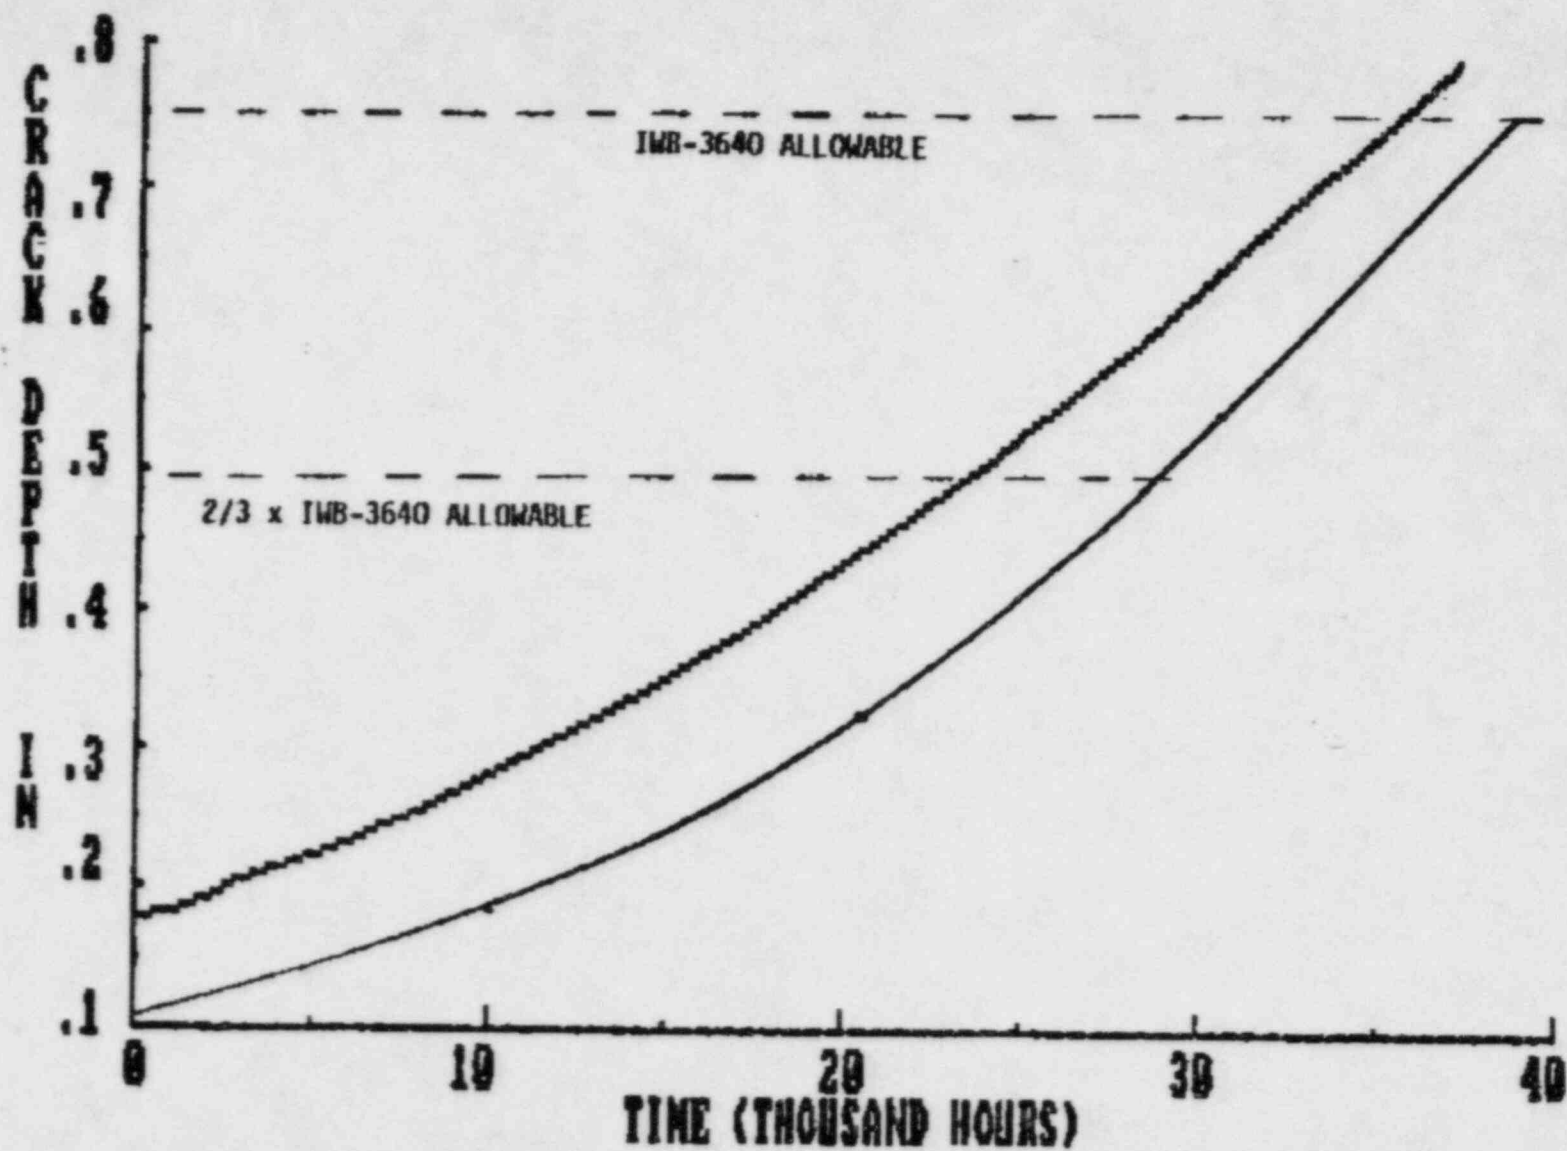
FIGURE 5.3 Projected Crack Growth Versus Allowable For Sweep-o-let
Weld 22-1BC1-AM1

Crack-like circumferential indications were also observed in two of the sweepolet to ring header welds during the inservice inspection of these welds. These crack-like indications were evaluated using the flaw evaluation methodology described above. The weld residual stress used assumed that the sweepolet to header joints had been solution annealed following welding, (a condition which was verified as a result of a review of shop fabrication records) and therefore produced a zero through thickness residual stress state. The flaw evaluation results indicated that all of the flaws would remain within the limits imposed by the ASME Code, Section XI, Paragraph IWB-3640 and NRC Generic letter 84-11 for a period of at least one fuel cycle (see Figures 5.3 and 5.4). These results were compared to those developed by NUTECH Engineers and were essentially in agreement.

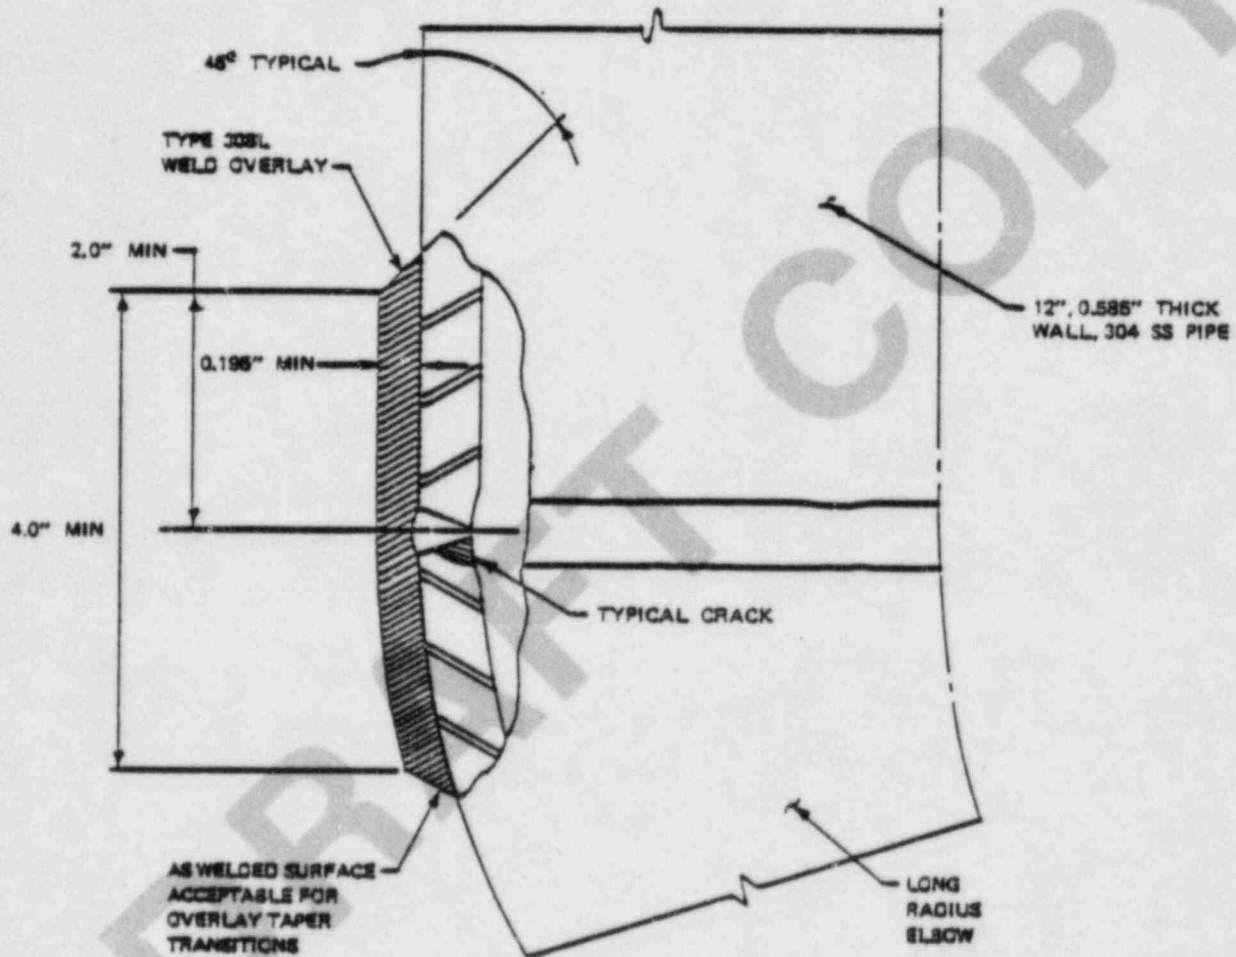
Figure 2.1

TYPICAL CONFIGURATION OF 12"
ELBOW-TO-PIPE WELD OVERLAY

The UT flaw indications requiring repair have been remedied by increasing the pipe wall thickness through the deposition of weld metal 360° around and to either side of the existing weld. This is shown for a typical geometry in Figure 2.1. The weld-deposited band provides additional wall thickness to restore the original design safety margin. In addition, the welding process produces a strong compressive residual stress pattern on the inside portion of the pipe wall which prevents further crack growth. The deposited weld metal is Type 308L with controlled delta ferrite content so as to be resistant to propagation of IGSCC. Design and as-built information for all overlays is shown in Tables 1.1 and 2.1.
