Northern States Power Company
Prairie Island Nuclear Generating Plant
1717 Wakonade Dr. East
Welch, Minnesota 55089

PRAIRIE ISLAND NUCLEAR GENERATING PLANT
Docket Nos. 50-282 License Nos. DPR-42
50-306 DPR-60

Steam Generator Inspection Reports

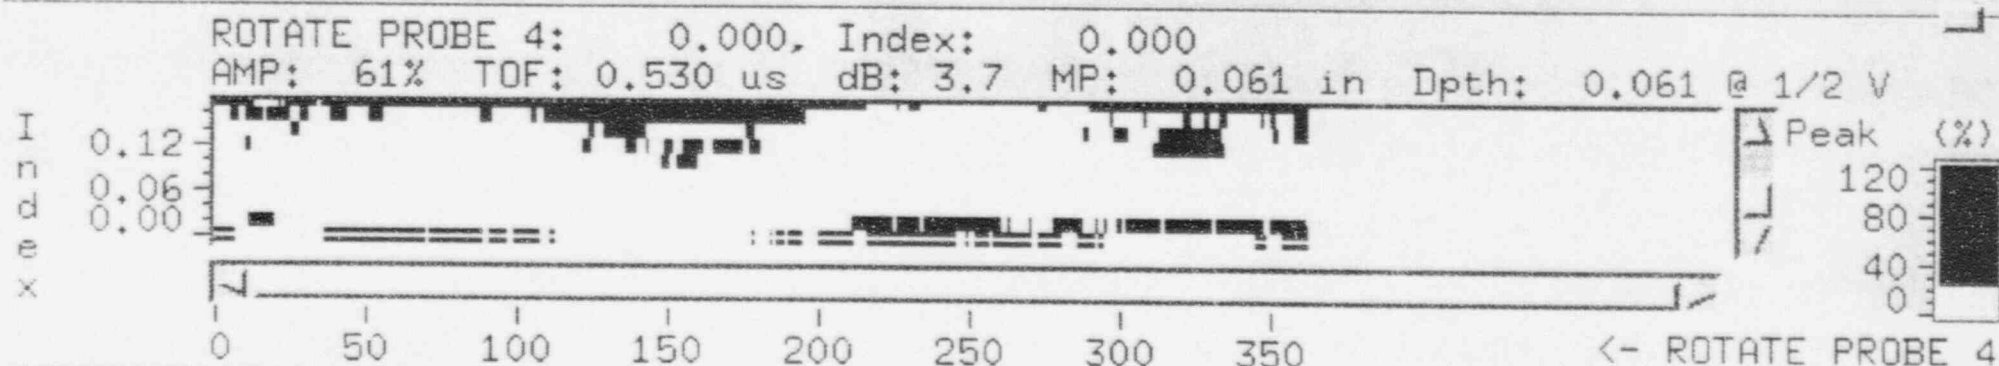
Leak tightness of the weld is determined from ultrasonic examination.

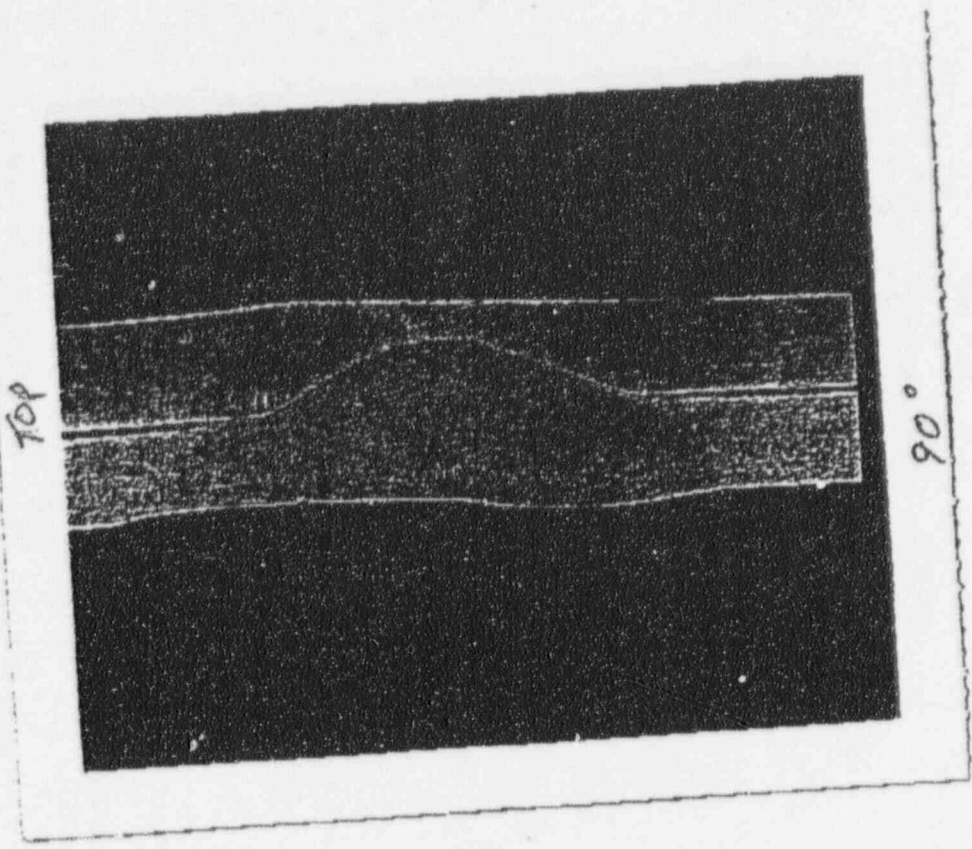
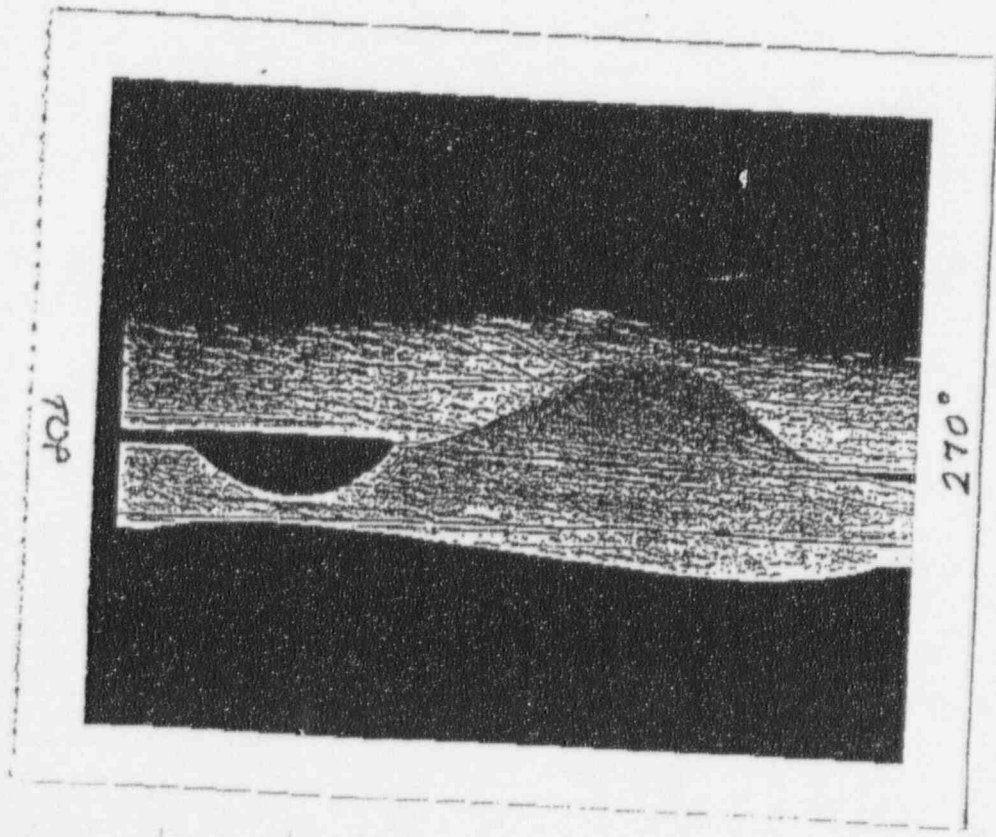
PREPRO SAMPLE 2B (PI 2A)

Pre-Production Sample 2A: Sample 2A had a sleeve weld indication by +Point™ and volumetric indication by 3 Coil RPC. Upon metallurgical examination, a void was found at the top of the upper edge of the weld extending upward away from the weld about 0.3" in circumferential extent.

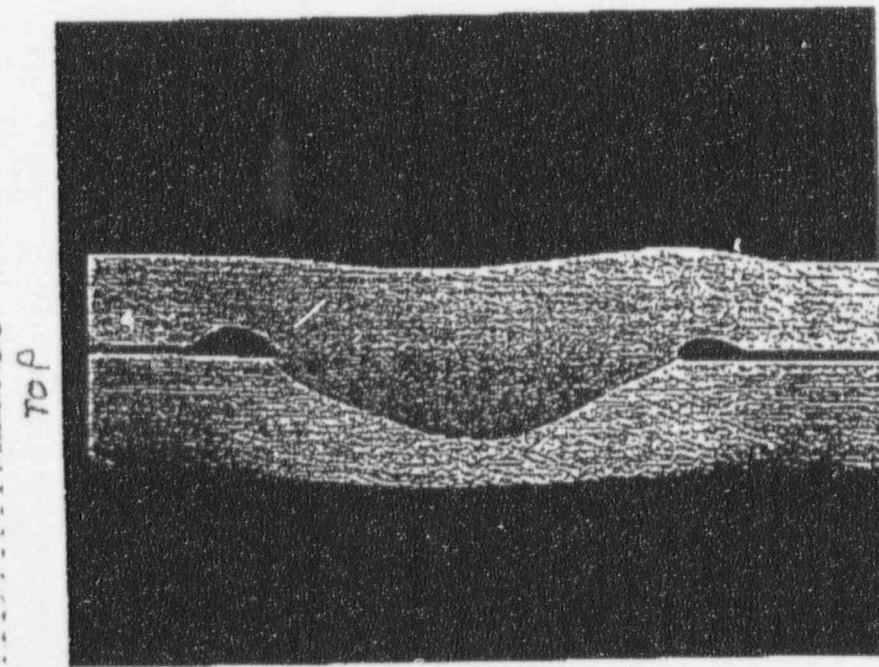
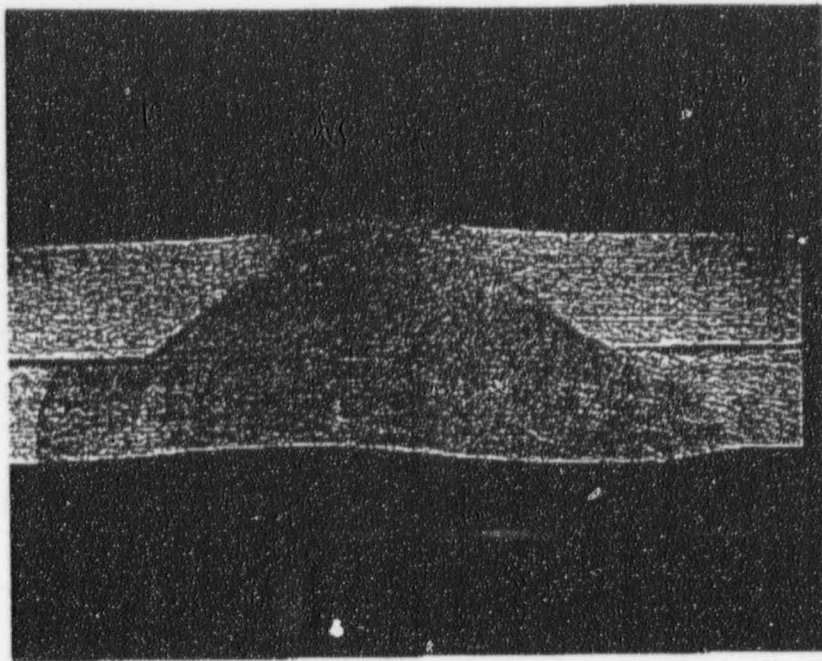
PREPRO SAMPLE 13B

Pre-Production Sample 13B: Sample 13B had a volumetric indication by +Point™ and 3 Coil RPC very similar to those found in 12 Steam Generator. Visual examination identified a blow hole at the location of the volumetric indication. Metallurgical examination identified a lower void at the bottom of the weld extending about 45 degrees in circumference.

Handwritten notes: "Handwritten notes" and "No loss in strength" are visible.
