LONG ISLAND LIGHTING COMPANY

(Shoreham Nuclear Power Station,
Unit 1)

SUFFOLK COUNTY'S EXHIBITS TO JOINT DIRECT TESTIMONY

DESIGN REVIEW OF TDI R-4 AND RV-4 SERIES
EMERGENCY DIESEL GENERATOR CYL. DER BLOCKS AND LINERS

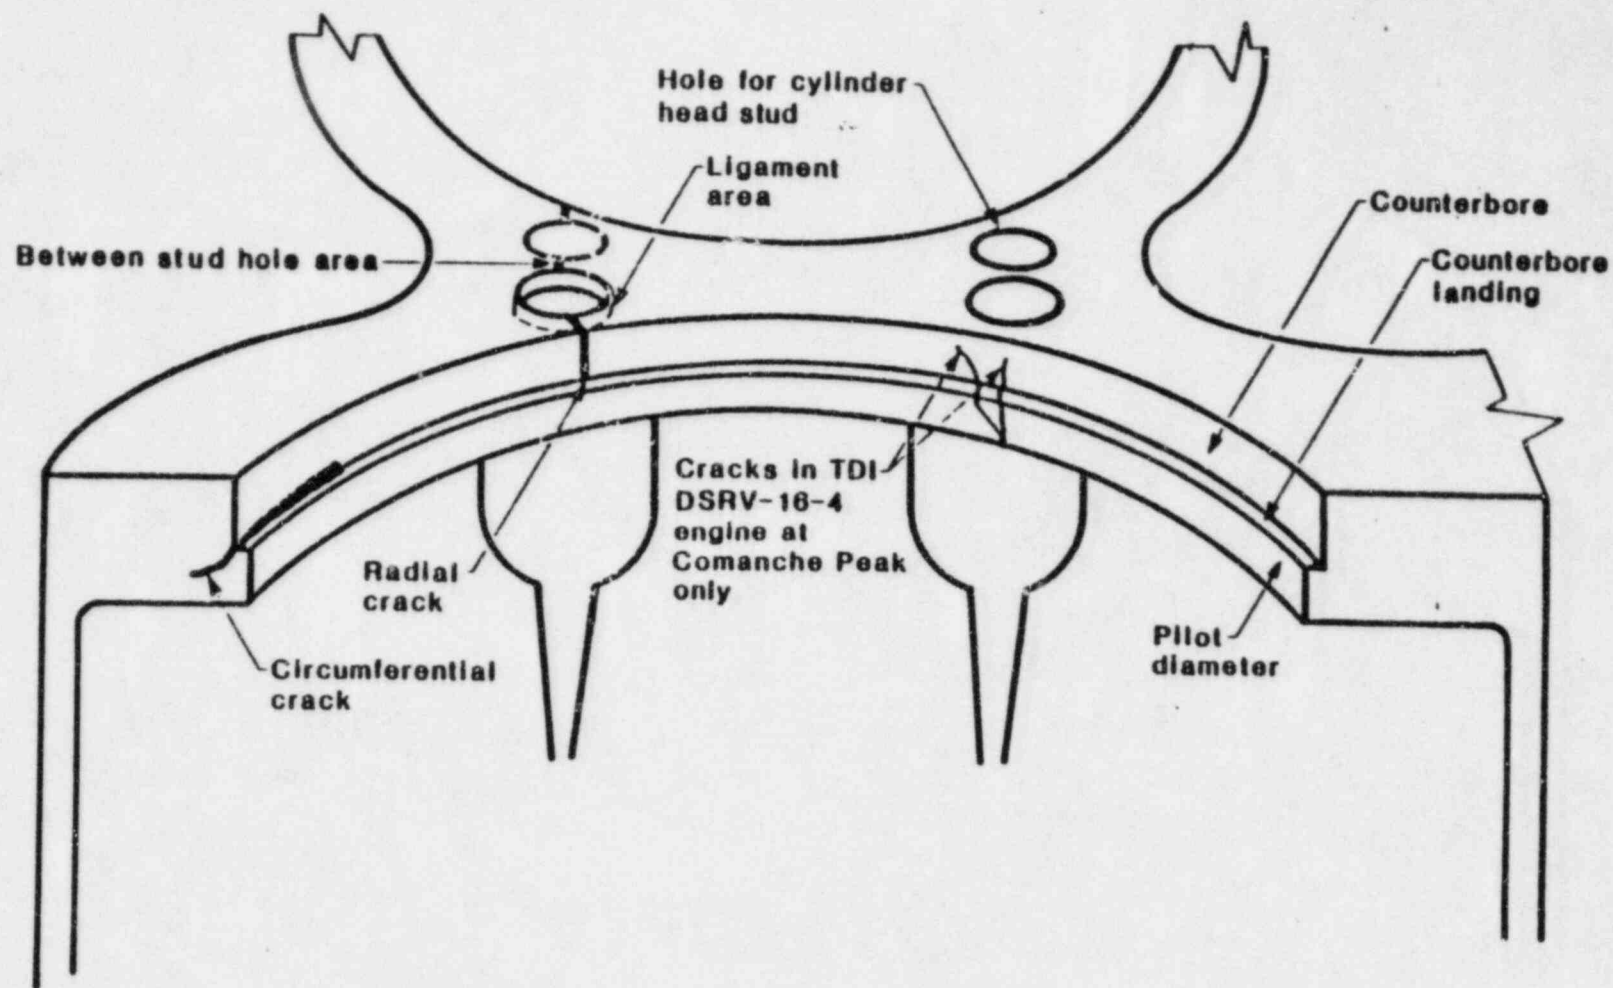
Figure 1-1. Location of cracks.

Two types of cracks have been found to occur in cylinder block tops of this design: cracks in the radial/vertical plane at the stud holes, and circumferential cracks in the liner counterbore at the liner landing ledge [1-1]. Figure 1-1 depicts the potential location of block top radial and circumferential cracks. In addition, for the in-line engines, cracks have occurred in the cam gallery above the cam shaft bearing supports. The survey of industry experience with TDI R-4 and RV-4 engines summarized in this section has not been independently confirmed by FaAA, and therefore is not subject to FaAA's usual quality assurance procedures.

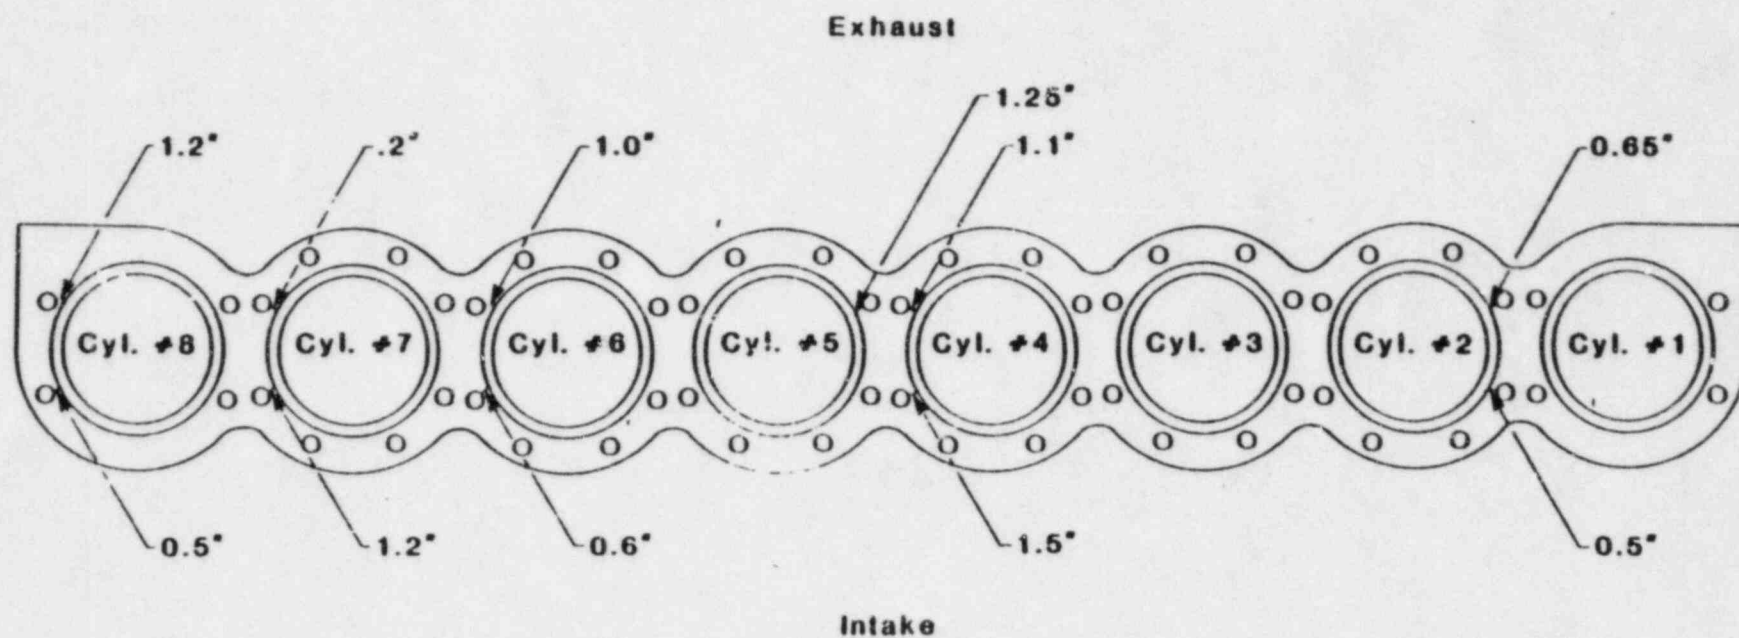
Figure 1-2. SNPS DG101 crack map.

As part of the engine requalification program after the crankshaft replacement, each engine was operated for 100 hours at or above full load and was then disassembled and inspected. During these inspections, radial/vertical cracks were discovered in the blocks of all three engines. Crack maps for DG101, DG102, and DG103 are presented in Figures 1-2, 1-3, and 1-4, respectively.

No circumferential cracks were found in any of the engines. However, each block had radial/vertical cracks between the cylinder bore and the stud hole. Sixty-seven percent of the ligament cracks were between 1 and 1 1/2 inches deep. A typical example of a cross-section of a radial/vertical crack through a ligament is shown in Figure 1-5. As depicted in the figure, none of the cracks extended below the corner formed by the counterbore and the counterbore landing. This demonstrates the apparent arrest of radial/vertical cracks that occur in the ligament region. In addition, when first inspected, the engine block from DG103 had a crack that extended between two adjacent studs on the exhaust side of Cylinder Nos. 4 and 5 as shown in Figure 1-6.

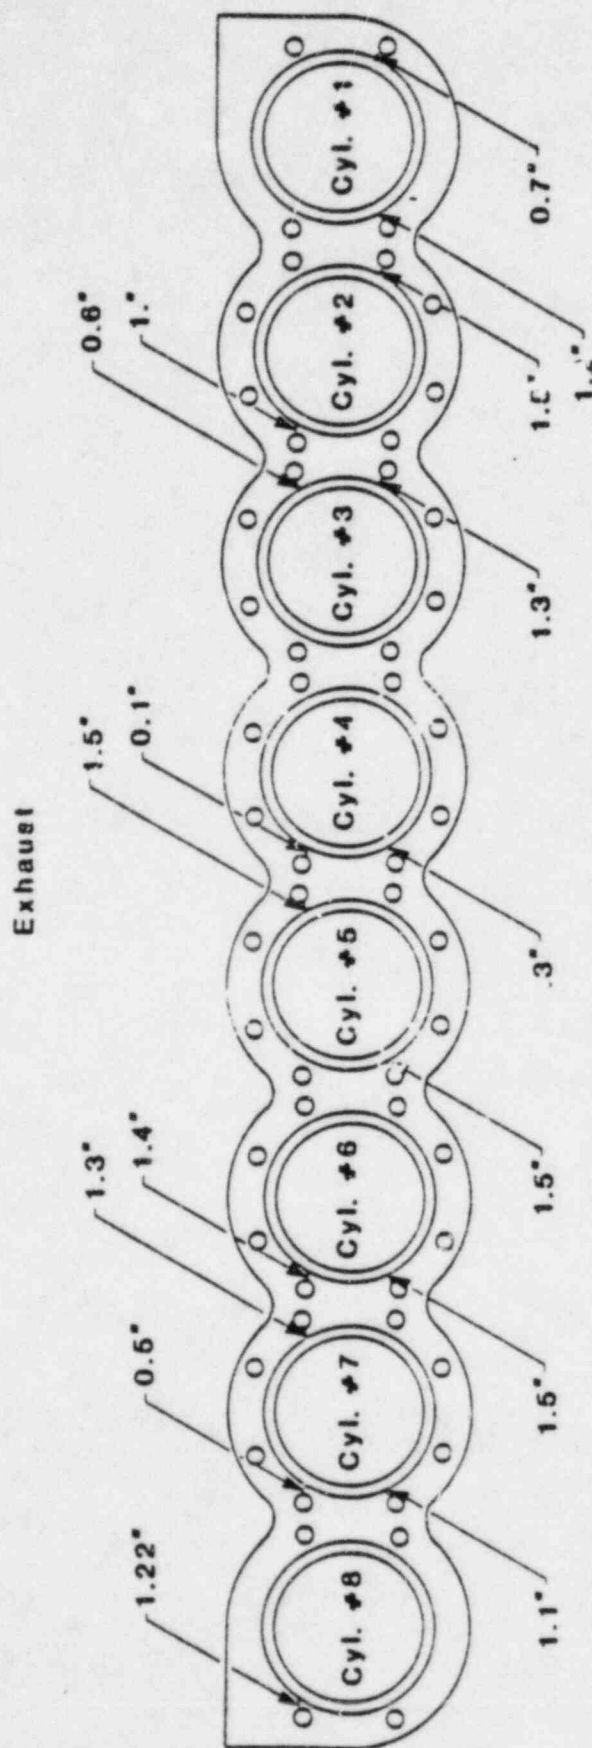
Figure 1-3. SNPS DG102 crack map.

After inspection, DG102 was operated through 100 starts to loads greater than 50% and was then reinspected. Review of inspection reports before and after the 100 starts showed no crack extension discernable by eddy current examination of the stud holes and liner counter bores.

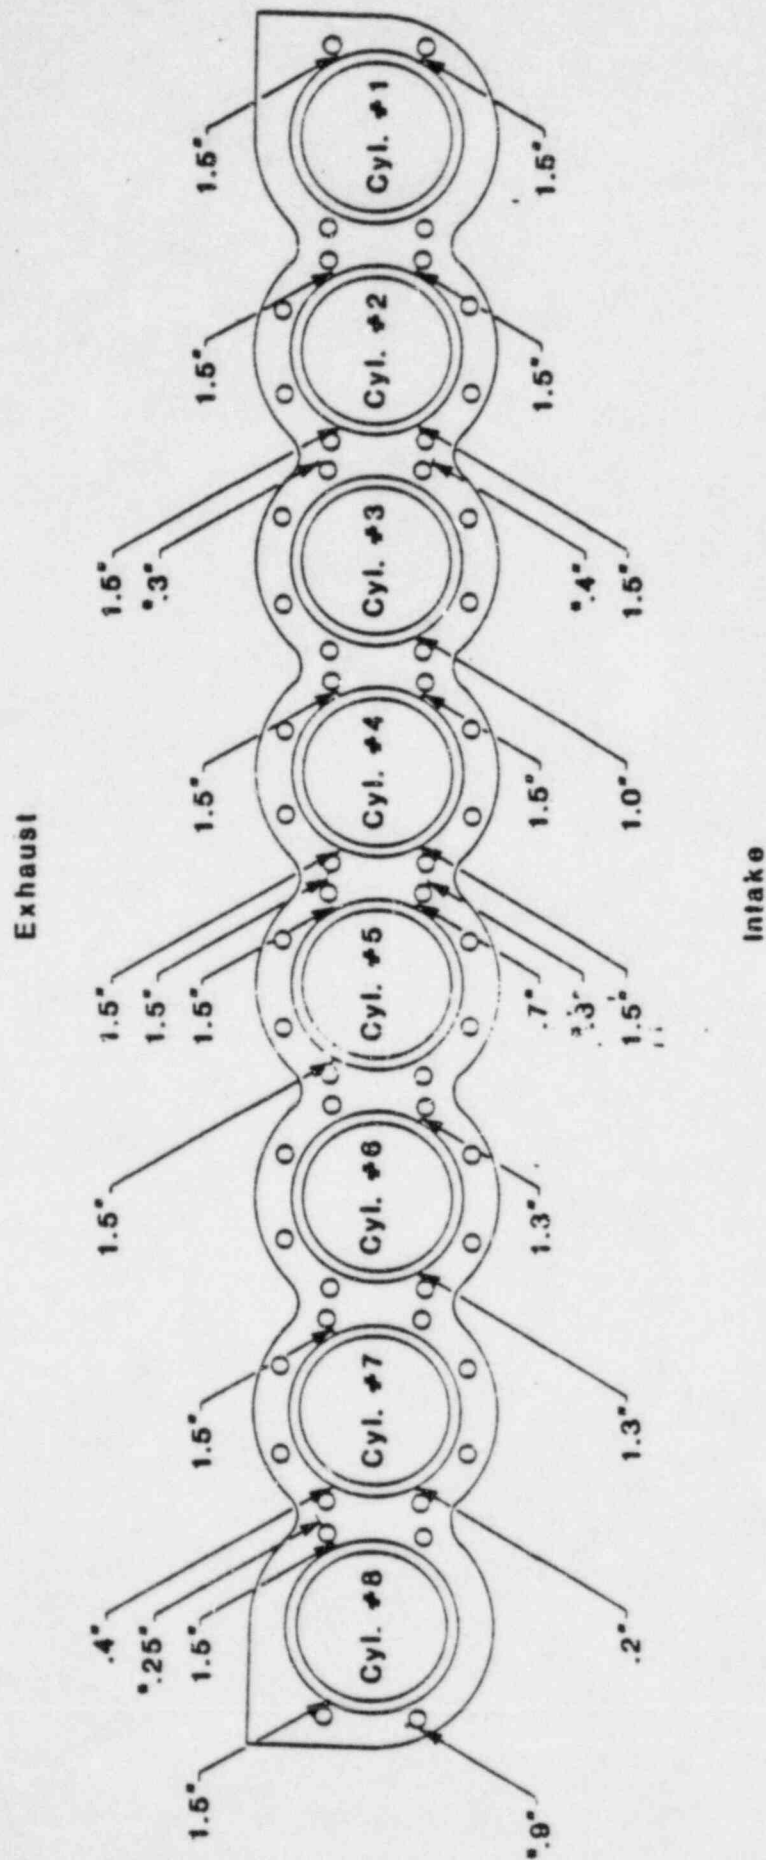
Figure 1-4. SNPS DG103 crack map as of 3/11/84.

Cracking between stud holes of adjacent cylinders has been observed infrequently, but is potentially more serious than ligament cracking. This cracking has been observed in SNPS engine DG103 to a depth of 5 1/2 inches. No adverse consequences to engine operation were experienced. Cracking between stud holes is conservatively predicted by Goodman diagram fatigue analysis, assuming a ligament to be cracked, either in LCF or HFF.

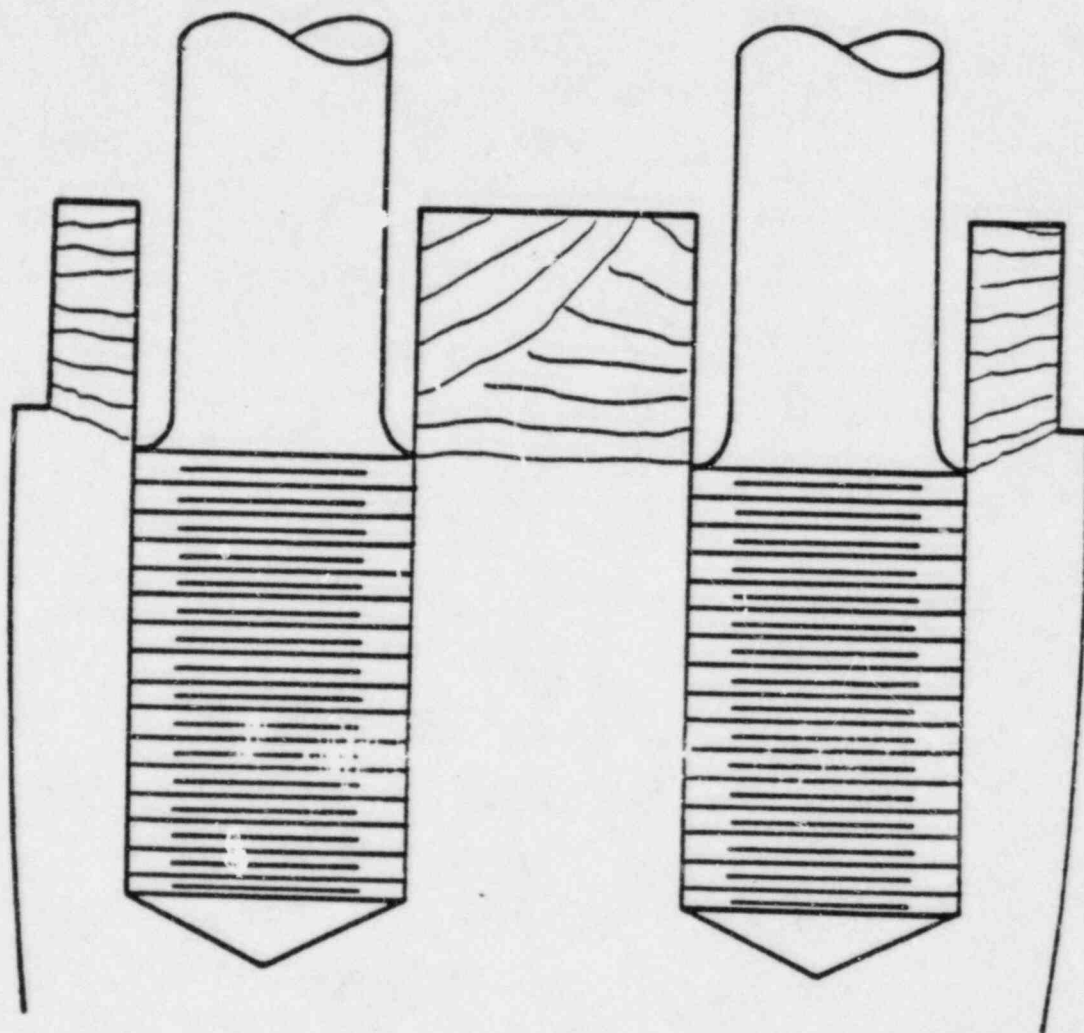
Figure 1-6. Longitudinal section between adjacent cylinders for
SNPS DG103.

Inspection of the block top revealed cracks between stud holes with depth of 1 1/2 inches similar to those shown in Figure 1-6 at three locations. At four other locations, between-stud cracks developed along the top surface which did not extend to measureable depths down the sides of the stud hole. At one location a crack that previously extended 0.8 inch radially from one stud hole towards the adjacent stud hole grew to a maximum depth of 3.9 inches. In addition, the original crack between Cylinder Nos. 4 and 5 had ex-

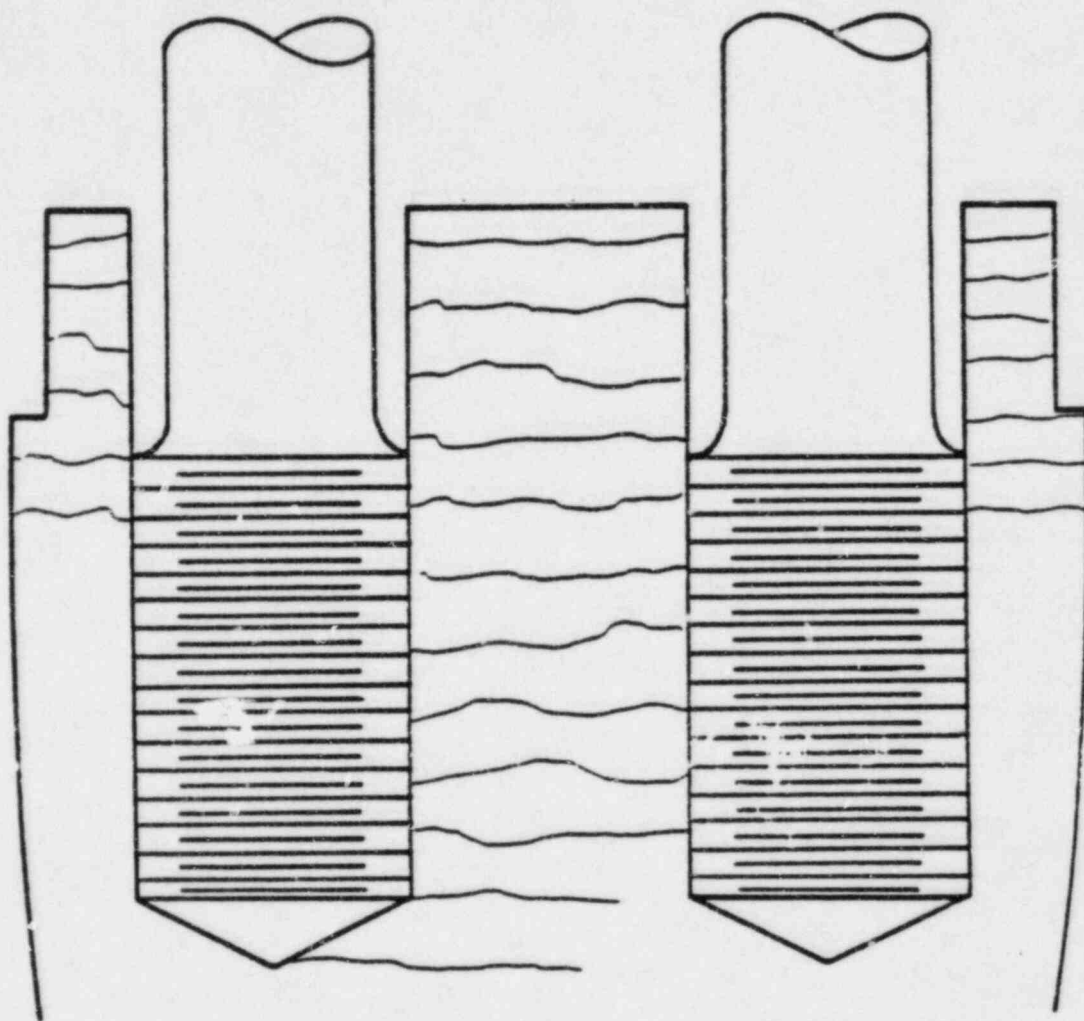
Figure 1-7. Longitudinal section between Cylinders 4 and 5 on exhaust side of SNPS DG103.

tended to a depth of at least 5 1/2 inches. As shown in Figure 1-7, the ligament cracks had also grown approximately 1 inch. Figure 1-8 is a crack map for DG103 as reinspected.

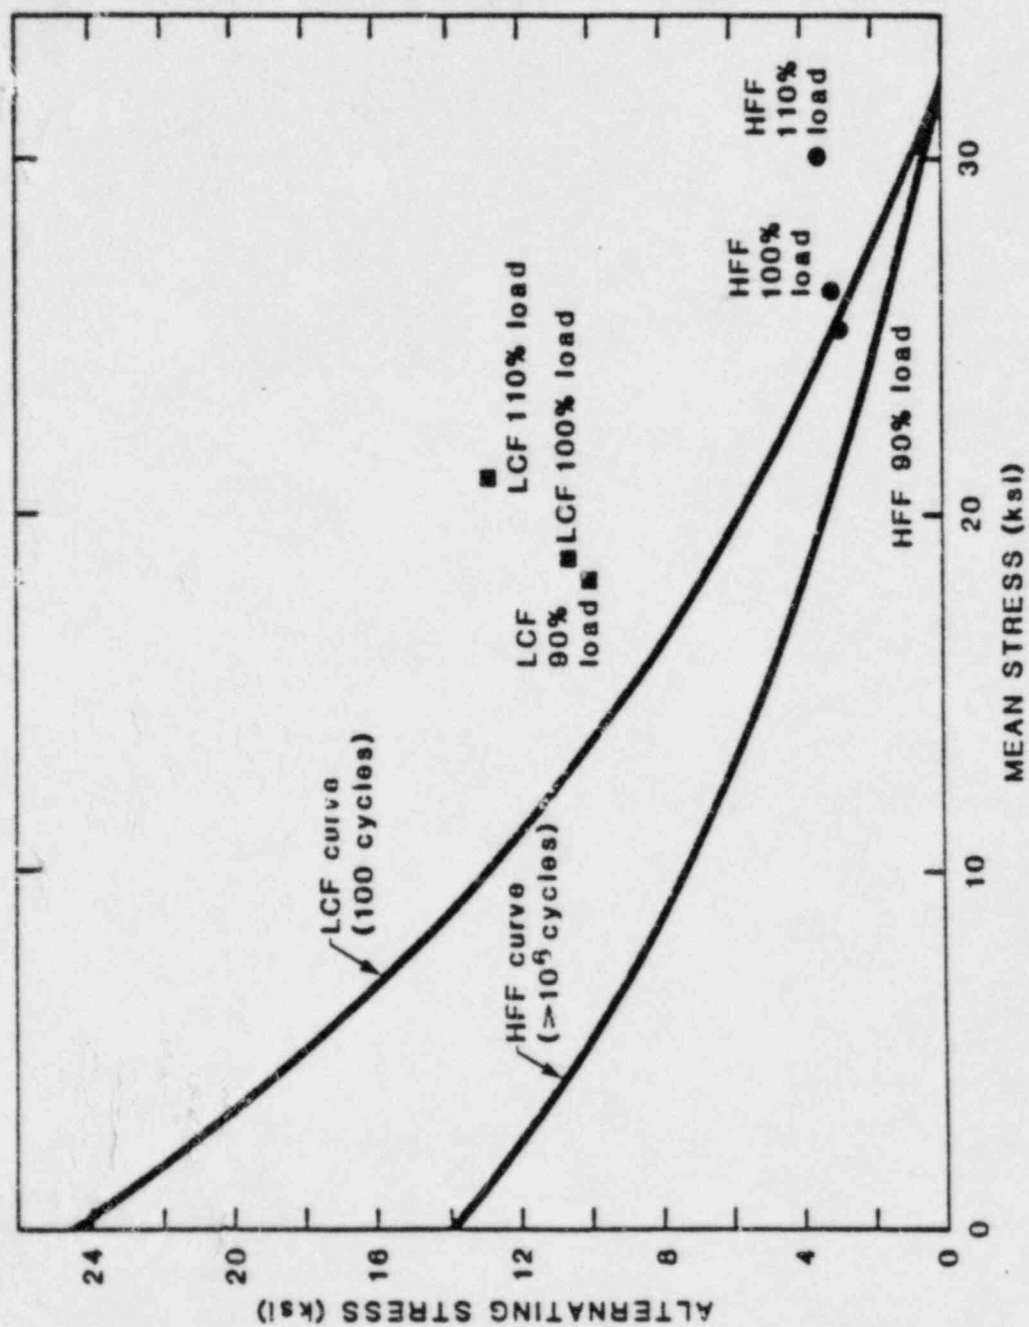
Figure 3-13. Goodman (Smith) diagram for ligament cracking.

The results are shown in modified Goodman (Smith) diagrams: Figure 3-13 for ligament cracking and Figure 3-14 for stud-to-stud cracking given cracked ligaments. The curves are derived from the minimum ultimate tensile strength in thick sections, the minimum specified endurance limit ($>10^6$ cycles), and the stress for failure in 100 cycles (from the lowest curve in Figure 1-16). In both cracking locations, the stress state is outside the Goodman (Smith) curve for either HFF or LCF and for any load level of 90% or higher. The implication is that initiation of ligament cracks in minimum strength material

is predicted, and given a ligament crack, initiation of stud-to-stud cracks is also predicted. Initiation could occur in less than 100 load excursions from 0 to 90% power or above and/or steady running for more than 10^6 cycles (about 100 hours) at 90% power or above if the minimum material properties are assumed. At 110% load, overload failure could occur in both locations with minimum strength material since the peak total stress is 33 ksi compared to 32 ksi minimum thick-section ultimate strength. The fact that few blocks that have run at 110% load have cracks at both locations is indicative of higher-than-minimum material properties and/or conservatism in the analysis.

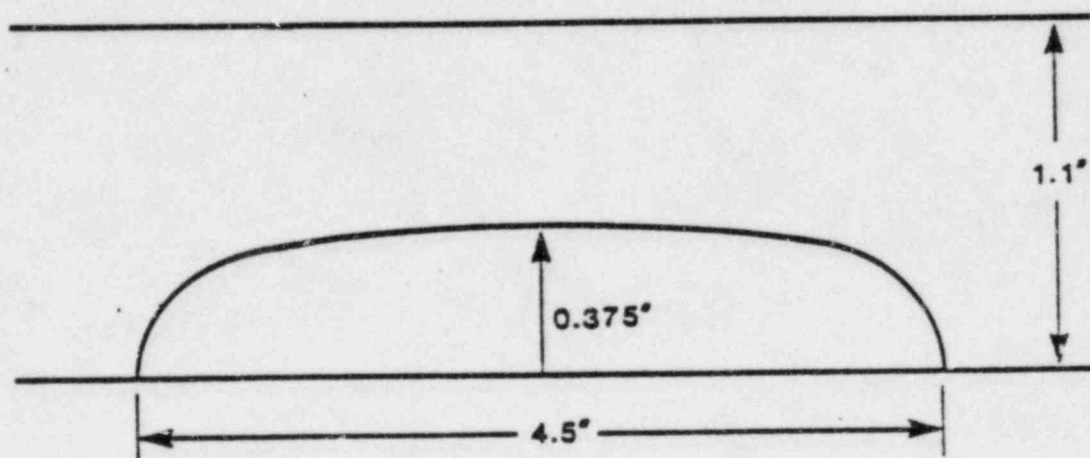
Figure 4-2. Cam gallery crack shape.

An inspection of the emergency diesel generators at Shoreham revealed crack indications in the cam galleries of all three SNPS engines. These indications were of varying lengths, the longest being 4 1/2 inches long and 0.375 inch deep in DG103. A typical cross-section of the cam gallery is displayed in Figure 4-2, indicating the crack region.
