LONG ISLAND LIGHTING COMPANY

(Shoreham Nuclear Power Plant,
Unit 1).

SUFFOLK COUNTY'S EXHIBITS TO JOINT DIRECT TESTIMONY

DESIGN REVIEW OF TDI R-4 AND RV-4 SERIES
EMERGENCY DIESEL GENERATOR CYLINDER BLOCKS AND LINERS

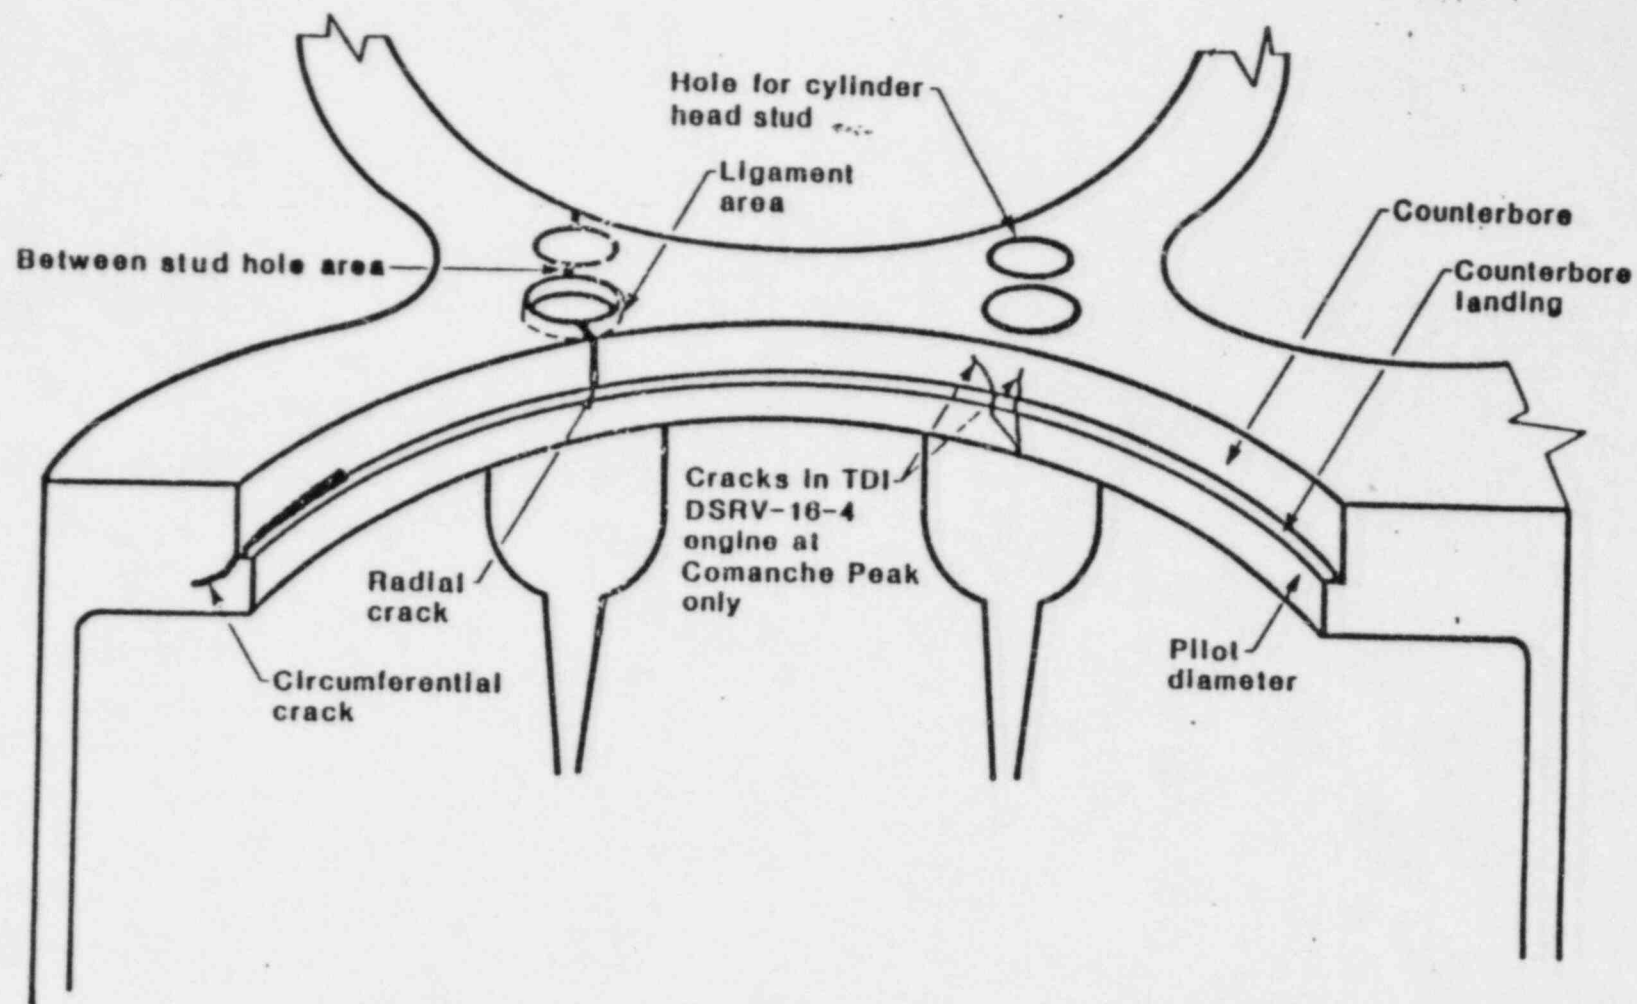
Figure 1-1. Location of cracks.

Two types of cracks have been found to occur in cylinder block tops of this design: cracks in the radial/vertical plane at the stud holes, and circumferential cracks in the liner counterbore at the liner landing ledge [1-1]. Figure 1-1 depicts the potential location of block top radial and circumferential cracks. In addition, for the in-line engines, cracks have occurred in the cam gallery above the cam shaft bearing supports. The survey of industry experience with TDI R-4 and RV-4 engines summarized in this section has not been independently confirmed by FaAA, and therefore is not subject to FaAA's usual quality assurance procedures.

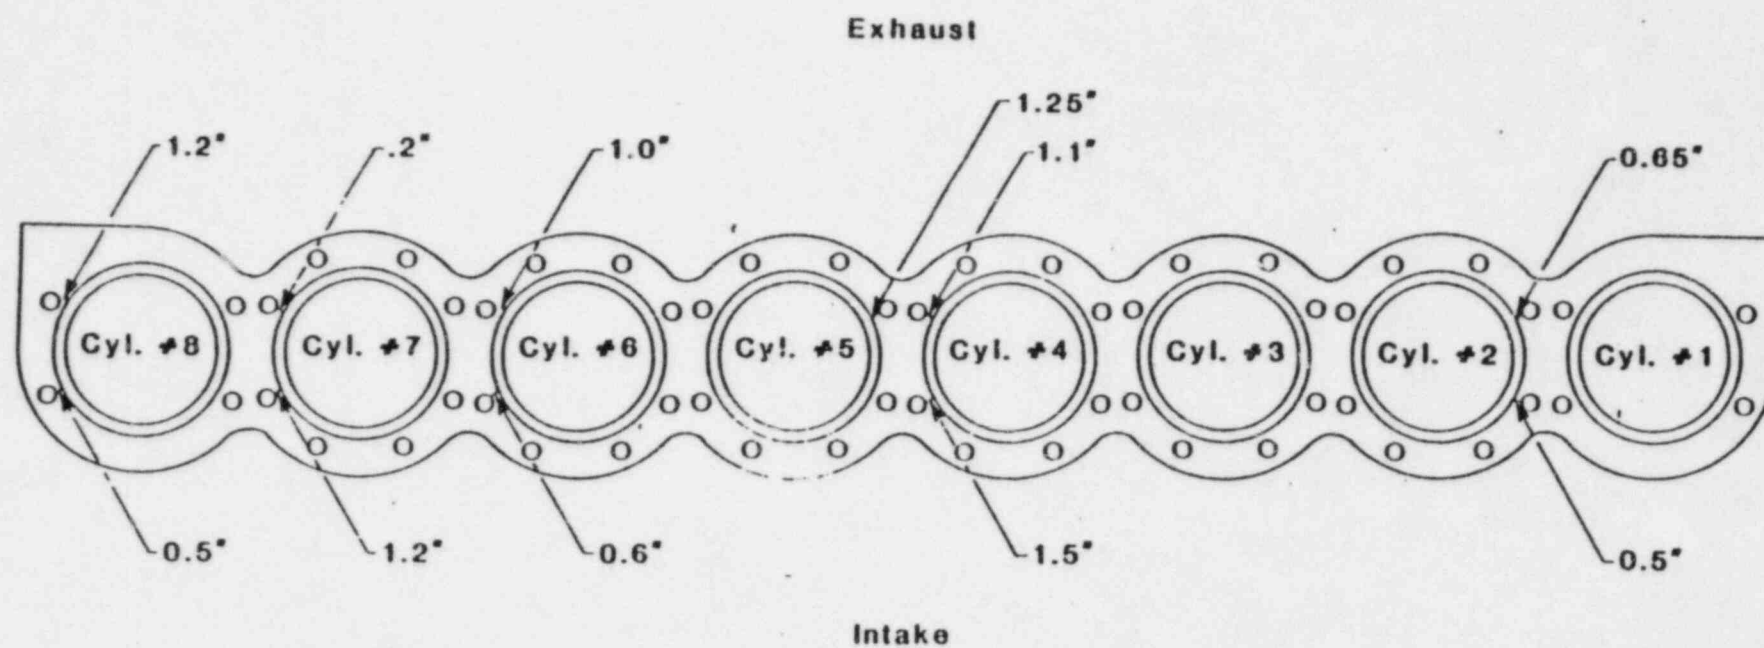
Figure 1-2. SNPS DG101 crack map.

As part of the engine requalification program after the crankshaft replacement, each engine was operated for 100 hours at or above full load and was then disassembled and inspected. During these inspections, radial/vertical cracks were discovered in the blocks of all three engines. Crack maps for DG101, DG102, and DG103 are presented in Figures 1-2, 1-3, and 1-4, respectively.

No circumferential cracks were found in any of the engines. However, each block had radial/vertical cracks between the cylinder bore and the stud hole. Sixty-seven percent of the ligament cracks were between 1 and 1 1/2 inches deep. A typical example of a cross-section of a radial/vertical crack through a ligament is shown in Figure 1-5. As depicted in the figure, none of the cracks extended below the corner formed by the counterbore and the counterbore landing. This demonstrates the apparent arrest of radial/vertical cracks that occur in the ligament region. In addition, when first inspected, the engine block from DG103 had a crack that extended between two adjacent studs on the exhaust side of Cylinder Nos. 4 and 5 as shown in Figure 1-6.

Dimensions indicate crack depth

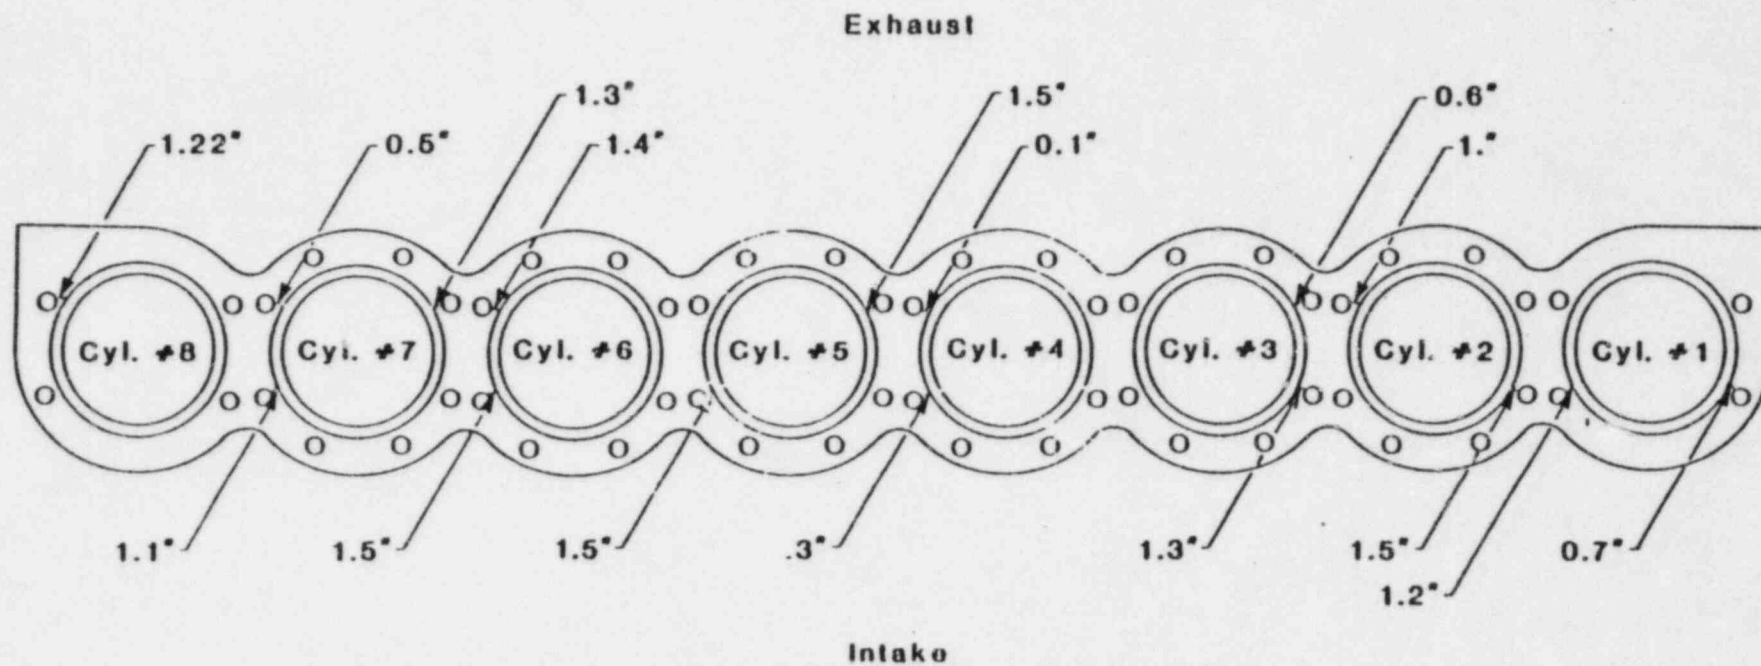
Figure 1-3. SNPS DG102 crack map.

After inspection, DG102 was operated through 100 starts to loads greater than 50% and was then reinspected. Review of inspection reports before and after the 100 starts showed no crack extension discernable by eddy current examination of the stud holes and liner counter bores.

Dimensions indicate crack depth

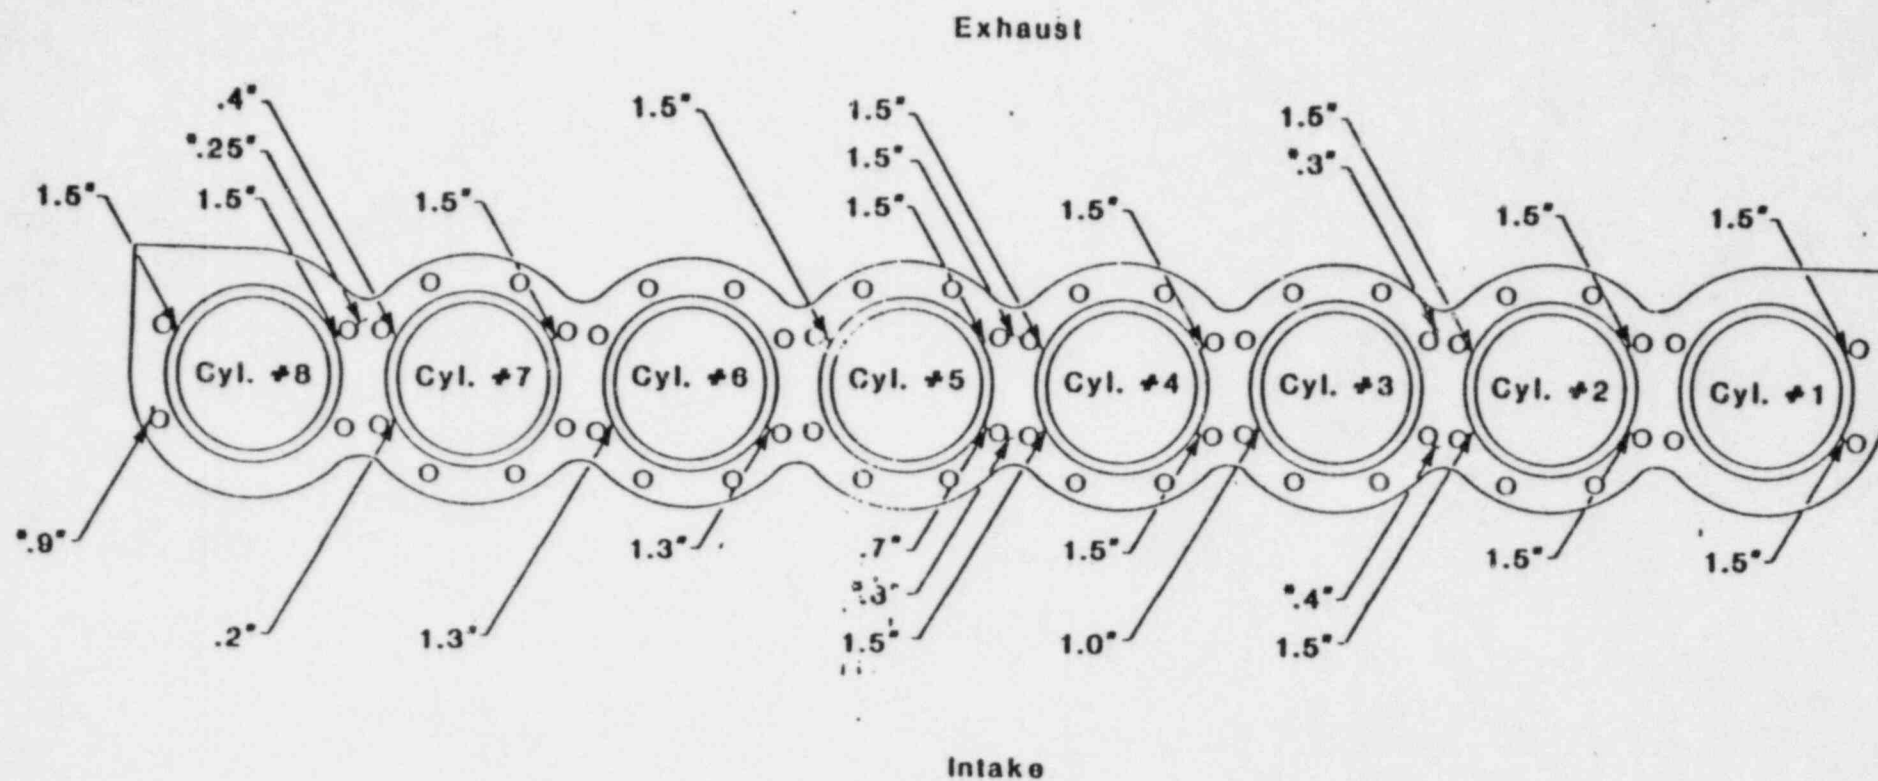
Figure 1-4. SNPS DG103 crack map as of 3/11/84.

Dimensions indicate crack depth

*Top surface indication. Depth not measured

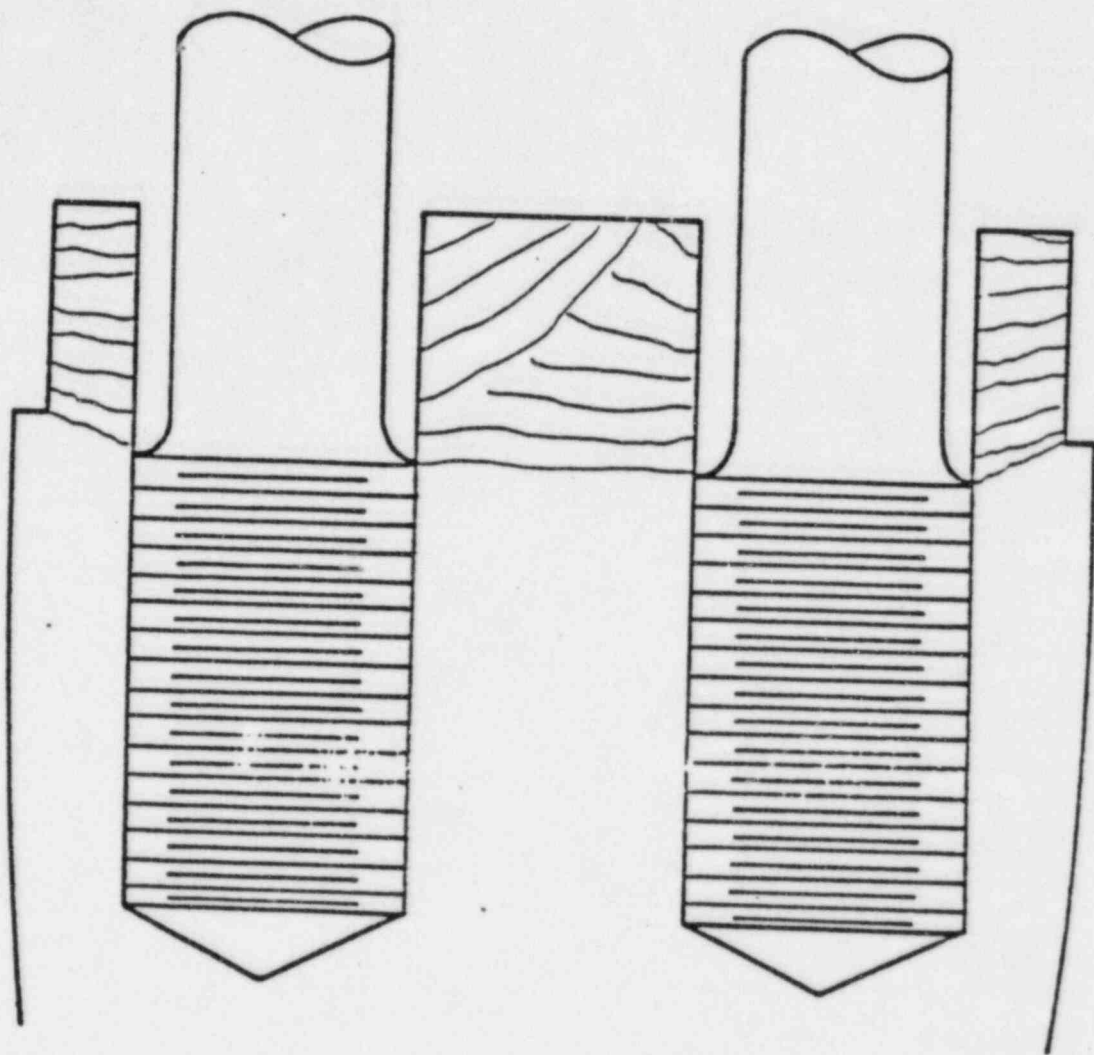
Figure 1-6. Longitudinal section between adjacent cylinders for SNPS DG103.

Inspection of the block top revealed cracks between stud holes with depth of 1 1/2 inches similar to those shown in Figure 1-6 at three locations. At four other locations, between-stud cracks developed along the top surface which did not extend to measureable depths down the sides of the stud hole. At one location a crack that previously extended 0.8 inch radially from one stud hole towards the adjacent stud hole grew to a maximum depth of 3.9 inches. In addition, the original crack between Cylinder Nos. 4 and 5 had ex-

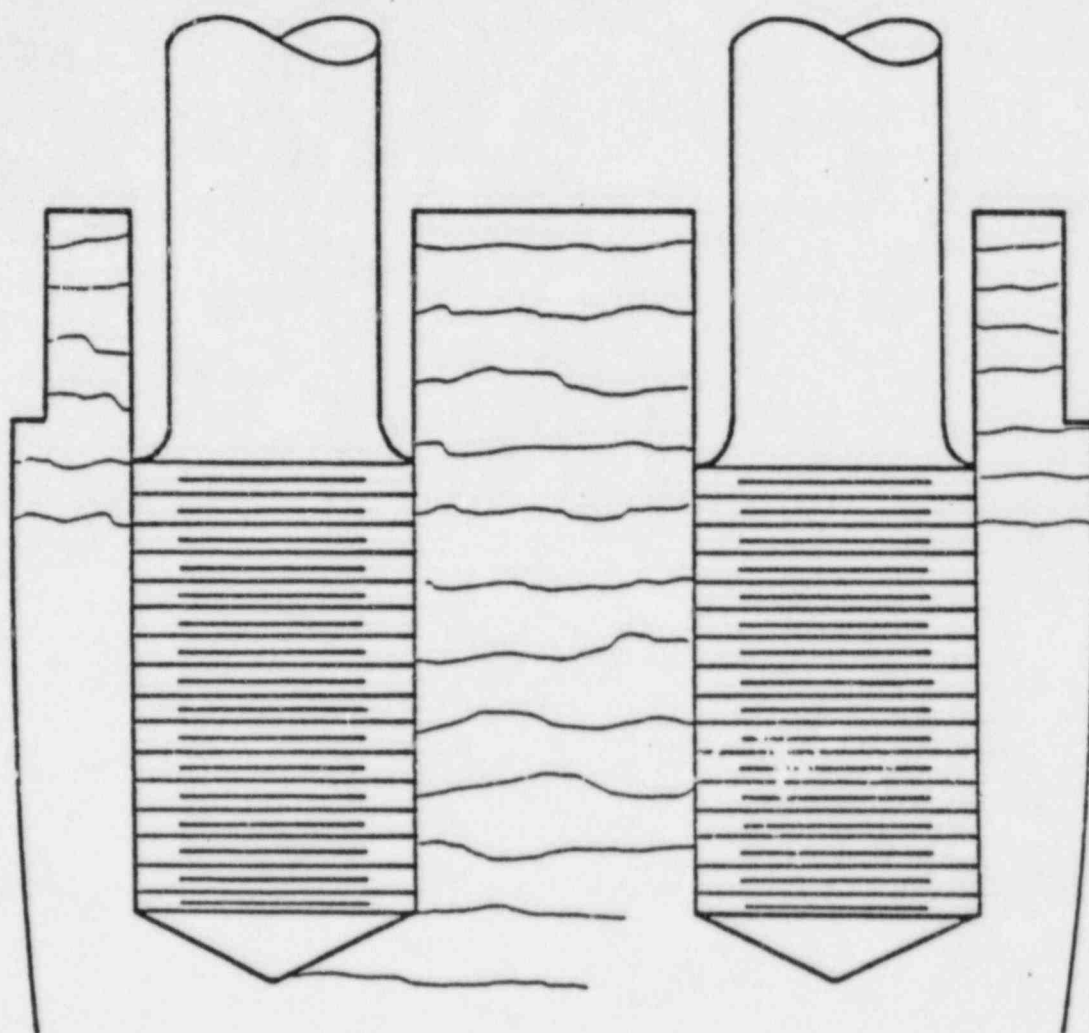
Figure 1-7. Longitudinal section between Cylinders 4 and 5 on exhaust side of SNPS DG103.

tended to a depth of at least 5 1/2 inches. As shown in Figure 1-7, the ligament cracks had also grown approximately 1 inch. Figure 1-8 is a crack map for DG103 as reinspected.

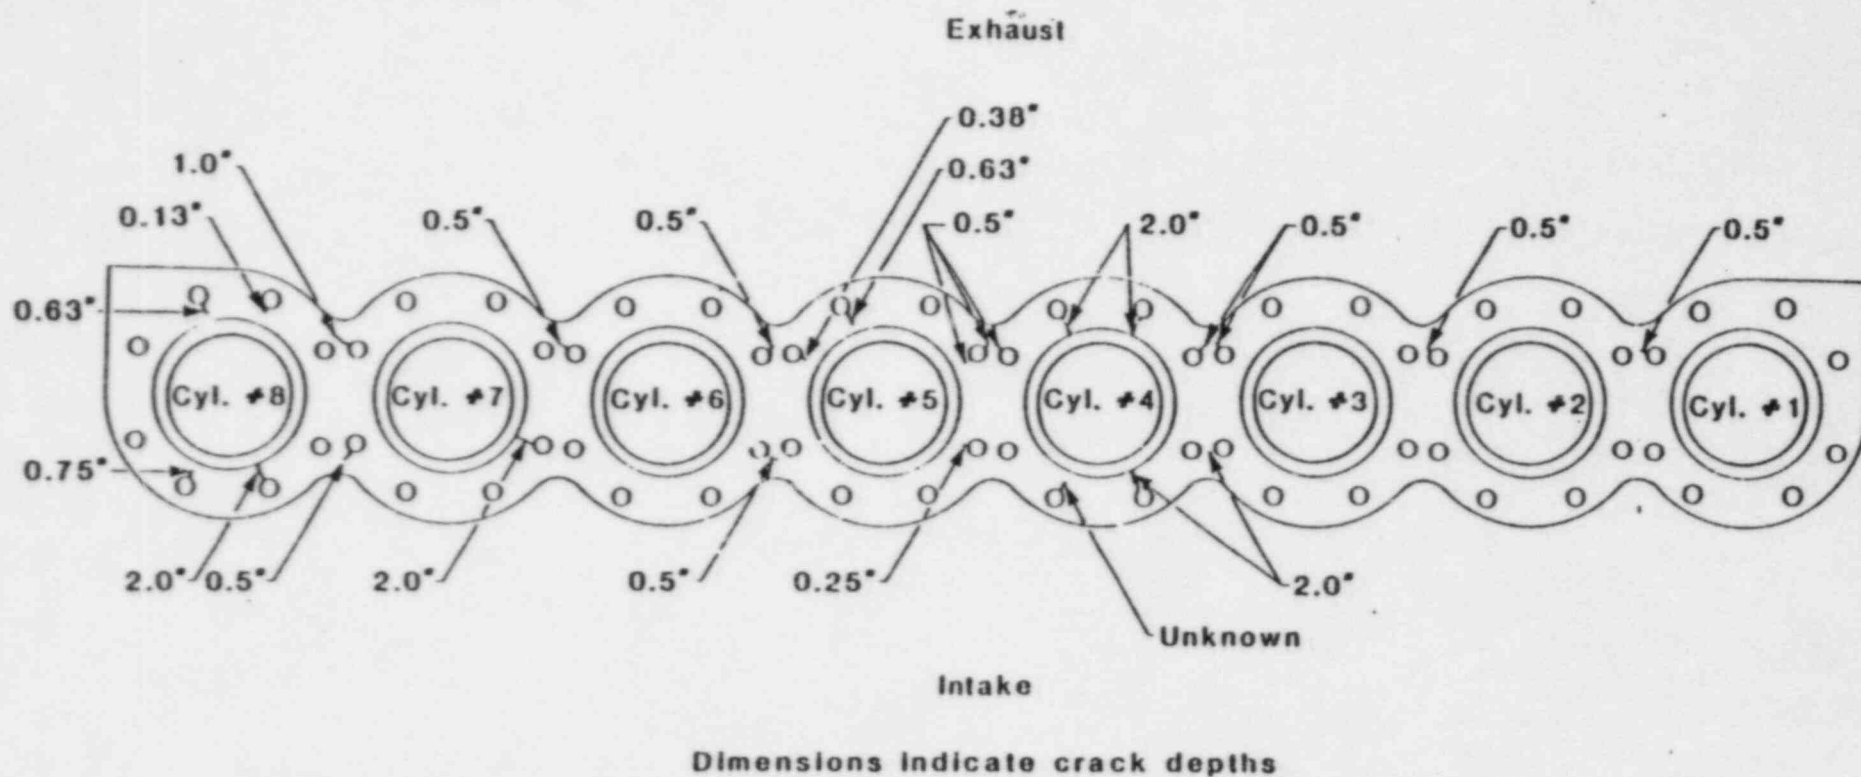
A block from a dual-fuel V-16 engine (the St. Cloud block at TDI in Oakland) shows extensive radial and circumferential cracks. Several radial cracks appear between stud holes without ligament cracks. The cracks are shown in Figures 1-9 and 1-10, but depths are not available. The detailed operating history of this block is unknown, but it had over 16,000 hours in municipal power service with fuels of varying heat content. Detonation of the gaseous fuel mixture is believed to have occurred in service, causing increases in cylinder pressure on the order of a factor of two.

Figure 1-9. Engine crack map. Plan view of St. Cloud block top.

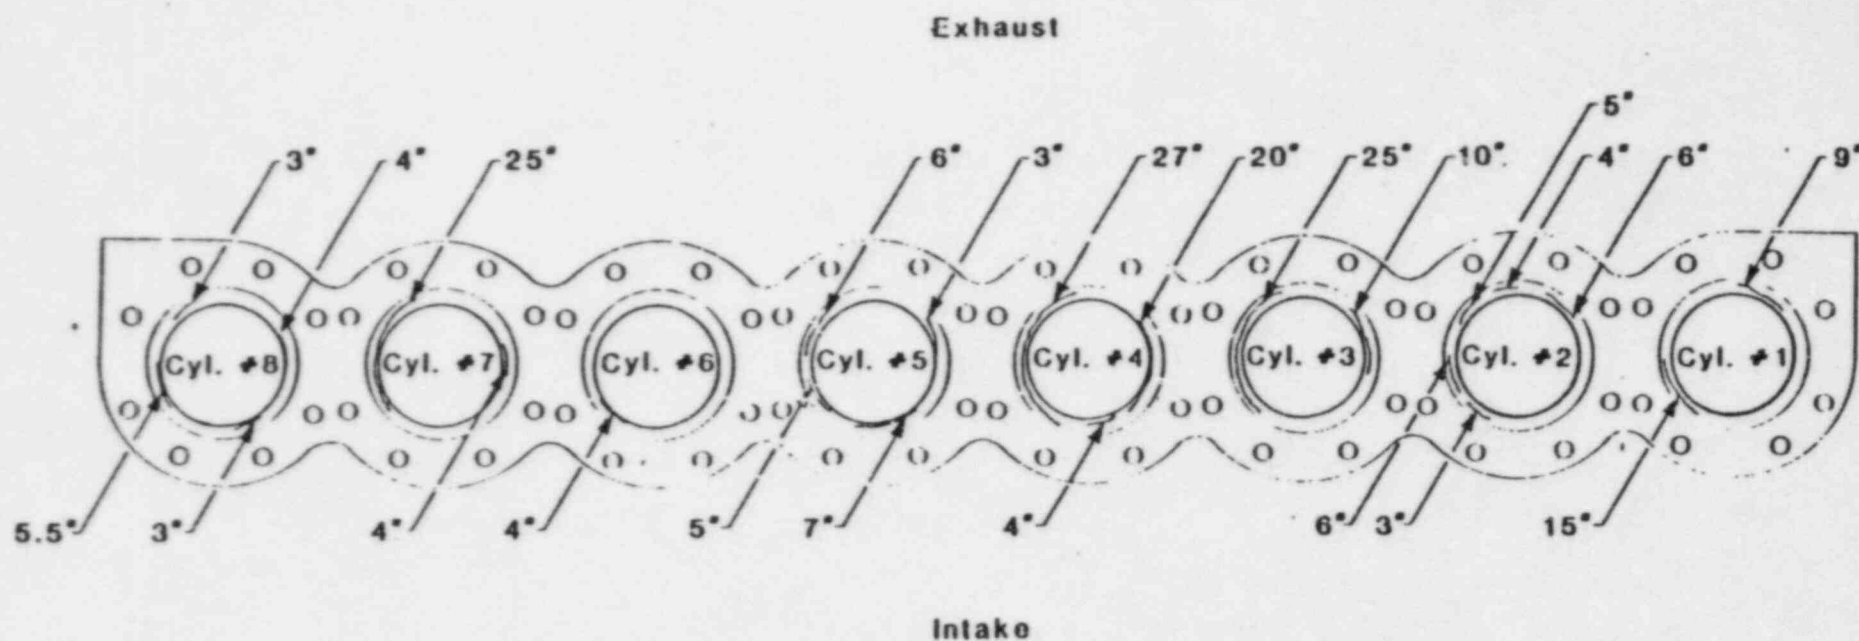
Figure 1-10. Engine crack map. Plan view of St. Cloud block top. Circumferential cracks in liner landing.

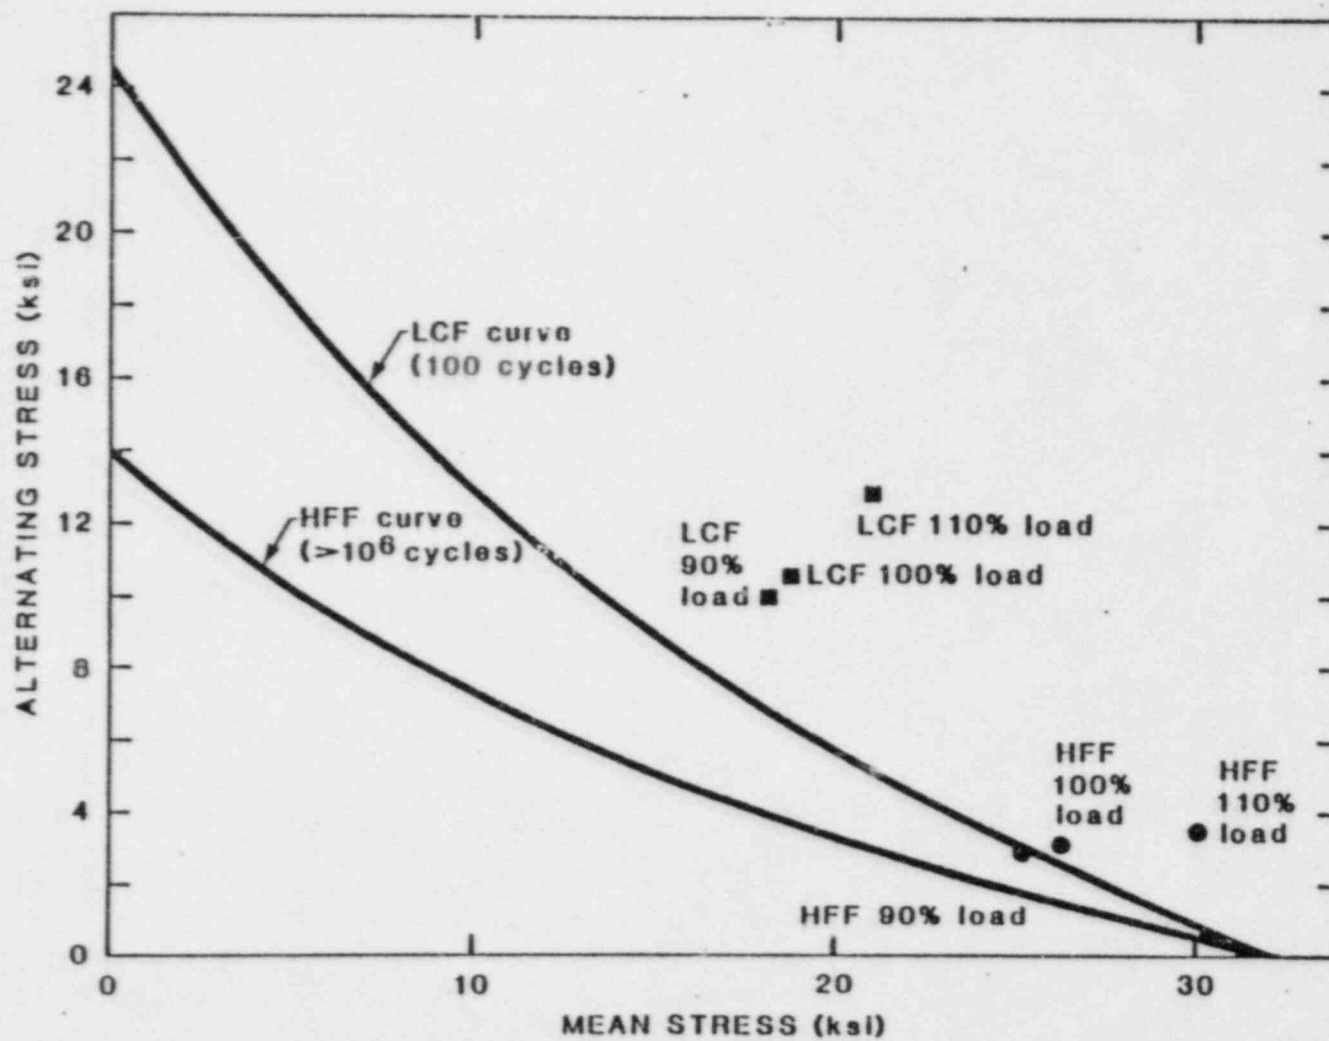
Figure 3-13. Goodman (Smith) diagram for ligament cracking.

The results are shown in modified Goodman (Smith) diagrams: Figure 3-13 for ligament cracking and Figure 3-14 for stud-to-stud cracking given cracked ligaments. The curves are derived from the minimum ultimate tensile strength in thick sections, the minimum specified endurance limit ($>10^6$ cycles), and the stress for failure in 100 cycles (from the lowest curve in Figure 1-16). In both cracking locations, the stress state is outside the Goodman (Smith) curve for either HFF or LCF and for any load level of 90% or higher. The implication is that initiation of ligament cracks in minimum strength material

is predicted, and given a ligament crack, initiation of stud-to-stud cracks is also predicted. Initiation could occur in less than 100 load excursions from 0 to 90% power or above and/or steady running for more than 10^6 cycles (about 100 hours) at 90% power or above if the minimum material properties are assumed. At 110% load, overload failure could occur in both locations with minimum strength material since the peak total stress is 33 ksi compared to 32 ksi minimum thick-section ultimate strength. The fact that few blocks that have run at 110% load have cracks at both locations is indicative of higher-than-minimum material properties and/or conservatism in the analysis.
