LICENSEE EVENT REPORT (LER)

FACILITY NAME (1)
McGuire Nuclear Station, Unit 1DOCKET NUMBER (2)
0 5 0 0 0 3 6 9 1 OF 0 8TITLE (4)
Upper Head Injection Accumulator Instruments Installed Incorrectly

Subject: McGuire Nuclear Station, Unit 1
Docket No. 50-369
LER 369/84-30

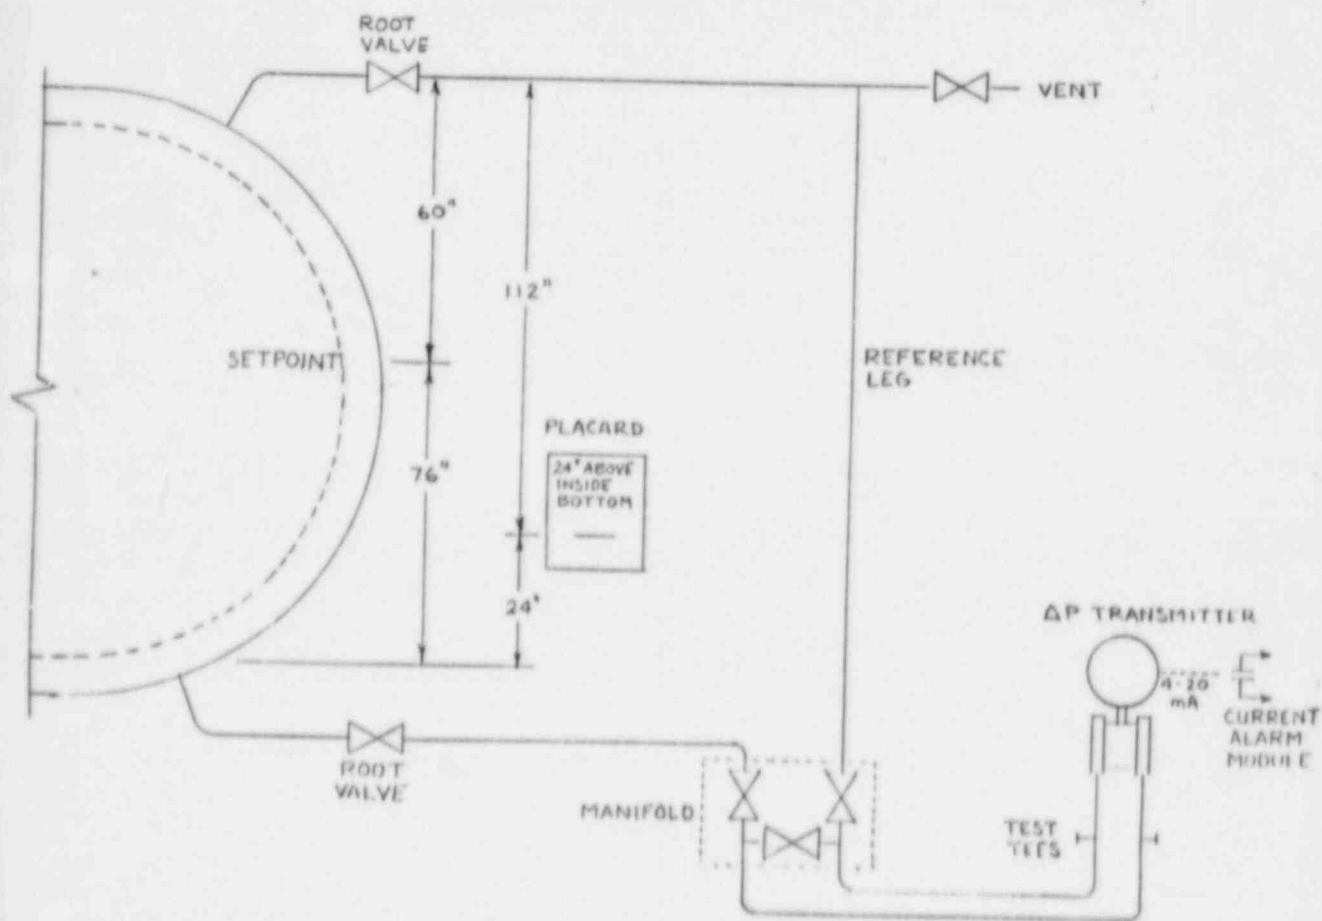
ENCLOSURE 1.0

The UHI accumulator level system is shown in Enclosure 1.0. The Rosemount level transmitter is connected to the UHI tank with a water filled reference leg on the High Pressure (HP) port and a variable tank level signal on the Low Pressure (LP) port. In this application, the level transmitters are connected as "direct acting" response instruments. Direct acting response means that as the differential pressure increases, the transmitter output (milliamps) will also increase. In normal operation, as the tank level decreases, the transmitter output should increase from 4 milliamps (ma) (tank full) to 20 ma (tank empty).

On November 1, 1984, IAE personnel discovered that the instrument impulse lines to the HP and LP ports were crossed on all four level transmitters. This error had been made in March 1984 when the original Barton level switches were replaced with the Rosemount level transmitter systems.
