LICENSEE EVENT REPORT (LER)

WOLF CREEK GENERATING STATION

Loss of A Train Essential Service Water Due to Icing on the Trash Racks

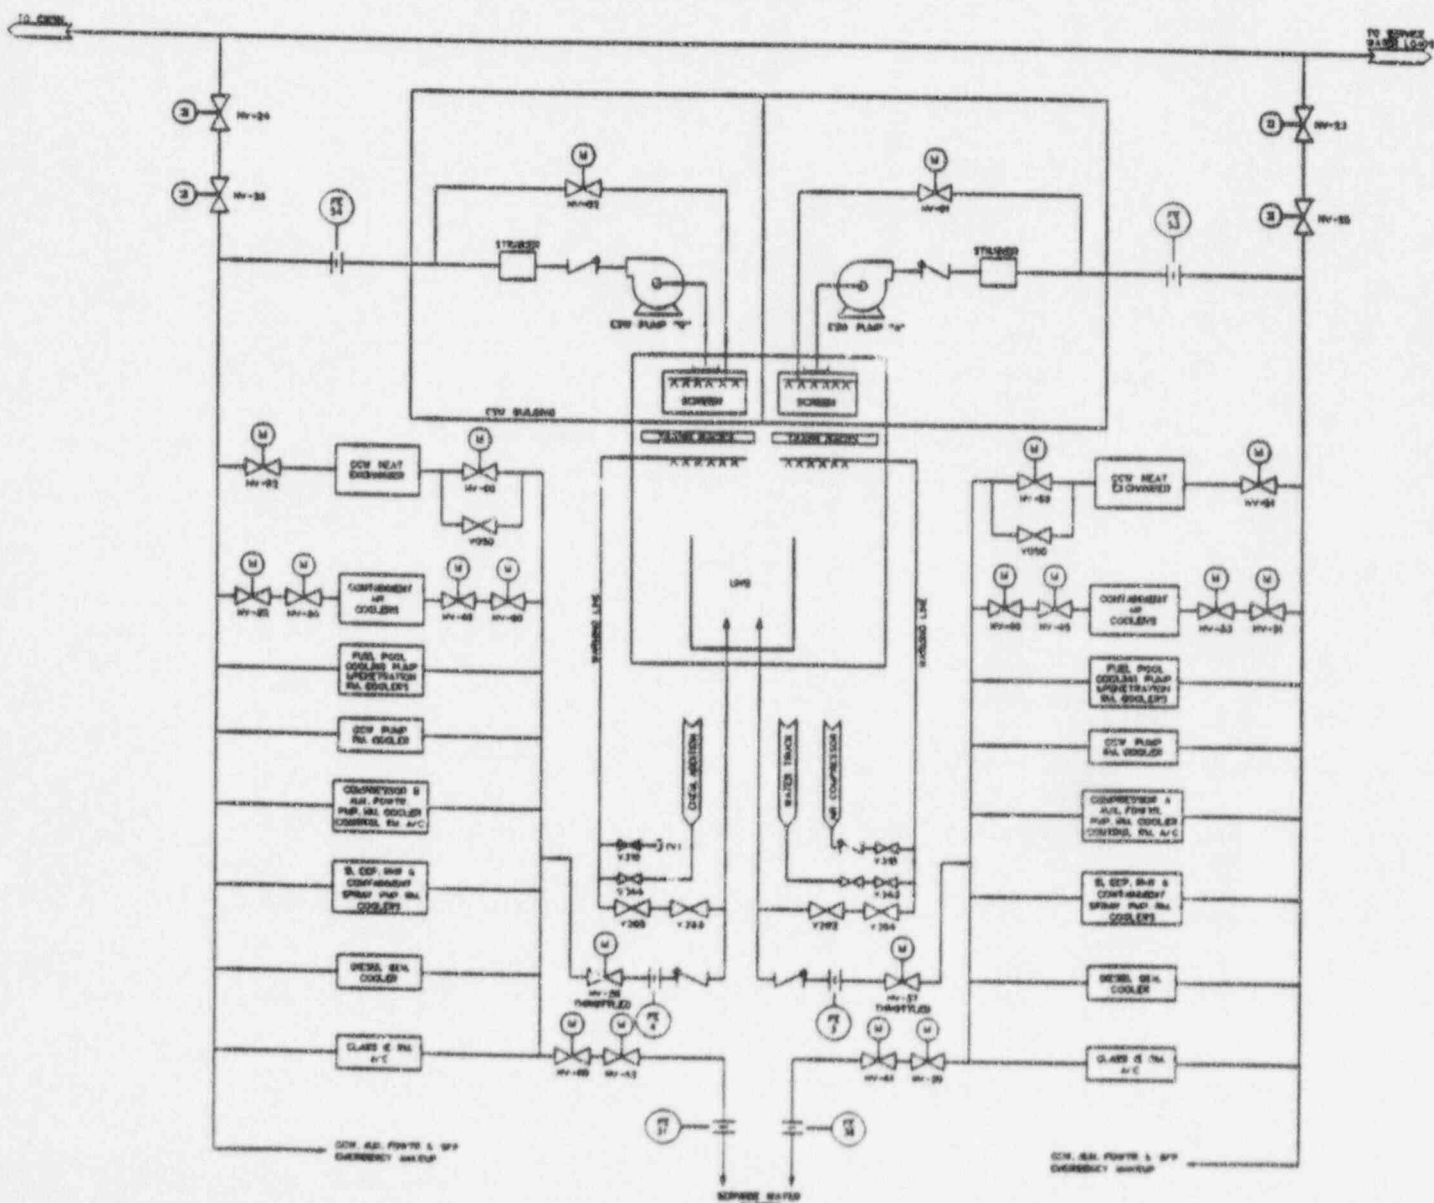
Figure One
Essential Service Water and Service Water
System Interface
