LICENSEE EVENT REPORT (LER)

FACILITY NAME (1)
MCGUIRE NUCLEAR STATION UNIT 1DOCKET NUMBER (2)
0 5 0 0 0 3 6 9 1 OF 8

HIGH GAS CONCENTRATION IN UPPER HEAD INSPECTION ACCUMULATOR

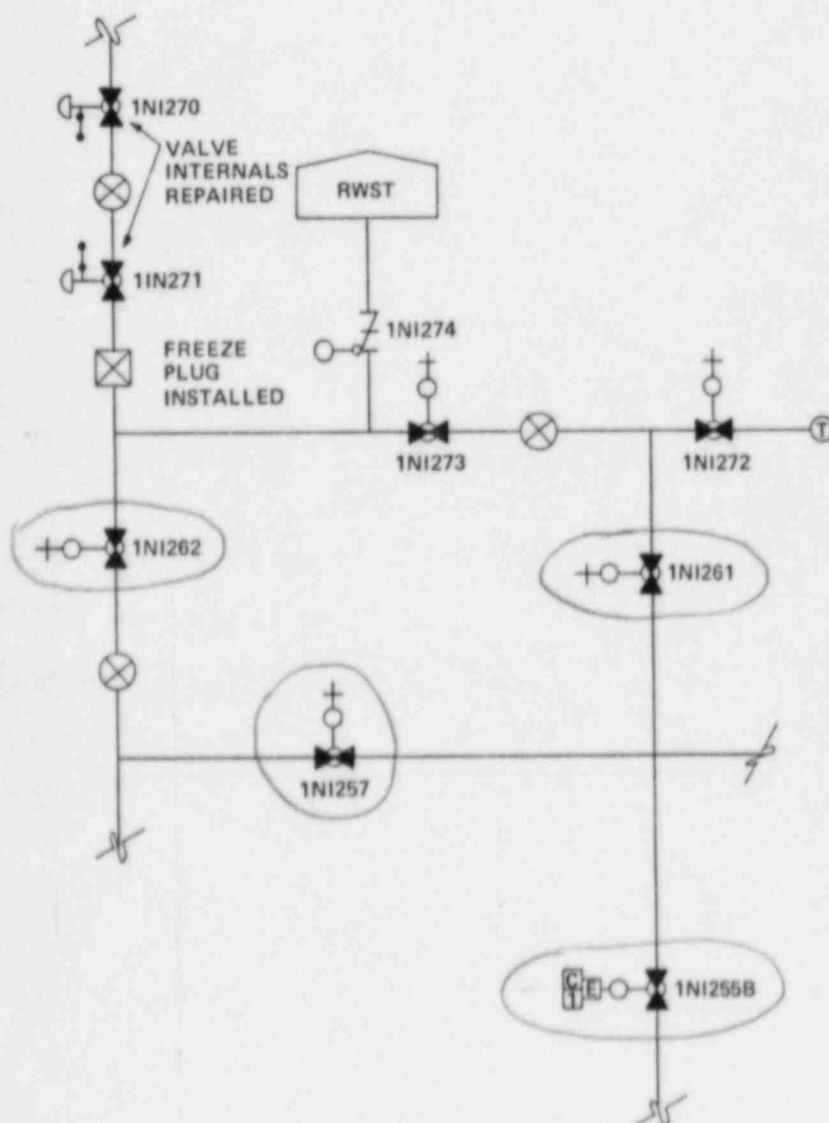
ENCLOSURE 1.0

requiring a new replacement before the refilling of the tank could be completed. (The rupture disc prevents nitrogen from dissolving in water and is designed to tear at a differential pressure of 40 psi. The rupture disc was sacrificed in order to speed up the draining process. It was determined that less time would be involved by rapidly draining the tank and replacing the disc as opposed to the normal drain technique. Several minor leaks were identified during the walkdown with INI-270 and INI-271 suspected as being the primary cause of system leakage. The basis for the suspicion of INI-270 and INI-271 and INI-273 were opened with INI-270 and INI-271 closed. (see enclosure 1.0)

Maintenance personnel replaced the internals of INI-270 and relapped the seat on INI-271; however, these valves, when repaired, did not prevent further system draindown. In an effort to prove leakage by INI-270 and INI-271, a freeze plug was installed downstream of INI-271 (see Enclosure 1.0) and valves INI-272 and INI-273 were opened. Water flowed from the vent at the same rate as before, indicating that leakage was not occurring through INI-270 and INI-271. Additionally, motor operated isolation valves were inspected to assure proper torque and closure. No problems were identified.

The exact cause of the system leakage has not been identified; however, system walkdowns by Operations personnel have provided several potential flowpaths. These flowpaths have been submitted to Design personnel in an effort to determine if system modifications would be necessary. Additionally, Design personnel are evaluating several modifications for both short term and long term solutions. The primary short term solution will provide full couplings with solid internals (similar to blank flanges) along the suspected flowpaths (see Enclosure 1.0). The suspected leakage flowpaths (indicated by arrows) through soft seated Kerotest valves 1NI-255B (circled), 1NI-261 (circled), 1NI-257 (circled), and 1NI-262 (circled) would be prevented from entering the RWST due to the full couplings. As system leakage along these flowpaths becomes water solid, pressure would equalize

across each valve and the leakage would stop. This modification is presently being evaluated for installation during the maintenance outage scheduled following the Thanksgiving Holiday. Long term solutions under evaluations are 1) providing a means to recirculate and deaerate the tank thus providing a representative sample and the capability for removing dissolved gases from the water 2) modify the system to provide faster filling and draining of the water accumulator and nitrogen accumulator 3) eliminate valves not necessary in the test header (one of the suspected flowpaths) and 4) the possibility of eliminating the UHI system entirely. Most of the long term solutions are not being pursued at this time but will be considered if the short term corrective action proves to be ineffective. The main concern at the present time is to find a way to eliminate the system leakage.

Corrective actions performed to date include repair of valves INI-270 and 271, and a system walkdown was performed to identify other potential leakage flowpaths. Other corrective actions which are being considered include: installation of full couplings with solid internals; elimination of the UHI system; deletion of valves, where possible - in cases where deletion is not possible, installation of leak-tight valves; and a system modification to allow more rapid filling and draining of nitrogen and water accumulators. The last three actions will be seriously evaluated only if the installation of the couplings and valve repair prove ineffective.
