Subject: McGuire Nuclear Station Unit 1  
Docket No. 50-369  
Licensee Event Report 369/92-03

FACILITY NAME(1) McGuire Nuclear Station, Unit 1						DOCKET NUMBER(2) 05000 369		PAGE(3) 1 OF 9		
TITLE(4) A Technical Specification Violation Was Caused By A Containment Isolation Valve Being Inoperable When Required Due To Management Deficiency										
EVENT DATE(5)			LER NUMBER(6)			REPORT DATE(7)			OTHER FACILITIES INVOLVED(8)	
MONTH	DAY	YEAR	YEAR	SEQUENTIAL NUMBER	REVISION NUMBER	MONTH	DAY	YEAR	FACILITY NAMES	DOCKET NUMBER(S)
02	12	92	92	03	0	03	20	92	N/A	05000
									05000	
OPERATING MODE(9)		3		THIS REPORT IS SUBMITTED PURSUANT TO REQUIREMENTS OF 10CFR (Check one or more of the following)(11)						
POWER LEVEL(10)		0		20.402(b)		20.405(c)		50.73(a)(2)(iv)		73.71(b)

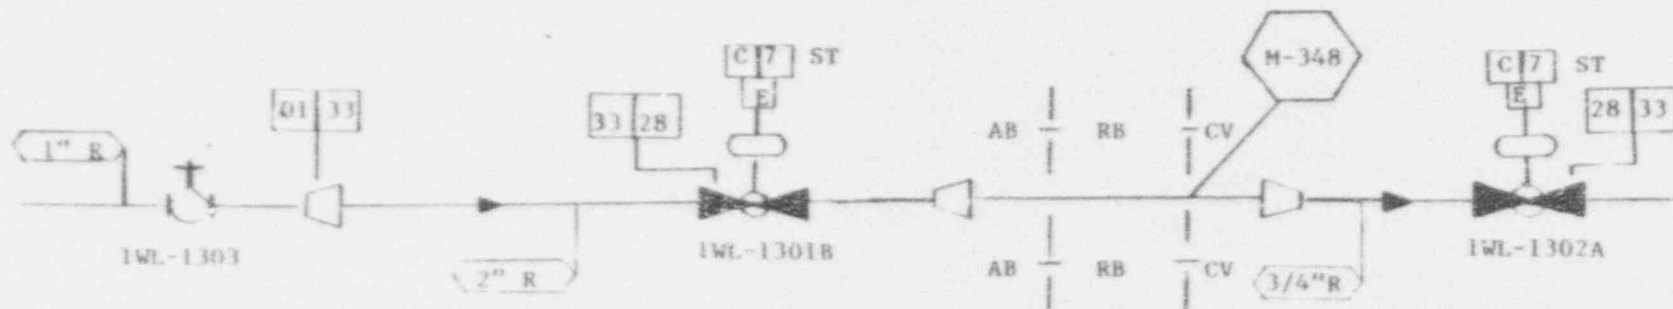
## ONE LINE DIAGRAM OF CONTAINMENT PENETRATION M-348

Corrective action was taken to restore the valve to an operable state immediately upon discovery of the oversight. Also, during the time period associated with the event, valve 1WL-1302A, Unit 1 Upper Head Injection Check Valve Test Line Isolation, and manual valve 1WL-1303, which are on either side of valve 1WL-1301B, were operable and closed at all times. However, because valve 1WL-1302A was not deactivated within four hours and valve 1WL-1303 is not seismically qualified, TSs were violated. See illustration on page 10 of 10.

The valve in question provides a means of isolating the associated test line that passes through penetration M-348 so as to confine to the containment any radioactivity which could be released following a design basis event.

During the time period associated with this event, valve 1WL-1302A was operable and closed at all times. Also, manual valve 1WL-1303 was closed. These two valves would ensure integrity of the containment should valve 1WL-1301B fail during a design basis event. Additionally, on receipt of a Safety Injection Signal, OPS personnel must verify all Phase A components to be properly aligned per existing emergency procedures. If a Safety Injection had occurred during the time period associated with this event, OPS personnel would have noted any misalignment of these valves and taken appropriate action to close them. For most accident sequences, there is significant time for such action to be taken before any release of radioactivity from the Containment could occur.
