CORPORATION  
Crystal River Unit 3  
Doclet No. 90-302

Subject: Licensee Event Report (LER) 96-001-01

FACILITY NAME (1)										DOCKET NUMBER (2)										PAGE (3)										
CRYSTAL RIVER UNIT 3 (CR-3)										0 5 0 0 0 3 0 2										1 OF 0 8										
TITLE (4)																														
Personnel Error by Contractor Results in Operation Outside 10CFR50 Appendix R Design Basis																														
EVENT DATE (5)			LER NUMBER (6)					REPORT DATE (7)			OTHER FACILITIES INVOLVED (8)																			
MONTH	DAY	YEAR	YEAR	SEQUENTIAL NUMBER	REVISION NUMBER	MONTH	DAY	YEAR	FACILITY NAMES					DOCKET NUMBER(S)																
									N/A					0 5 0 0 0																
0	1	1	0	9	6	9	6	---	0	0	1	---	0	1	0	3	0	8	9	6	N/A					0 5 0 0 0				
OPERATING MODE (9)		3		THIS REPORT IS SUBMITTED PURSUANT TO THE REQUIREMENTS OF 10 CFR §: (CHECK ONE OR MORE OF THE FOLLOWING) (11)																										
POWER LEVEL (10)		0 0 0		20.402(b)					20.405(c)					50.73(a)(2)(iv)					73.71(b)

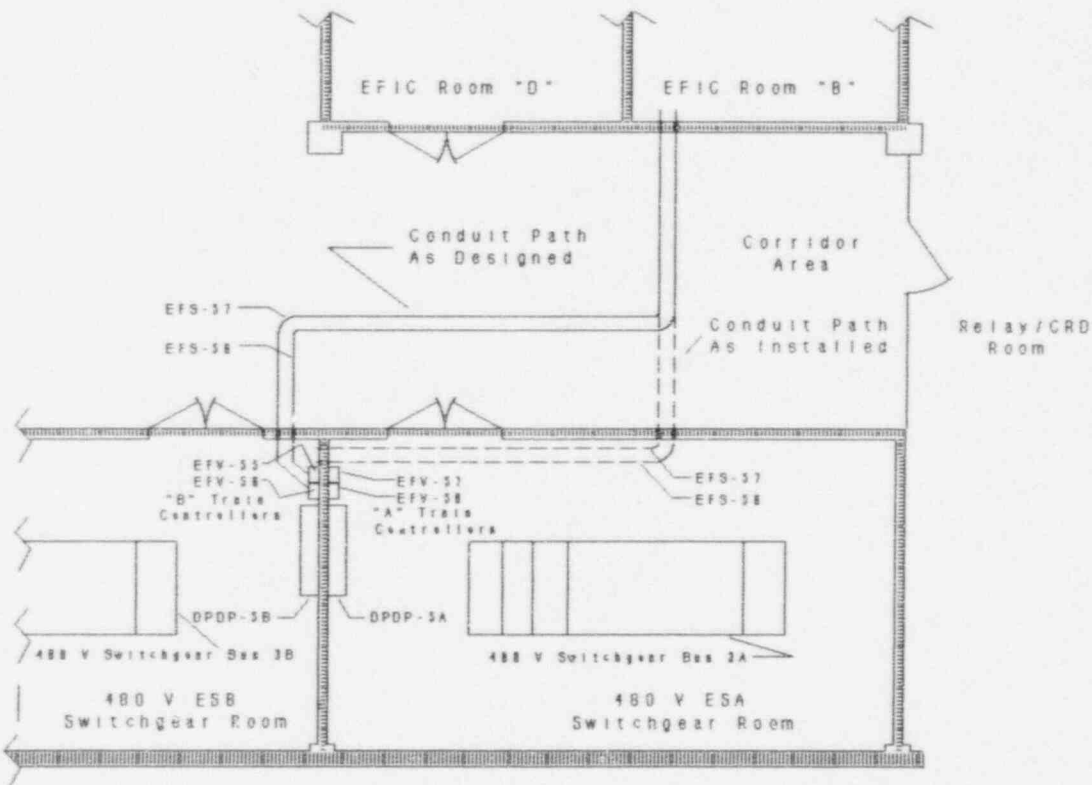
FIGURE 1

On January 10, 1996, Florida Power Corporation's (FPC) Crystal River Unit 3 (CR-3) was in MODE THREE (HOT STANDBY). The plant was in the process of shutting down due to a forced outage associated with an earlier saltwater intrusion through a condenser tube leak. During a walkdown by personnel involved in developing a modification for upgrading CR-3's Thermo-Lag fire barriers, it was noted that conduits EFS56 and EFS57, which contain "B" Train circuits for Emergency Feedwater System [BA] (EFW) components, were routed through the "A" 480-Volt Engineered Safeguards (ES) Switchgear Room. The portion of the "B" Train conduits in the "A" Switchgear Room are not protected by fire barriers and are within 20 feet of redundant "A" train circuits. See Figure 1.

Conduits EFS56 and EFS57 contain circuits which provide flow control signals and motive power to controllers [BA,FC] for the "B" train Emergency Feedwater Flow Control Valves [BA,FCV]. The redundant "A" train circuits are associated with controllers for "A" train Emergency Feedwater Flow Control Valves. A Problem Report was generated to identify a noncompliance with 10CFR50 Appendix R, Section III.G.2.b separation criteria in that circuits and components for both trains of Emergency Feedwater are located in the same fire area and both trains of Emergency Feedwater are subject to loss of flow control if a fire occurred. The Problem Report was initially considered not to be reportable on the basis that the conduit was in the confirmed route of the continuous roving fire watch established in response to NRC Bulletin 92-01 "Failure of Thermo-lag 330 Fire Barrier System to Perform its Specified Fire Endurance Function".

The primary cause of this event was cognitive personnel error by contractor engineering personnel. Conduits EFS56 and EFS57 were installed in 1985 during Refuel 5 as part of a field change to modification 88-10-66-08A "EFIC Electrical Conduit and Cable Installation". The field change was a multi-discipline (electrical and structural) change initiated by the electrical discipline for the purpose of addressing Appendix R. After the electrical design was completed, structural engineering completed the balance of the design for the conduit installation and approved the change notice. The structural design engineer selected a different route for conduit supports from that depicted on layout sketches provided by electrical engineering. It is surmised that this route was selected to take advantage of existing conduit supports and/or due to interferences present in the route selected by electrical engineering. The structural engineer was apparently not aware of the impact this change had on Appendix R criteria. Further, design verification of the field change did not include a final review by electrical engineering.

1. Drawings which indicate the routing of Conduits EFS56 and EFS57 have been revised to depict the correct routing.
2. FPC will conduct a validation of Appendix R drawings using a sample-based approach to compare the as-built configuration against the configuration confirmed by field walkdown. The sample will be both horizontal and vertical. The horizontal sample will consist of validating the location of all fire barrier protected raceways for a selected plant system. The vertical sample will consist of validating the location of all fire barrier protected raceways for a selected fire area. It is expected that field validation will be completed by the end of 1996 consistent with other actions noted in Item 3, below. Depending on the results of the initial validation, a decision will be made to proceed with additional validation.

3. Circuits contained in Conduits EFS56 and EFS57 will be brought back into compliance with 10CFR50 Appendix R. This may include wrapping with Mecatiss per the commitment described in FPC letter 3F1295-05 to NRC dated December 21, 1995. Consistent with commitments in the letter for Mecatiss wrapping, compliance with Appendix R will be achieved by the end of 1996.
