JOB NO. 7597-03	ACCESSION NO.
UNIT 1	U-400932
TITLE ENVIRONMENTAL QUALIFICATION TEST REPORT OF RAYCHEM NUCLEAR CABLE BREAKOUT AND END SEALING KITS	
JOB: JOSEPH M. FARLEY NUCLEAR PLANT ALABAMA POWER CO.	
Supplier: RAYCHEM CORPORATION (071508)	P.O. APCO Req. APCO PCN No. (If Applic.) B-87-0-4475

Environmental Qualification Test Report
of
Raychem Nuclear Cable Breakout and End Sealing Kits
for
Raychem Corporation
Menlo Park, California

REPORT NO. 58442-2
OUR JOB NO. NDQ 58442
CONTRACT ---
YOUR P. O. NO. A01183

ENVIRONMENTAL QUALIFICATION TEST REPORT
OF
RAYCHEM NUCLEAR CABLE BREAKOUT AND END SEALING KITS
FOR
RAYCHEM CORPORATION
MENLO PARK, CALIFORNIA

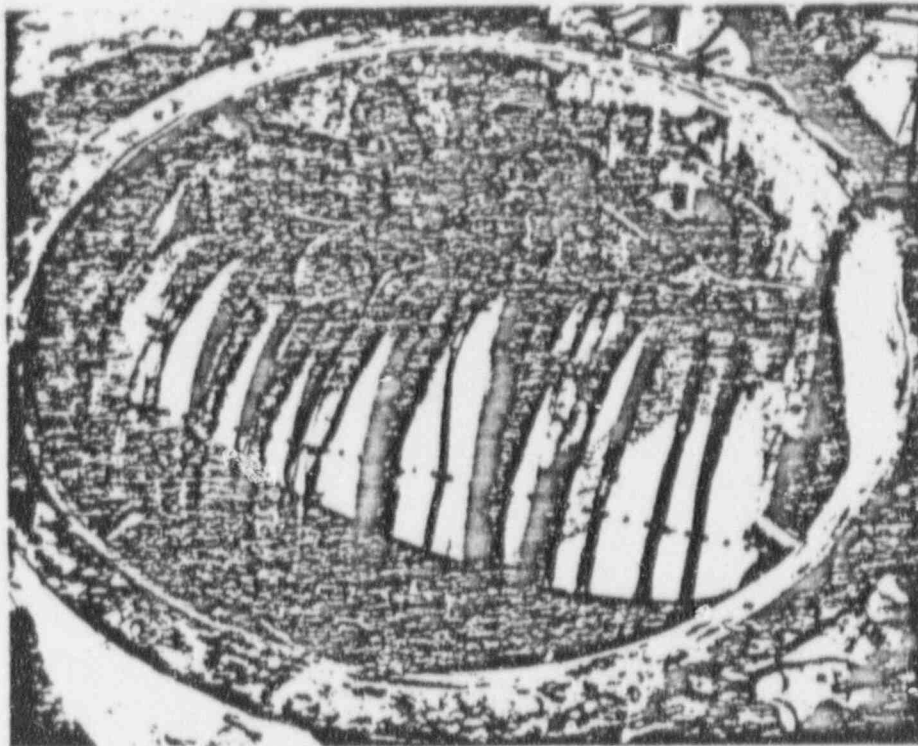
FIGURE 8. Test Chamber and Samples

At the conclusion of the test profile (Figure 5), the test vessel was flooded with tap water. The specimens were then given a voltage withstand test, and the insulation resistances measured. The results of the insulation resistance tests are given in Table 1. The vessel was then opened and the cause for some of the specimens being unable to hold rated voltage investigated. The test vessel with the specimens in place is shown in Figure 8. Figure 9 shows the test specimens after removal from the test vessel.

The extension wires were cut inside the vessel so that the mandrel could be removed. This also allowed the test vessel penetrations to be inspected. It was found that some of the wires in the penetration had a low insulation resistance and would not pass the 3.6kV a-c voltage withstand test. The specimens associated with the penetration wires having a low insulation resistance were retested immersed in water (see Figure 4). The retest of specimens 2-1R, 2-2B, and 2-5W2 showed high values of insulation resistance and all specimens passed the voltage withstand test. The low values previously measured on these specimens can therefore be attributed to the test vessel penetrations and not the specimens.

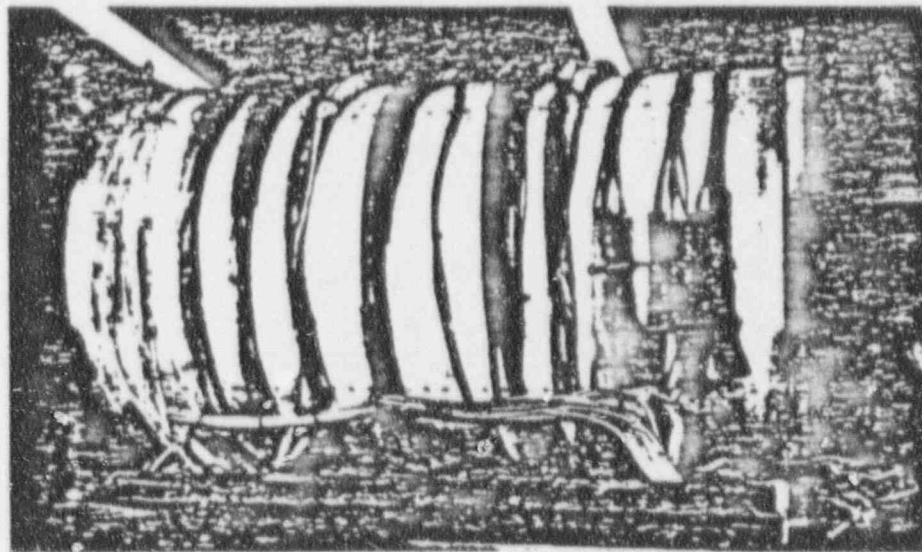
FIGURE 9. Mandrel After Removal from Vessel

Visual examination of the sleeves used over the cable breakouts and end caps showed surface degradation and some superficial crazing. This was most apparent on specimens 2-4 and 2-5.
