Incident Investigation Team Report

96-002

"Plant Shutdown Due To Circulating Water and Essential Service Water Intake Icing"

Wolf Creek Nuclear Operating Corporation

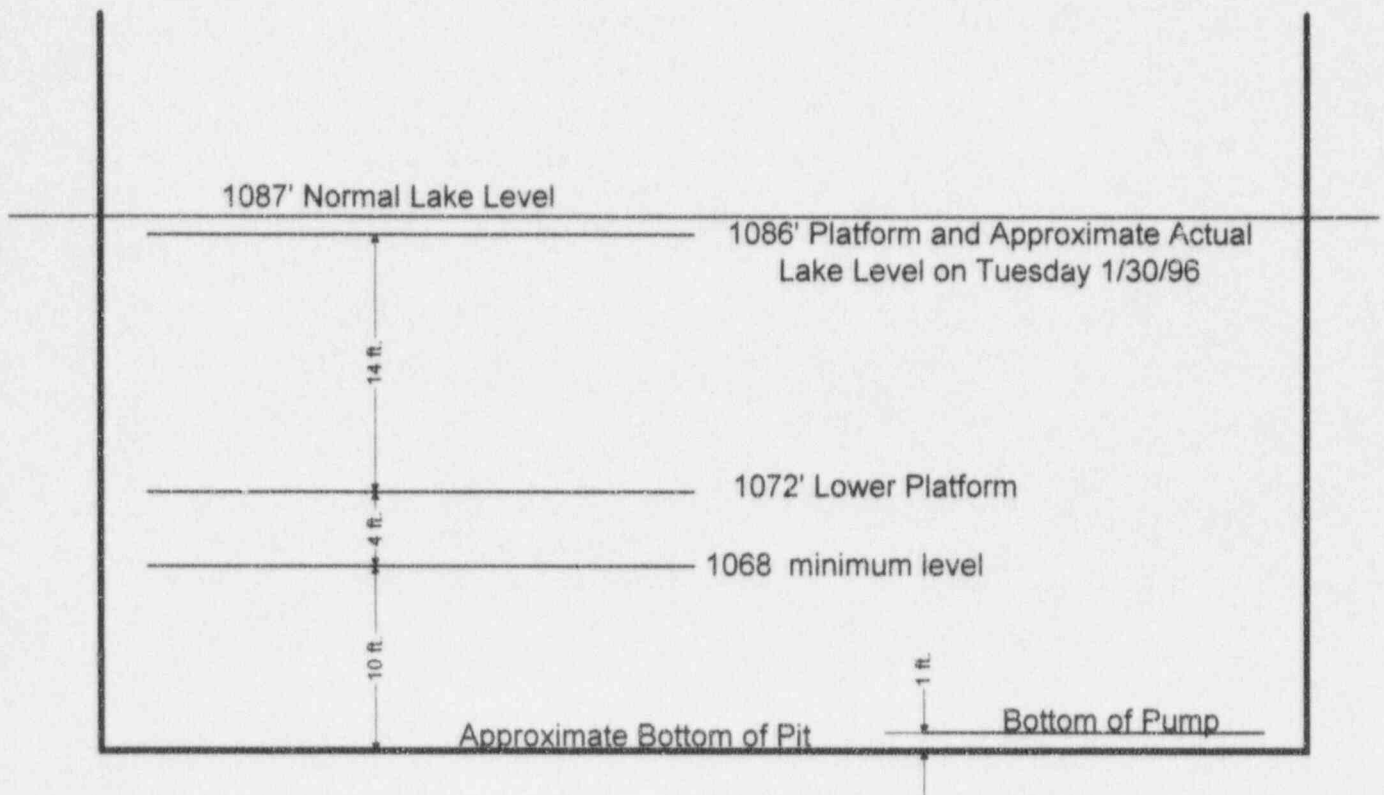
ESW Inlet Bay Elevations

Accounts of eyewitnesses at the ESW Pumphouse during the event, were that the fore bay level varied approximately 8' to 10.' It is believed that the trend of level indicated by the level instrument follows the pattern of actual level. The minimum and maximum spikes observed appear to be from turbulent water, including frazil ice mixtures, in the fore bay. However, the periods of instability for the level instrument coincide with the securing of "A" ESW Pump.

"B" CCW dwarfs other ESW loads present on "B" Train ESW on Tuesday, January 30, 1996. A plot of "B" CCW Heat Exchanger Δ -temperature is attached. It remained steady throughout the day until late afternoon when it decreased slightly. From site operator and control room logs additional RHR load was put on "B" CCW by Operators in an attempt to reverse falling "B" ESW suction fore bay levels at about 2015 hours.

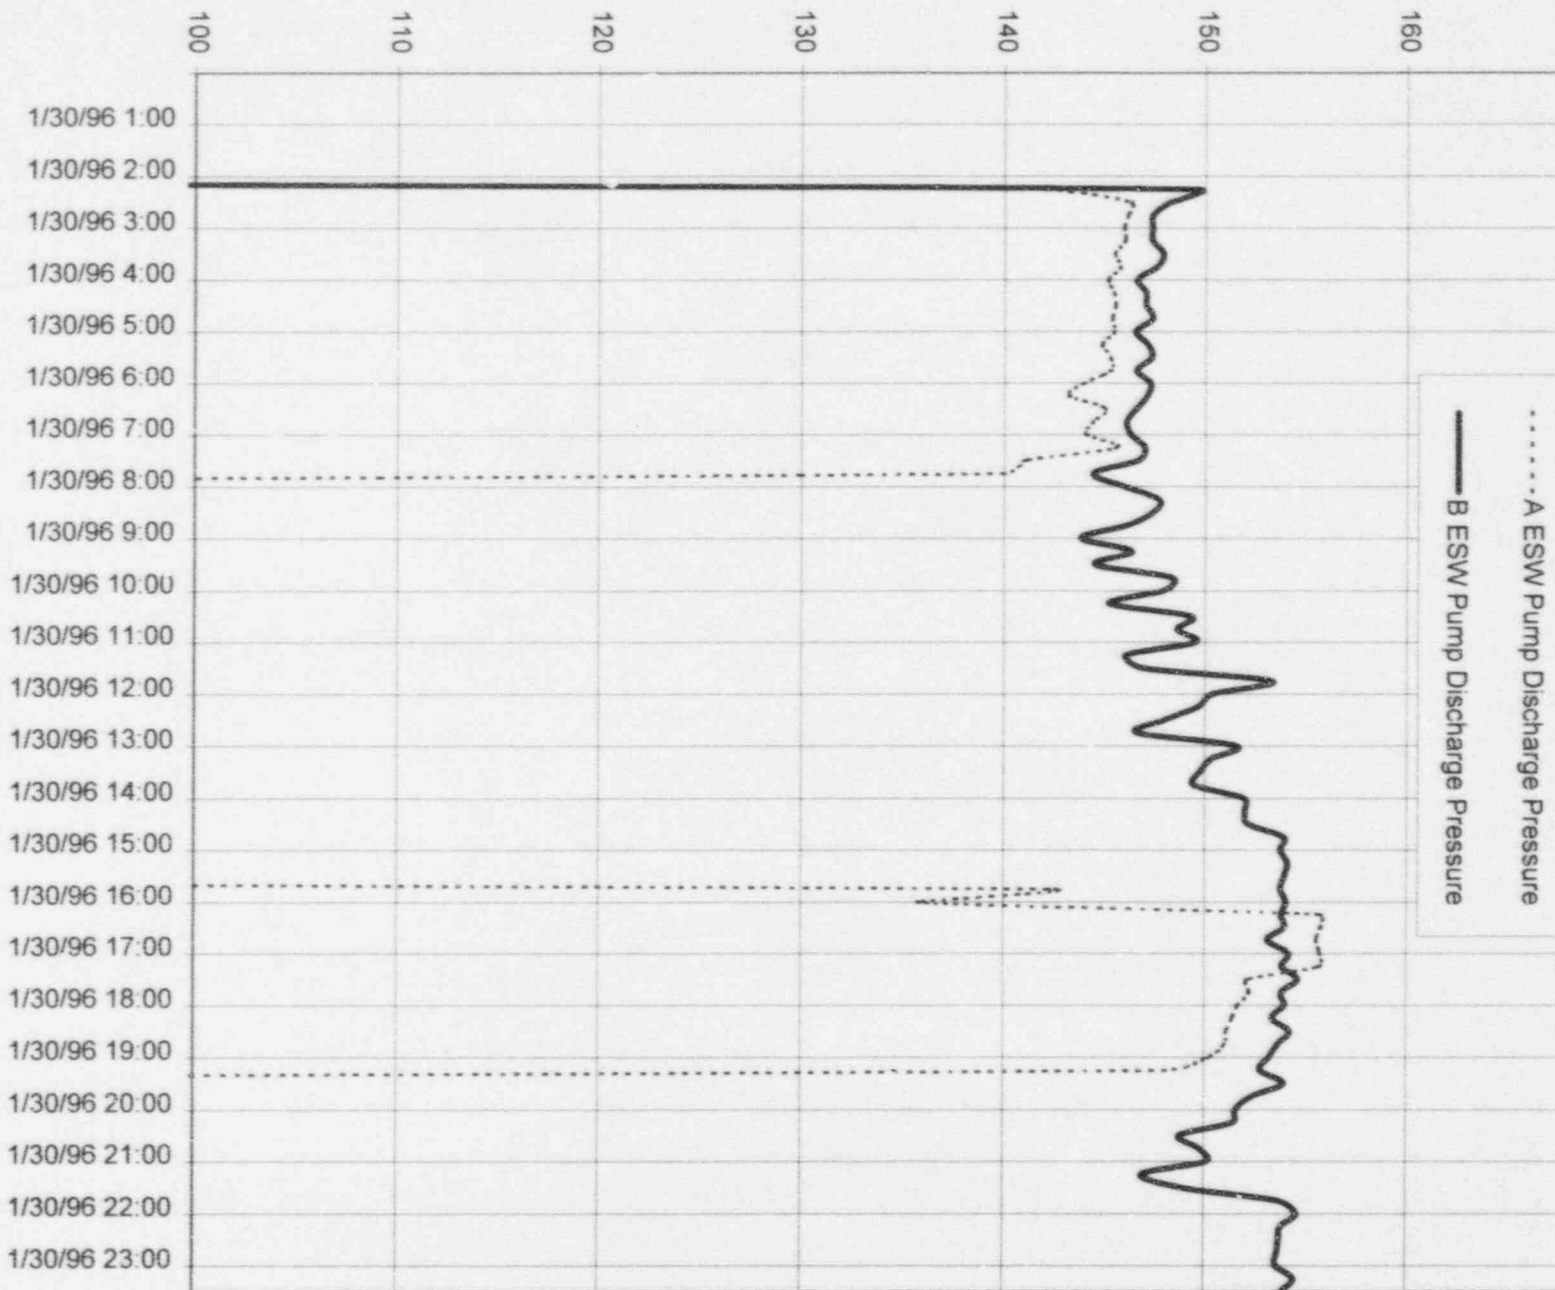
ESW Pump Pressures 1/30/96

Formation of ice on the "A" Train ESW trash racks caused fore bay levels to decrease and pump discharge pressures to drop. In order to avoid damage to the pump, Operators secured the pump and placed it in PTL. This placed the plant in T/S 3.7.1.2 b, requiring a six hour Cooldown to <350°F. An additional Licensed Operator in the Control Room, while
