April 14, 1983

NSD-83-190

Trip Report - Diesel Generators at Kansas
and Delaval, California

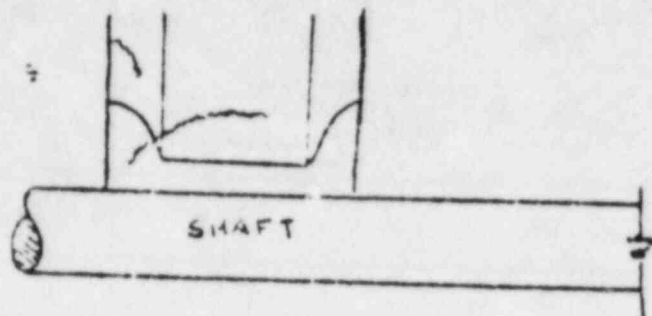
No. 9

Inspected No.'s 8 and 9 cam shaft pillars. Found indications identical to SNPS (diagrams).

Lincoln, Kansas - Ind. Found

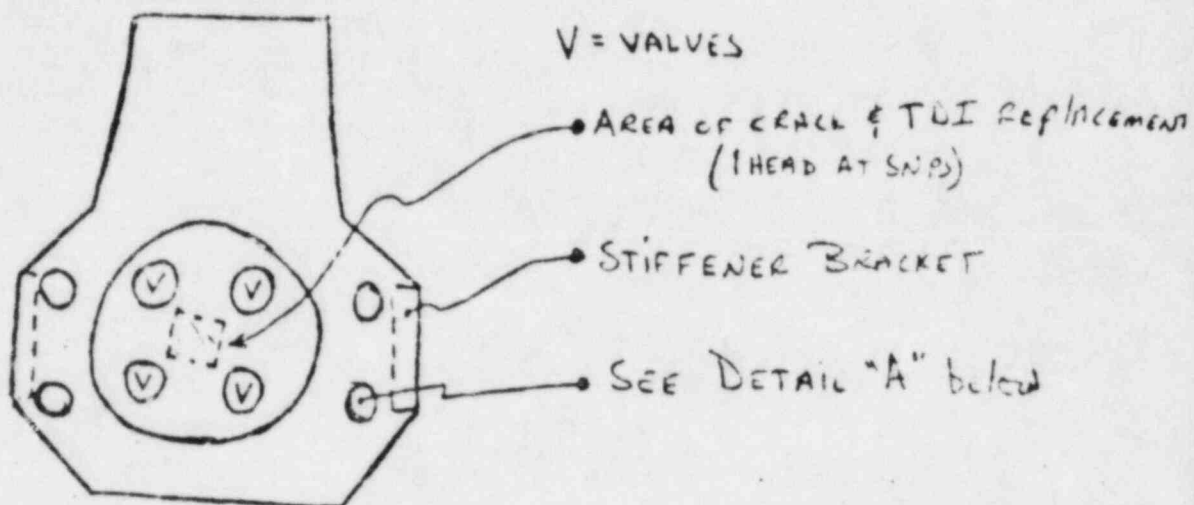
5) Thin Side Wall

Of concern to the undersigned is some of the repairs Delaval performed on the cylinder heads. Most of these repairs are outlined in the attachment, however, one of Shoreham's heads required welding of a steel piece into the valve hot-face due to an existent crack (see attachment). This repair, if not adequate, may cause severe damage to the engine, and may render the engine inoperable if this weld fails and metal falls into the valve seats (or engine block). It is recommended that LILCO require the newer design heads from Delaval, and preclude the use of any rebuilt heads. This may seem unnecessary, however, if these diesels are to operate properly under the prescribed conditions, LILCO should maintain a superior quality engine.

- Mill Side
- Weld Stiffener Bracket (Steel)
- Re-build Bolt Holes
