# WOLF CREEK

Subject: Docket No. 50-482: Licensee Event Report 96-001-00

WOLF CREEK GENERATING STATION

Loss of Circulating Water Due to Icing on Traveling Screens Causes Reactor Trip

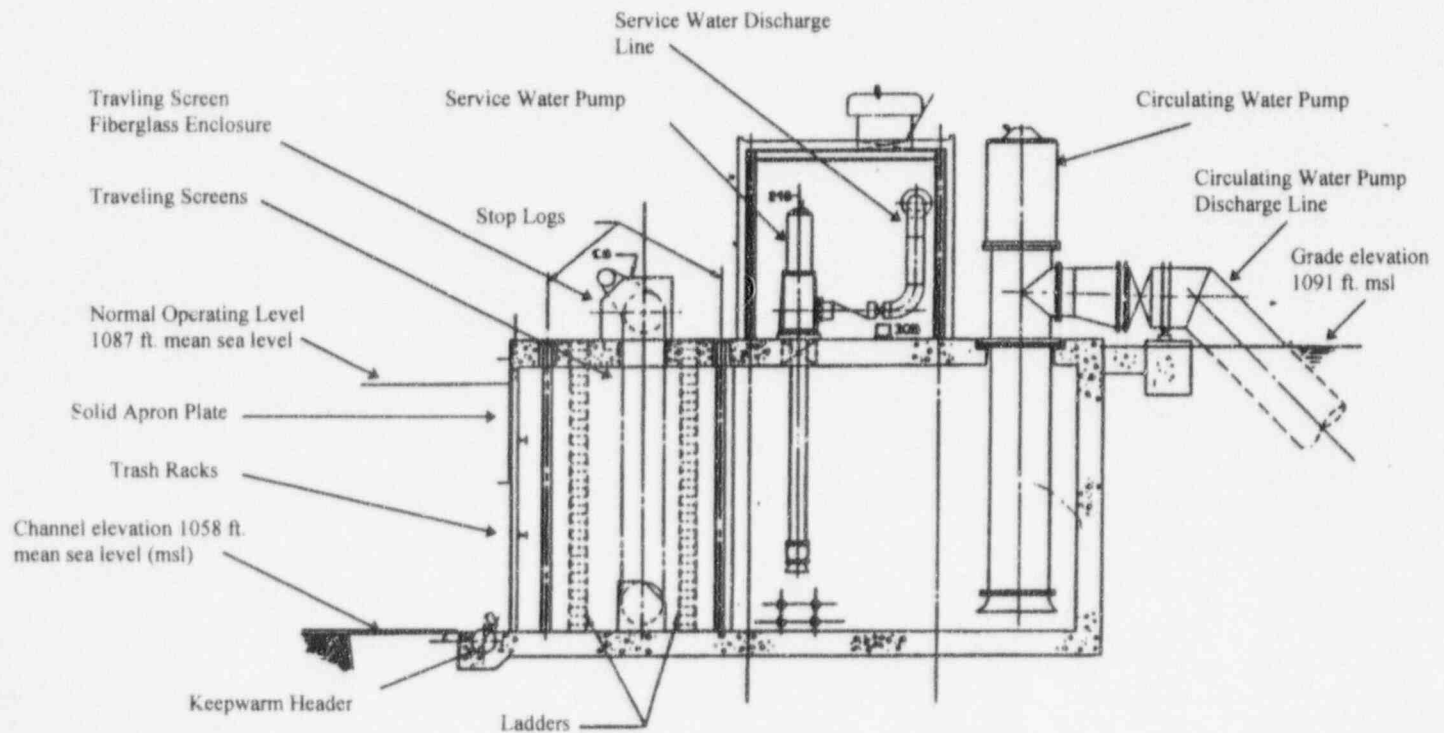
**FIGURE 1**

The CWSH has three suction bays which are physically separated by concrete walls. There are four 12" pipe sleeves which penetrate the walls that divide the A and B suction bays and the B and C suction bays. The level fluctuations in one bay are noticed to some degree in the others. (Refer to Figure One on Page 13)
