DUKE POWER

Subject: Catawba Nuclear Station
Docket No. 50-414
LER 414/96-001

Attached is Licensee Event Report **Loss of Off-Site Power Due to Electrical Component Failures.**

LOSS OF OFFSITE POWER DUE TO ELECTRICAL COMPONENT FAILURES

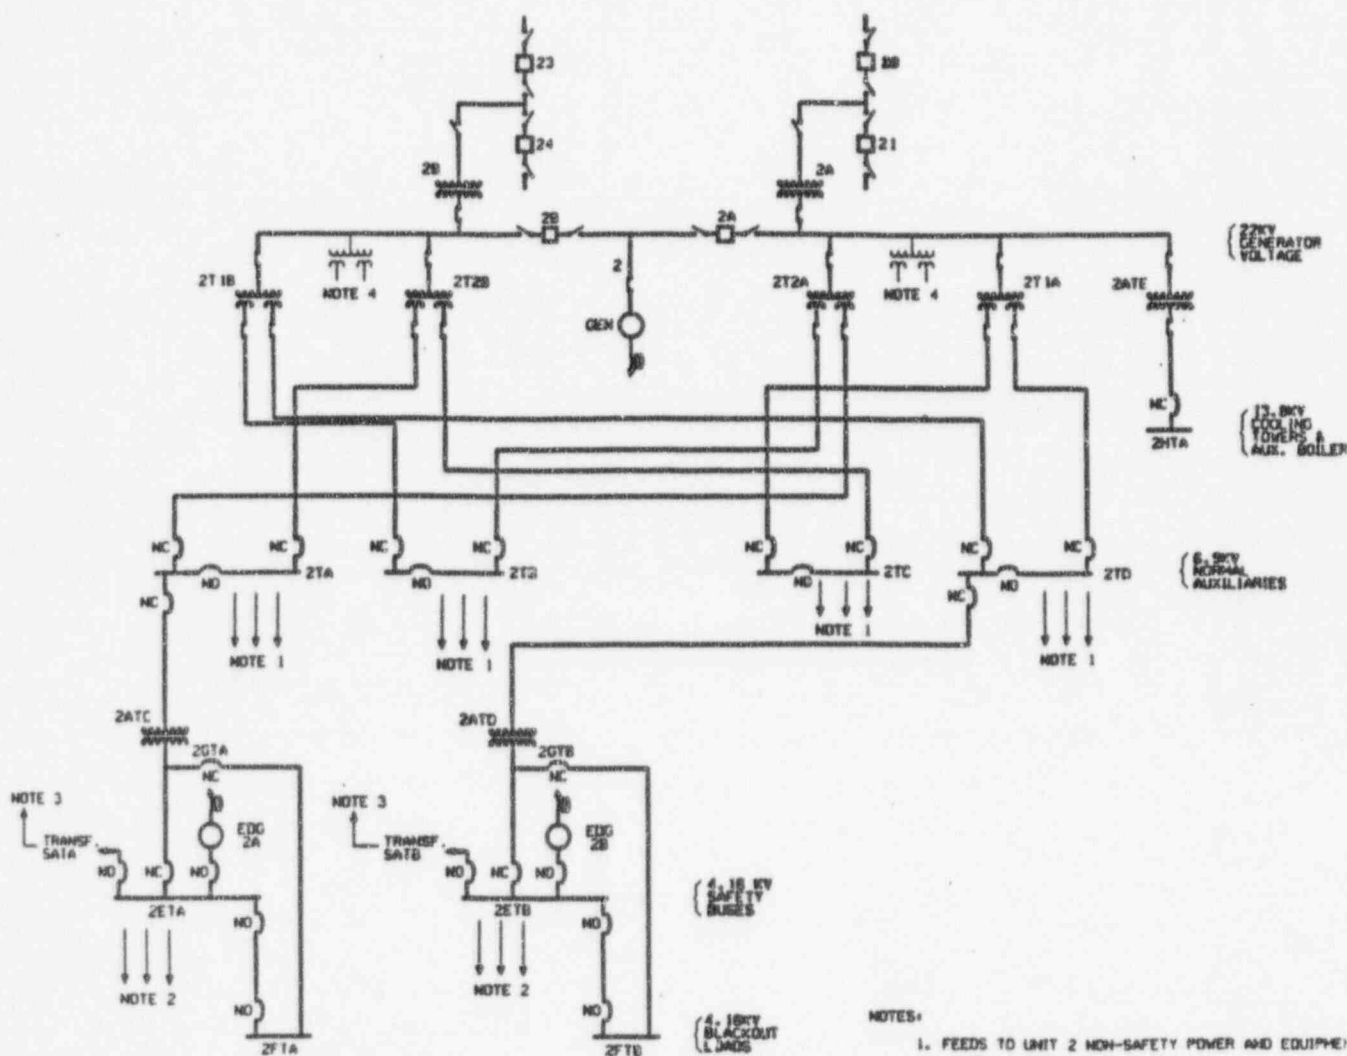
ATTACHMENT 1
CATAWBA UNIT 2 MAIN POWER DISTRIBUTION SYSTEM

Event Description: On February 6, 1996, at 1231 hours, ground faults on the resistor bushings for 2A Main transformer X phase potential transformer and 2B Main Transformer Z phase potential transformer resulted in a phase to phase fault. Protective relay actuation on both Main Transformers resulted in a loss of offsite power. The reactor tripped on Reactor Coolant Pump bus underfrequency. As a result of the blackout, 2A Emergency Diesel Generator started and sequenced on all required loads. 2B Emergency Diesel Generator was inoperable due to battery charger repairs, therefore B Train 4Kv Essential Bus did not automatically reenergize. Cold auxiliary feedwater being automatically supplied to the steam generators, in combination with the effects of various steam loads, resulted in a Low Steamline Pressure Safety Injection. At 1522 hours, B Train 4Kv Essential Bus was energized from 2B Emergency Diesel Generator. By 2000 hours, both 4Kv Essential Buses were being supplied from train related offsite power sources.

Event Cause: The root cause of the event is attributed to the application of the type of resistor bushings used. A deficiency lies in the use of these resistor bushings in a vertical orientation at the bottom of vertical branch-lines of the Isolated Phase Bus ducting leading to the potential transformers. The outdoor location and lack of air flow within this portion of the ducting, is conducive to moisture intrusion and corrosion. A contributing factor was the lack of adequate preventative maintenance to prevent moisture intrusion/condensation problems.

Corrective Action: All resistor bushings in this application were replaced on both Catawba units with bushings having external resistors. The current preventative maintenance programs for the IPB system and transformer yard equipment will be enhanced to ensure continued equipment reliability. Enhancements should include measures to protect against the effects of moisture and condensation.
