BRUNSWICK STEAM ELECTRIC PLANT  
TECHNICAL SUPPORT MEMORANDUM

TSM 91-0856

PROGRAM or  
COMPONENT ID: Diesel Generator #3

SUBJECT: Long Term Operability of EDG #3

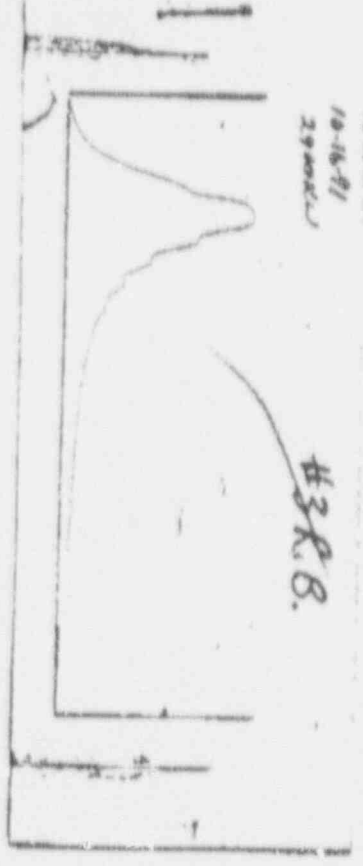
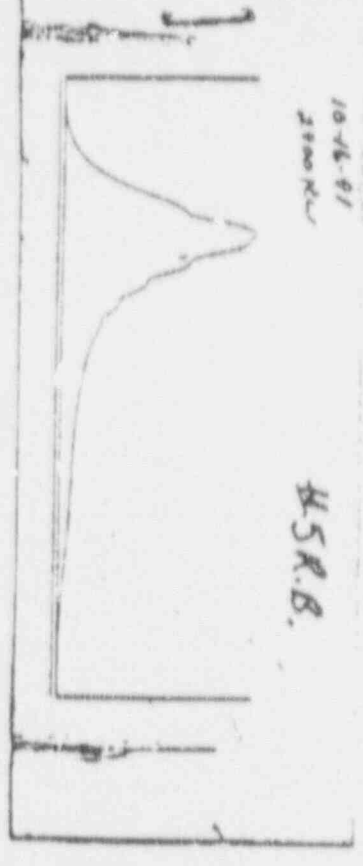
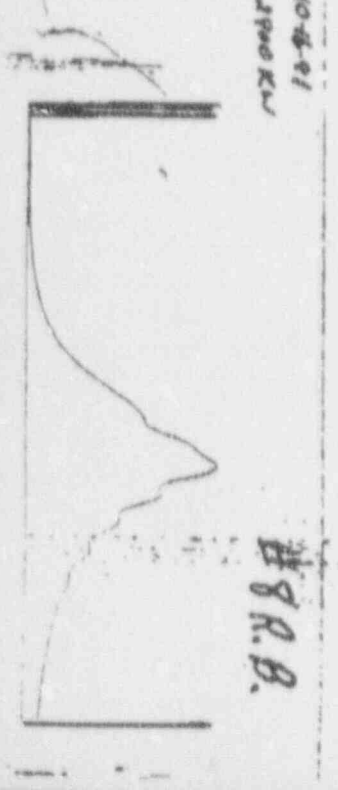
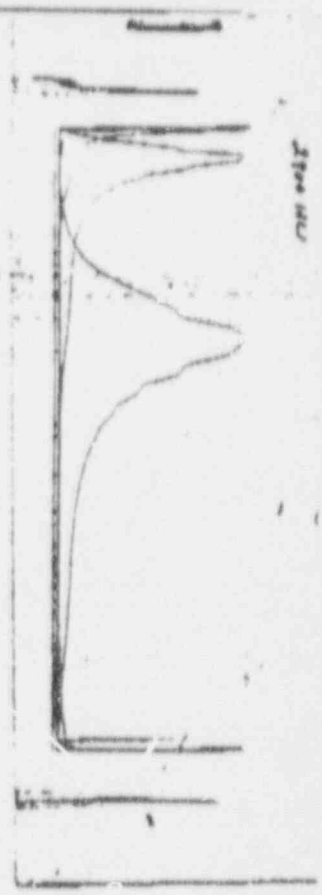
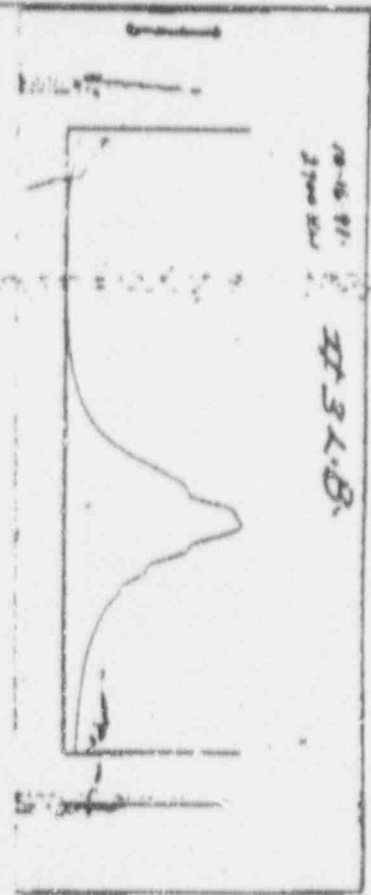
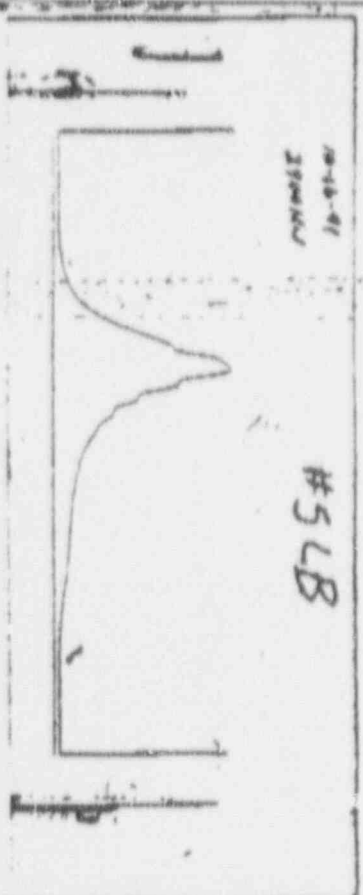
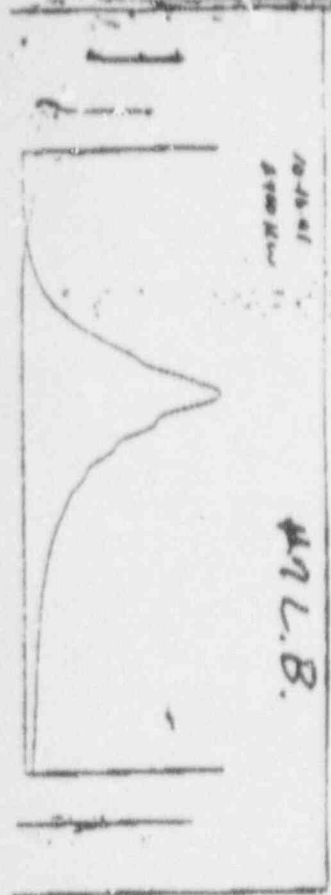
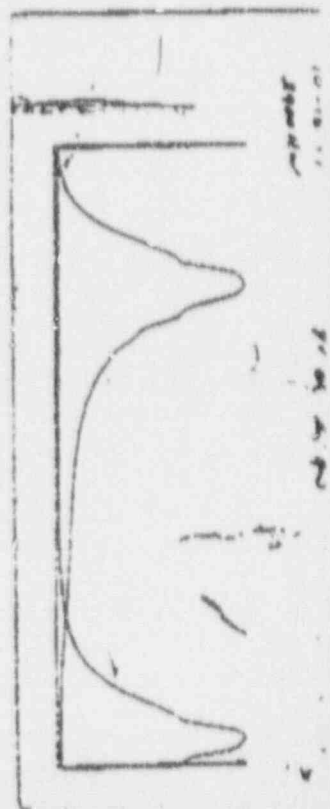
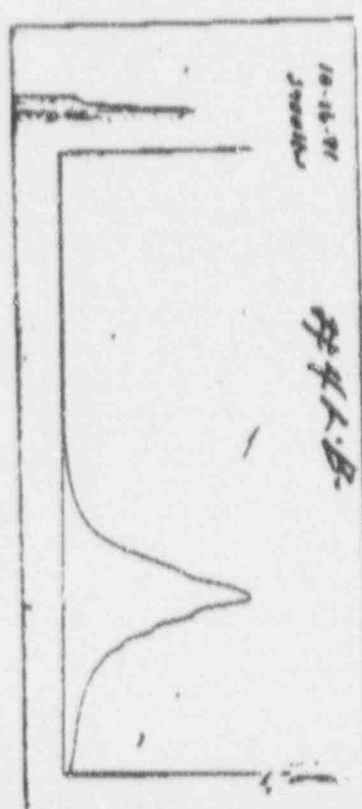
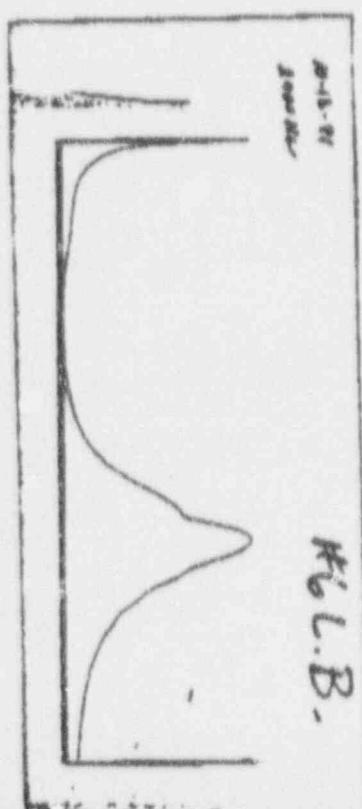
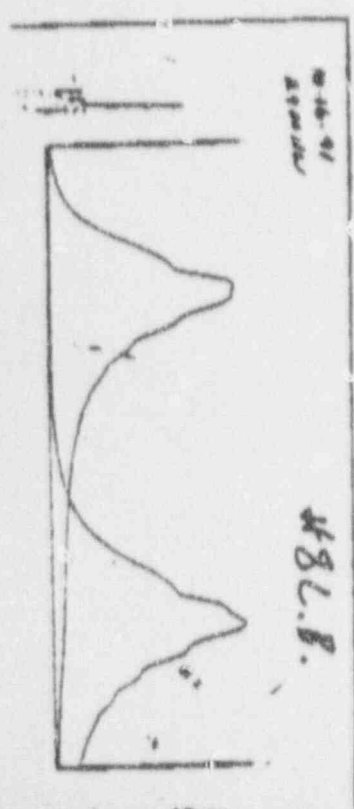
Attachment 1

1) No. The material of construction of intake and exhaust valves are identical except that the exhaust valves are stellite faced. Pull cards were taken on the PMTR run on 10/16/91. The pull cards measure both the compression and ignition pressures of the cylinders during actual running conditions. The compression pressures were approximately 775 psi and were within 40 psi of each other. These values were within the normal range and in close agreement with the last set of pull card readings. This indicates good cylinder compression, and therefore, no valve or valve seat damage. Additionally, besides no degradation of the valves, this analysis shows that the engine is performing well. (Reference Attachment 1)
