LICENSEE EVENT REPORT (LER)

FACILITY NAME (1) H. B. Robinson SEG Plant, Unit No. 2	DOCKET NUMBER (2) 0 5 0 0 0 2 6 1	PAGE (3) 1 OF 13
---	--------------------------------------	---------------------

Steam Generator Snubbers

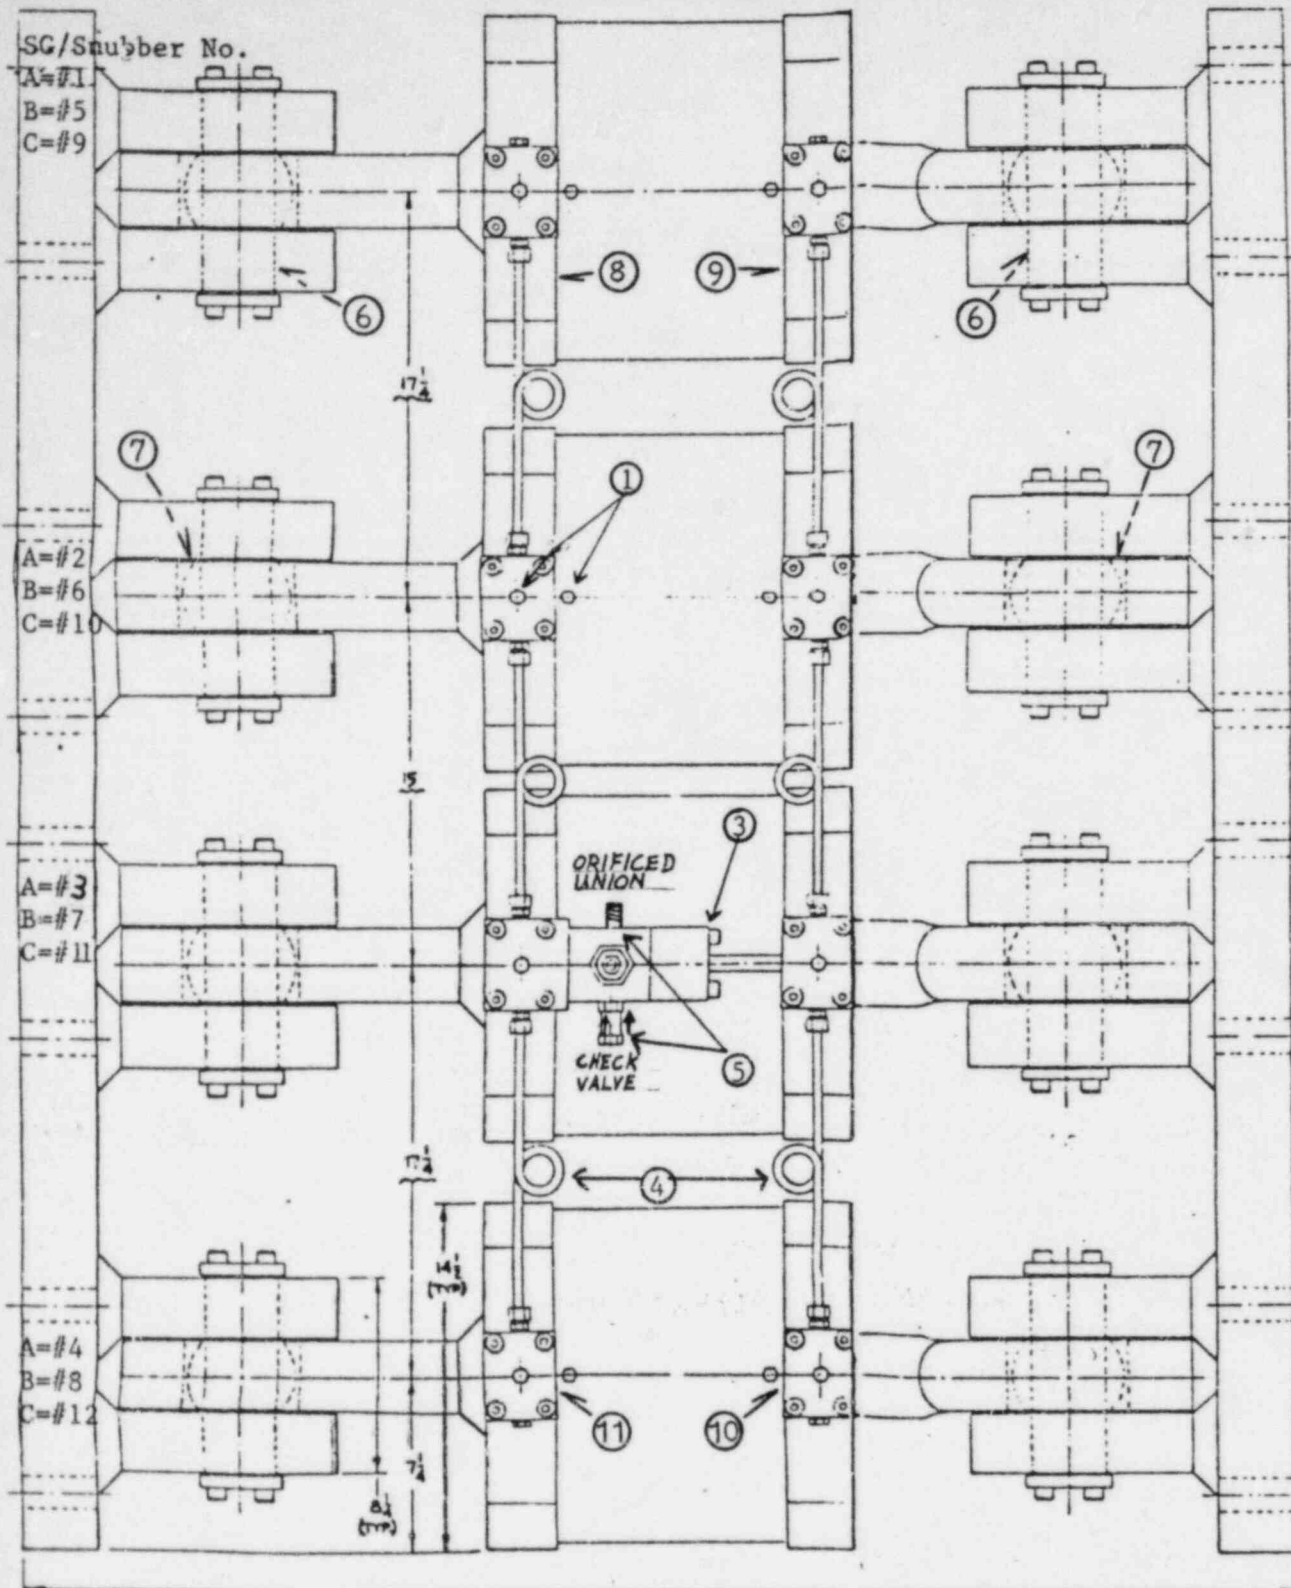
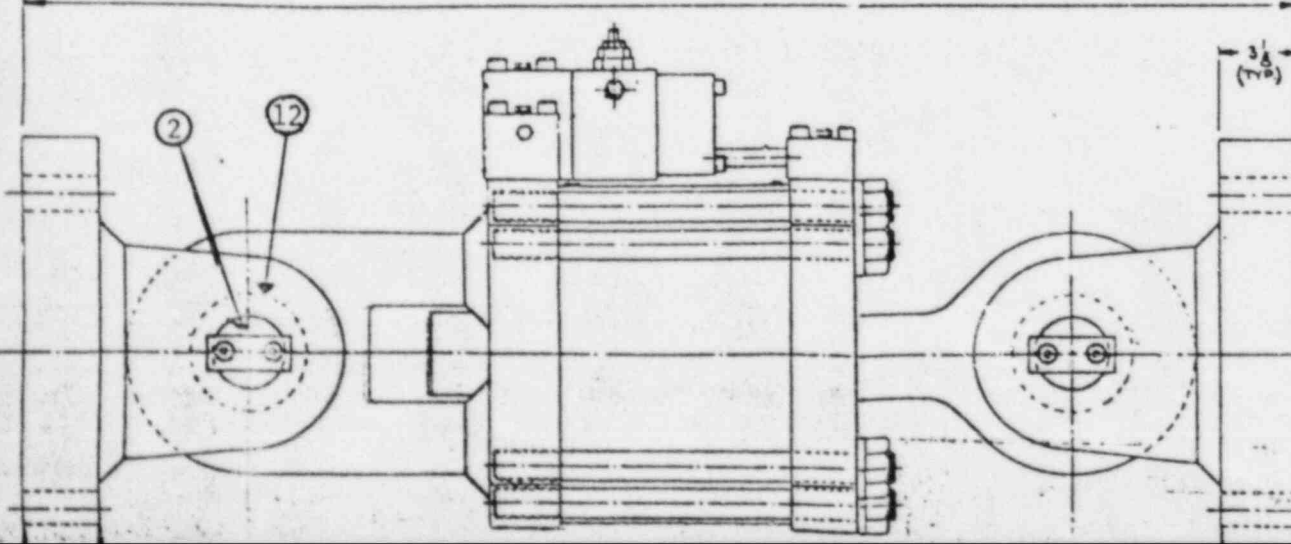
Steam Generator

1. Two snubbers, 2011 and 2014, did not lock up because they were low on fluid.
2. The rear monoball bearing failed while snubber 2011 was under a load of 412,000 pounds force, and the monoball hole was subsequently deformed. The design load for these snubbers is 470,000 pounds force.
3. Snubber 2008 did not meet the lockup velocity requirement of 1 to 10 inches per hour. The tension and compression lockup velocities were 5.75 inches per minute and 4.7 inches per minute, respectively. Snubber 2008 did not meet the bleed rate requirement of 3 to 6 inches per hour. The tension and compression bleed rates were 0.25 inches per minute at 200,000 pounds force.

1. Low fluid level in the snubber may have resulted from the improper installation of the tubing between the control block and the fluid reservoir. The line from the reservoir should have split and connected at two locations on the control block, a check valve connection for make-up from the reservoir, and an orificed connection for return to the reservoir (See Attachment). The orificed connection was originally installed. However, the check valve and the tubing to the control valve for make-up were not installed, and its control valve connection was plugged.

2. The snubber manufacturer, Baxter Fluid Power (Anker-Holth), has submitted a 10CFR21 report on the failure of the rear monoball bearing on snubber 2011. Subsequent to the snubbers' installation, the bearing rating had been revised downward to less than the snubber design load. The load at which the failure occurred (412,000 lbf.) is greater than the load imposed on the steam generator by a seismic event or an RCS line break. However, a main steam line break could impose a load greater than the failure load which would have resulted in probable bearing failure and plastic deformation of the front and/or rear mounting clevis. This failure could have allowed excessive movement of the steam generator

The fluid supply tubing between the control block and the reservoir has subsequently been reinstalled per the snubber manufacturer's requirements to ensure proper reservoir to snubber flow.

The snubbers front and rear attachment clevises and spherical bearings were replaced with components designed for the maximum faulted load, 470,000 lbf.
