Subject: Duane Arnold Energy Center  
Docket No: 50-331  
Op. License No: DPR-49  
Licensee Event Report #95-013, Rev. 1  
File: A-118a

## LICENSEE EVENT REPORT (LER)

HPCI Inoperability Due To Water in HPCI Turbine Steam Exhaust Line

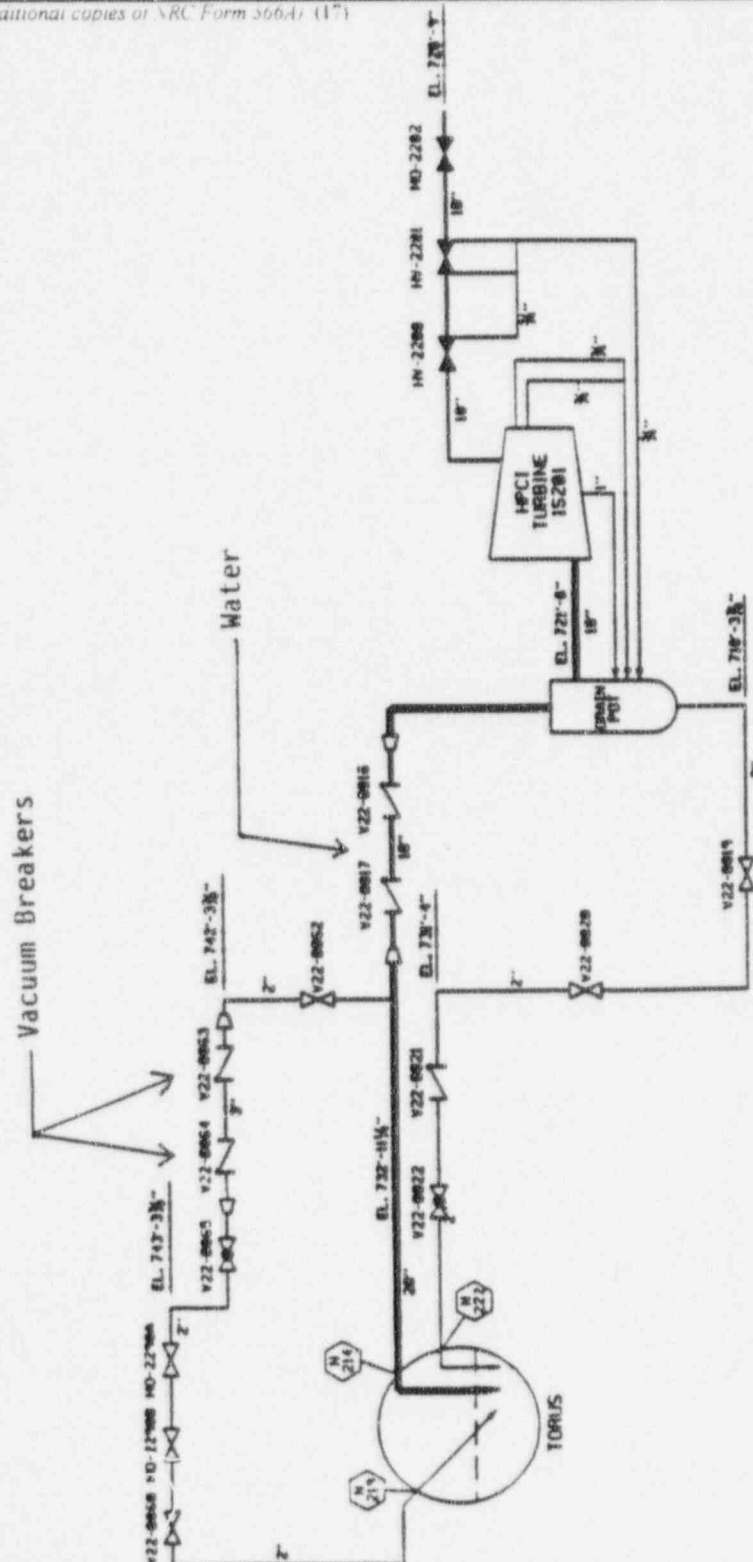
Figure 1  
HPCI System Exhaust Line

On December 21, 1995, during the CMAR investigation, approximately 170 gallons of water were drained from the exhaust line between isolation valve V22-0017 and check valve V22-0016. See Figure 1. The source of this water was not immediately known and the effect of this water on HPCI operability was also unknown. Therefore, at 1003 hours, the HPCI auxiliary oil pump was placed in "pull-to-lock" to prevent HPCI operation. HPCI was declared inoperable and a 14 day Limiting Condition for Operation (LCO) was entered. HPCI was then test run without incident from 2151 to 2222 hours on December 21, 1995, but not declared operable. Following this run, approximately one cup of water was drained from the exhaust line.

Following HPCI turbine operation, steam condensation cycles cause vacuum conditions within the exhaust line as the steam cools. This vacuum is sufficient to draw water from the torus into the exhaust line. Vacuum breakers V22-0063 and V22-0064 (See Figure 1) open upon sufficient vacuum in the exhaust line to allow water in the vertical exhaust line leg to drain to the torus. However, they may not prevent water from entering the exhaust line initially. If valve V22-0017 does not promptly close following turbine operation, the 58 foot length of 16 inch pipe between valves V22-0017 and V22-0016 provides additional vacuum to draw water into the exhaust line from the torus and water may be drawn into the section of pipe between the two valves. The geometry of valve V22-0017 is such that a dam exists that will not allow water in the bottom half of the horizontal pipe between the two valves to drain out to the torus, even when V22-0017 is open. It is believed that valve V22-0017 was open long enough following HPCI operation on December 15 and 27 and on January 11 to draw water into the exhaust line in this manner. Chemical analysis of the water drained from the exhaust line supported the conclusion that the water came from the torus.

Once water is in this section of the exhaust line, it is trapped except for possible minor leakage through valve V22-0016 to the drain pot. (The possibility of water becoming trapped in the exhaust line following HPCI operation was documented in 1973 General Electric correspondence.) The vacuum breakers were verified to be operable and leakage past check valve V22-0016 was measured and found to be acceptable but increased from the previous refuel outage test. This increased leakage past check valve V22-0016 resulted in the additional and prolonged drain pot alarms that ultimately caused HPCI to be declared inoperable as discussed above. Valve V22-0016 was subsequently inspected and repaired on January 11, 1996.

- Water was found in the exhaust line only between valves V22-0017 and V22-0016, and not in the HPCI turbine.
- The HPCI exhaust line is horizontal with no vertical loop seals.
- The horizontal pipe where the water was found should be no more than half full.
- The pipe diameter increases from 16 inches to 20 inches downstream of V22-0017, decreasing potential water slug velocity in the downstream piping during HPCI operation.
- General Electric Service Information Letter 480 has been implemented at DAEC, providing a softer HPCI startup transient.
- Vacuum breakers V22-0063 and V22-0064 were verified to be operable.
- Non-intrusive monitoring of V22-0017 operation indicated normal disc to seat contact upon flow reduction, indicating that its isolation function is operable and leak rate testing found seat leakage within the acceptable range.

A subsequent test of the HPCI system on January 11, 1996 showed that the exhaust line could potentially be more than half full of water. The potential to be more than half full is supported by a more detailed engineering review of the V22-0017 valve geometry (i.e., the valve seat is physically above the pipe centerline). Also by this date, it was determined that water in the line could potentially form a solid water slug upon HPCI initiation. Preliminary analysis supported by General Electric determined that in spite of these two changes from the December 22 operability determination, the HPCI system would still be able to fulfill its safety function. Work on a final detailed analysis is underway.

- With support from General Electric, a detailed analysis of HPCI operability with water in the turbine exhaust line will be performed. This analysis will be completed by May 1, 1996.
- The HPCI exhaust line will continue to be drained following each HPCI run until the detailed analysis has been reviewed by the Operations Committee. This is implemented via Operations Department Shift Orders.
- Valve V22-0017 will be opened and inspected during the next cold shutdown. CMAR A28281 has been written for this inspection. This will be completed no later than December 31, 1996.
- Valve V22-0016 was repaired under CMAR A28570 on January 11, 1996.
