TENNESSEE VALLEY AUTHORITY - SEQUOYAH NUCLEAR PLANT UNIT 1 AND UNIT 2 -  
DOCKET NOS. 50-327 AND 50-328 - FACILITY OPERATING LICENSES DPR-77 AND  
DPR-79 - LICENSEE EVENT REPORT (LER) 50-327/92007, REVISION 1

## LICENSEE EVENT REPORT (LER)

FACILITY NAME (1) Sequoyah Nuclear Plant, Unit 1										DOCKET NUMBER (2)   PAGE (3) 05101013   2   17   110F   1   1									
TITLE (4) Inoperable Ice Condenser Lower Inlet Doors Because of Upward Movement of the Floor																			
EVENT DAY (5)					LER NUMBER (6)					REPORT DATE (7)					OTHER FACILITIES INVOLVED (8)				
					SEQUENTIAL   REVISION					FACILITY NAMES   DOCKET NUMBER(S)									
MONTH   DAY   YEAR   YEAR					NUMBER   NUMBER					MONTH   DAY   YEAR					Sequoyah, Unit 2   05101013   2   8				
0   3   1   6   9   2   9   2					0   0   7   0   1   0   6   1   6   9   2					05101010   1   1									
OPERATING MODE (9)   THIS REPORT IS SUBMITTED PURSUANT TO THE REQUIREMENTS OF 10 CFR 5: (Check one or more of the following)(11)

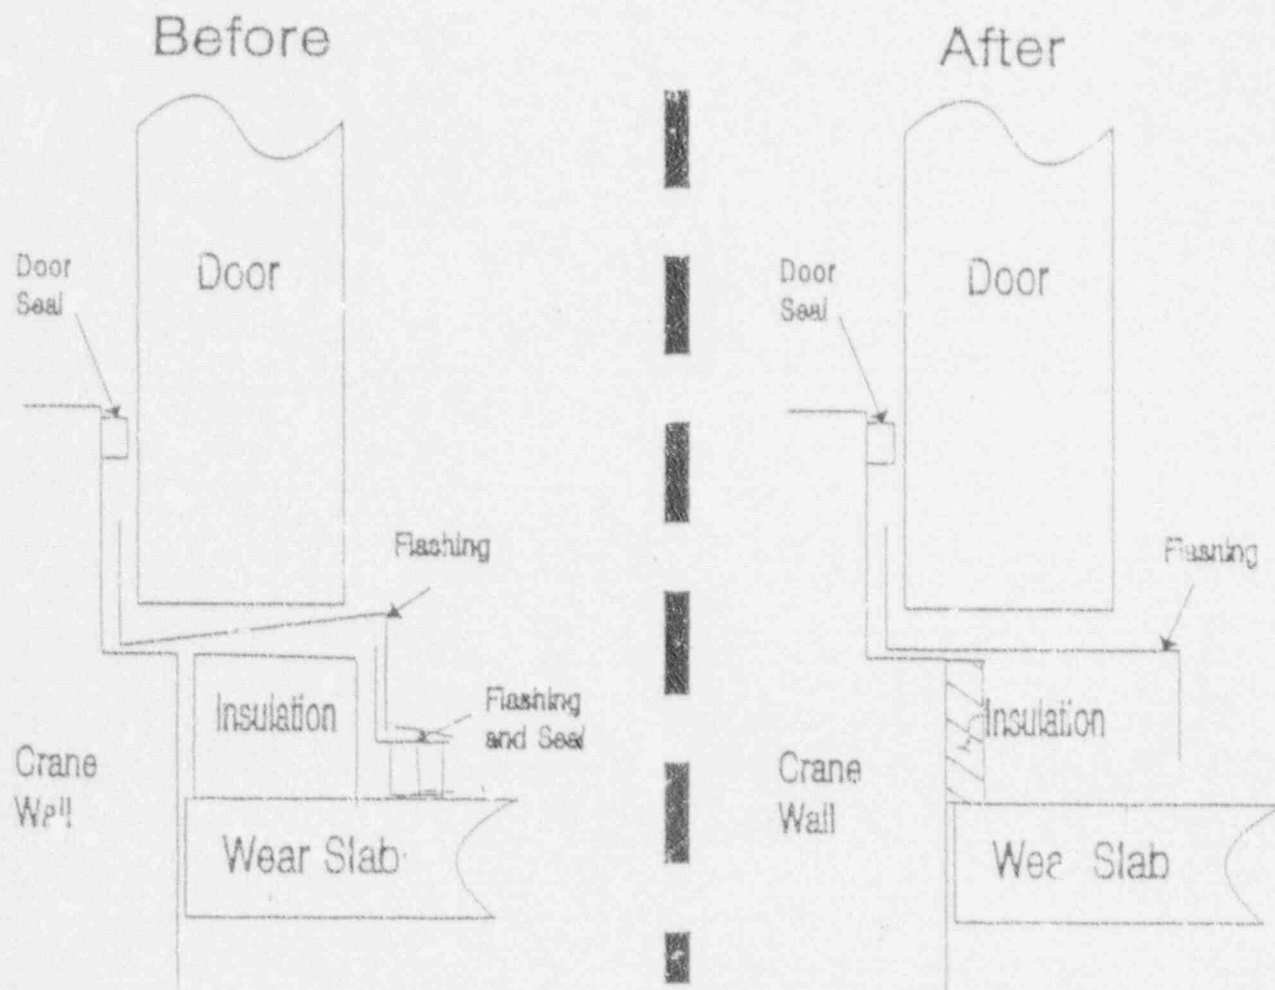
Figure 1

- A. On March 16, 1992, Technical Support and Systems (TSS) personnel were informed by the ice condenser maintenance crews that several of the Unit 2 ice condenser (E11S Code BC) lower inlet doors were inhibited from opening. TSS personnel performed a walkdown of the ice condenser doors and confirmed that the doors would not move as freely as required. TSS then initiated a problem evaluation report. The TSS personnel initially believed that the insulation beneath the doors had absorbed water, frozen, and expanded up underneath the doors, thus "jamming" the doors. On March 17, 1992, a team of TSS and Nuclear Engineering (NE) personnel inspected the Unit 2 ice condenser doors. During the inspection, ice condenser maintenance personnel informed them that they had seen cracks in the floor slab. The team inspected the floor slab in detail and identified the cracks in the floor and concluded that the floor slab had moved upward in various locations resulting in interference between the sheetmetal flashing and the base of the doors (see attached Figure 1).

Ice Condenser Lower Inlet Door

3. A temporary modification was performed to remove the lower "L-shaped" sheetmetal flashing and gasket mounted on the wear slab and connected to the flashing piece that forms the jam for the lower inlet doors (see Figure 1). This removed the interference with the bottom of the doors and provided physical margin for wear slab growth without interference with the doors.

5. A second temporary modification was implemented to replace the insulation bags installed under the flashing with a double layer of Armaflex rubber insulation. This provided improved sealing of air-leakage paths and ensured retention under accident conditions (see Figure 1).

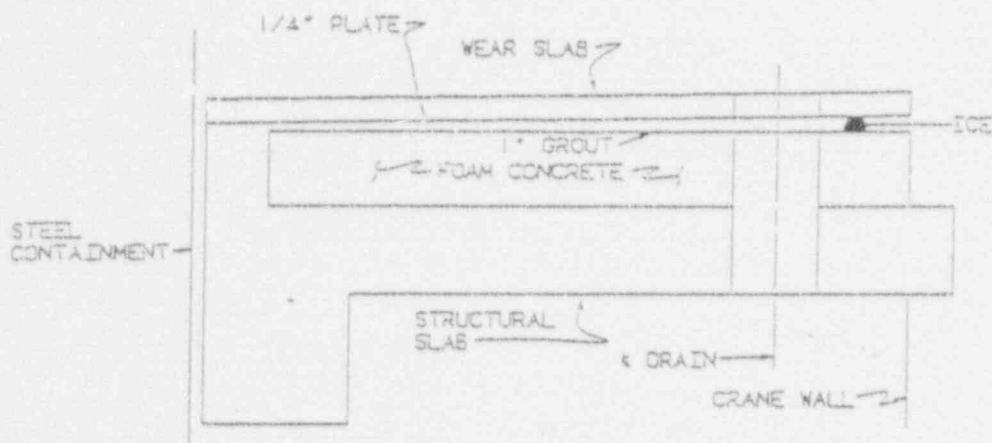
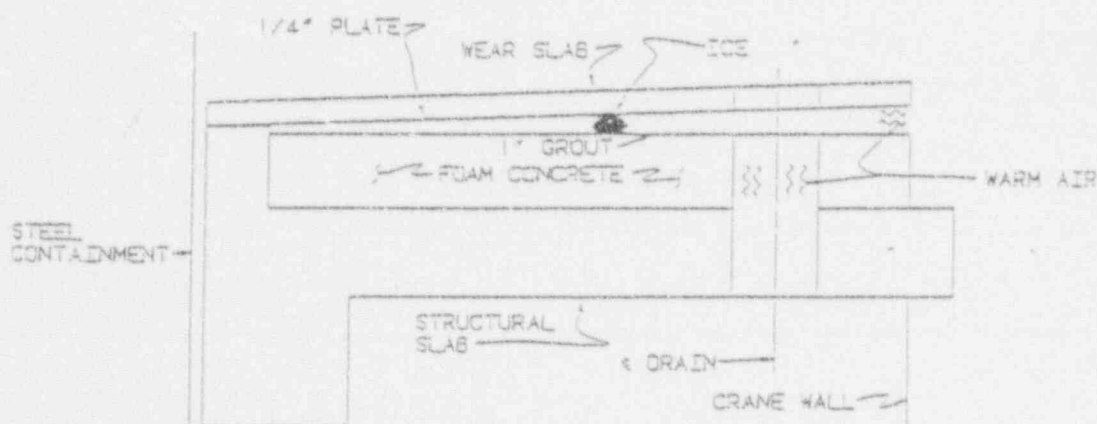
The immediate cause of the wear slab degradation was water intrusion, freezing, and expansion within the floor assembly. (See Figure 2 for depiction of floor assembly.)

The root cause of this condition was determined to be the failure to install sealant material in some of the wear slab joints during initial construction, thereby providing paths for water intrusion to the floor assembly.

Also, the design of the floor assembly allowed the 1/4-inch plate located beneath the wear slab to be installed on hardened grout, allowing voids to form beneath the plate.
